**Building Audit/Assessment**

**City of Fridley  
Municipal Center  
6431 University Avenue NE  
Fridley, MN 55432**

**December 6, 2013**

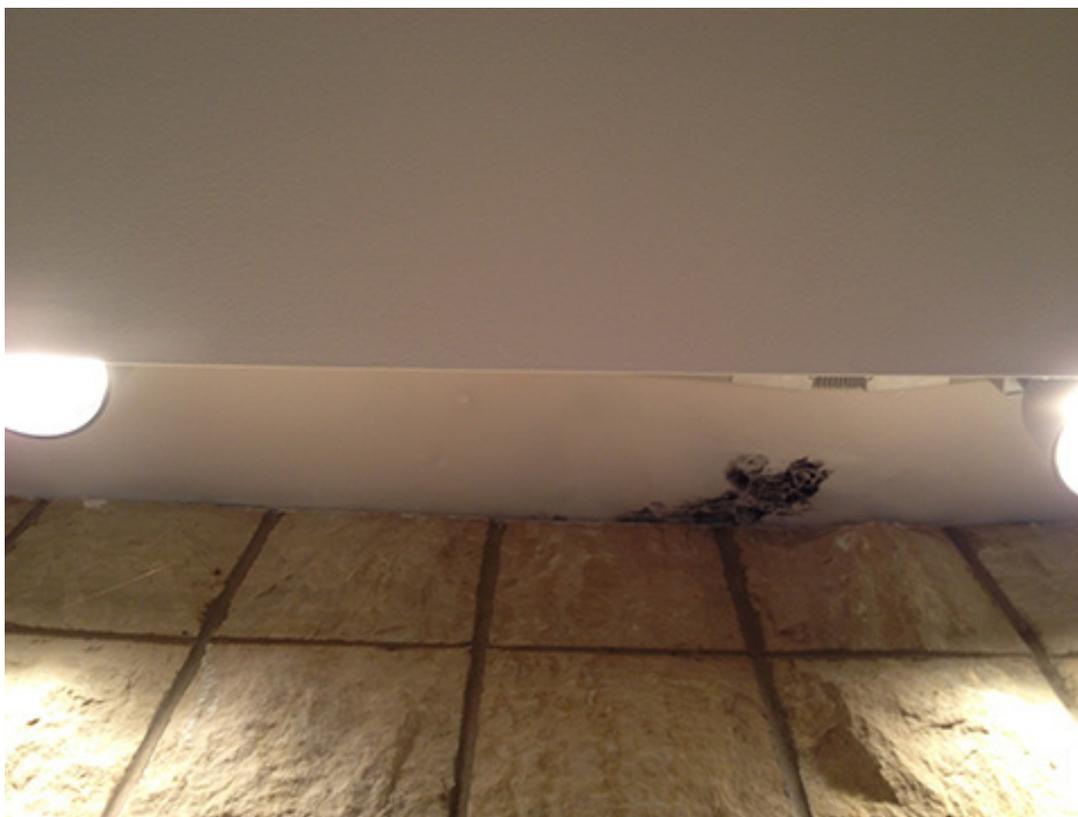
1

- East wall has a history of water leaks (photo 1).

City Hall Council Chambers: Water leakage on east wall

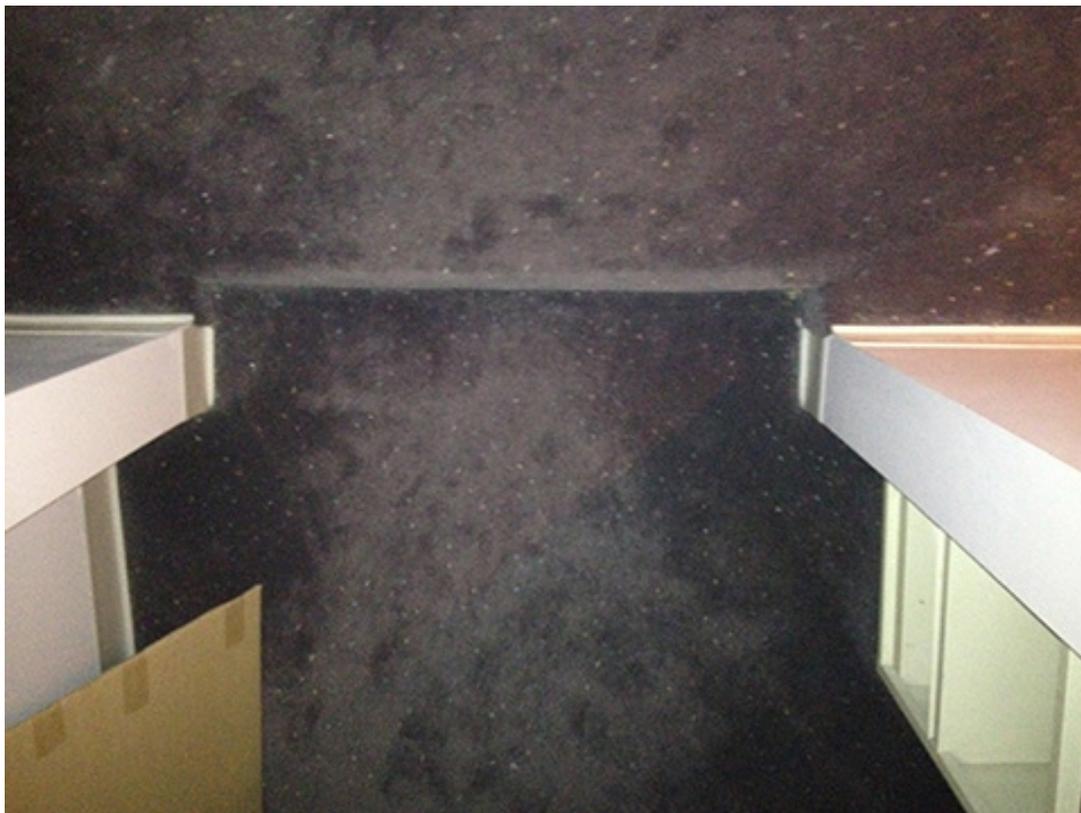
3

City Hall- AV Room: Wall damage & possible water infiltration at wall base

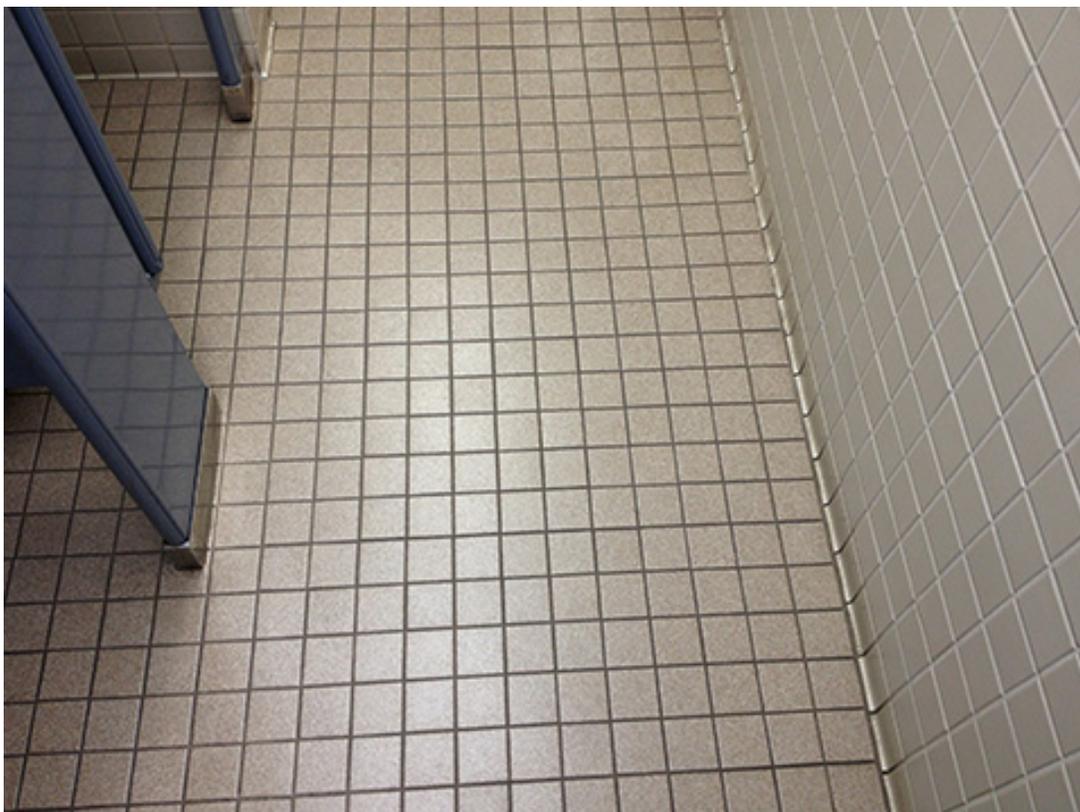
15

Restroom ADA Non-Compliance: Inadequate clearances at water closets, grab bars required

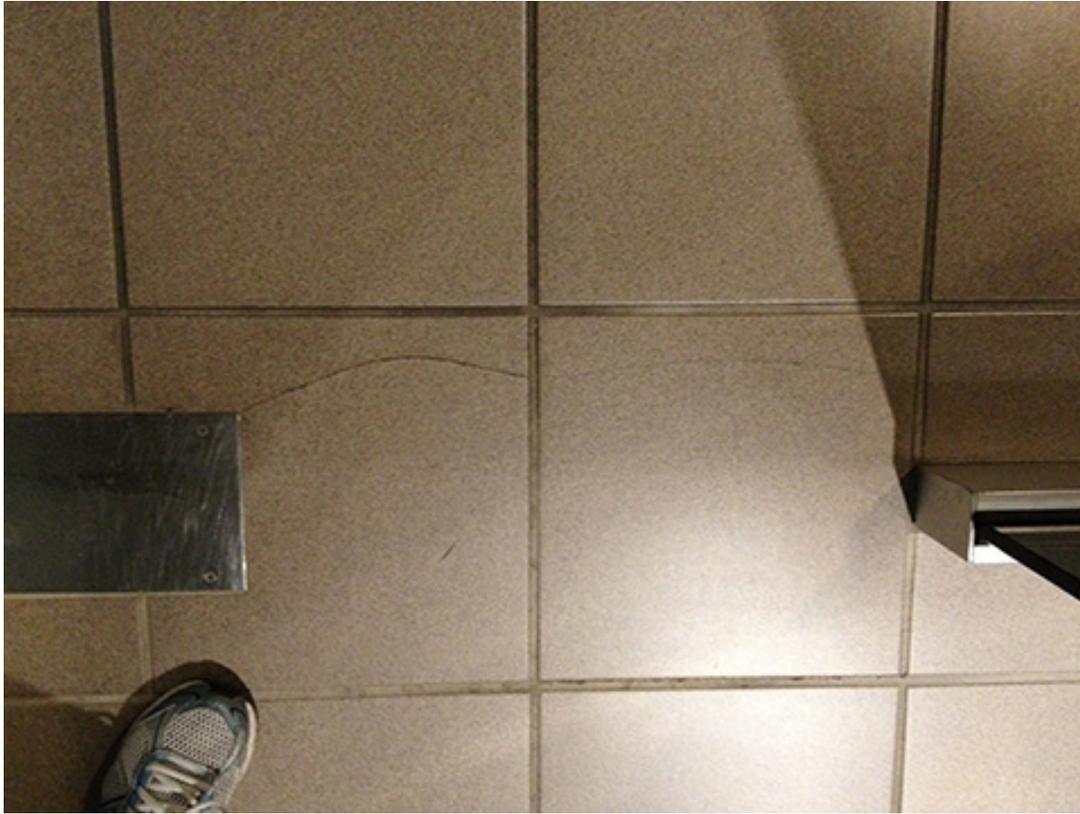
16

Restroom ADA Non-Compliance: Inadequate circulation clearances

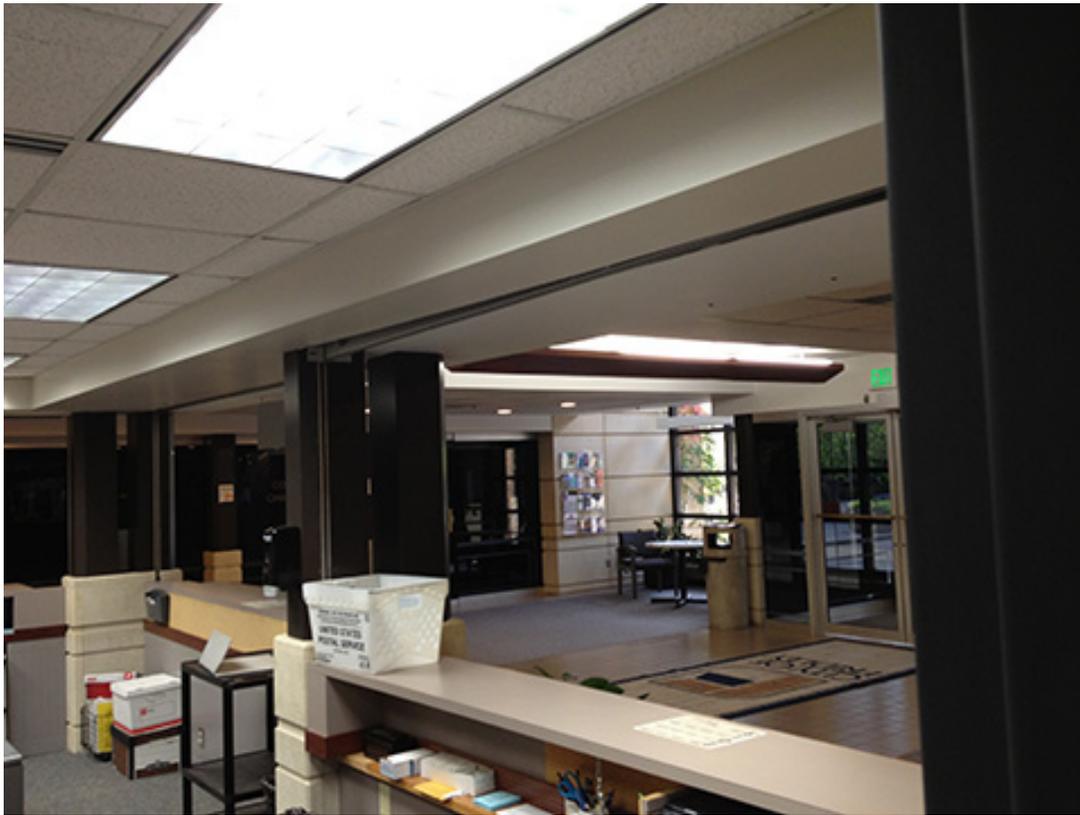
18

City Hall- Public Hallway: Carpet screwed to coiling grilles to protect public counters

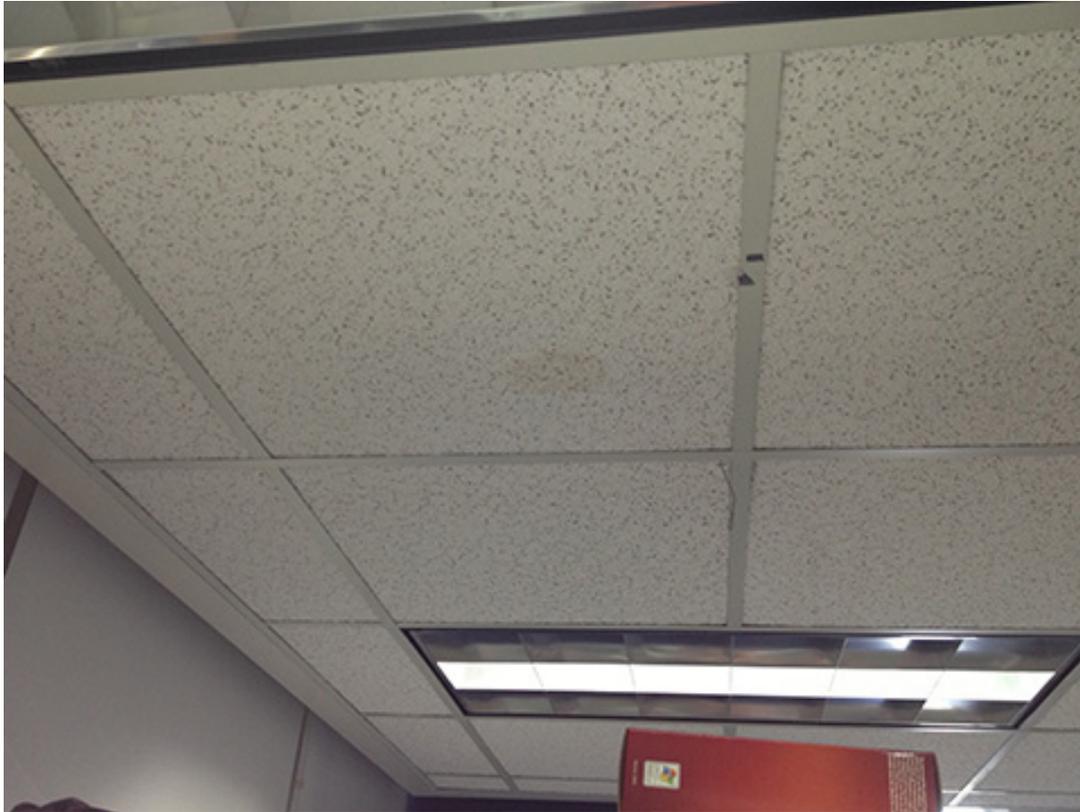
22

- Signs of water leaks or condensation dripping, as indicated by stained ceiling tiles (photos 22, 23).
- Sink is not accessible (photos 67, 71).
- There is a single riser at the server room access and not enough clear floor space at the door into the server room (photos 24, 25).

City Hall- Offices: Stained ceiling tiles from water leaks/condensation

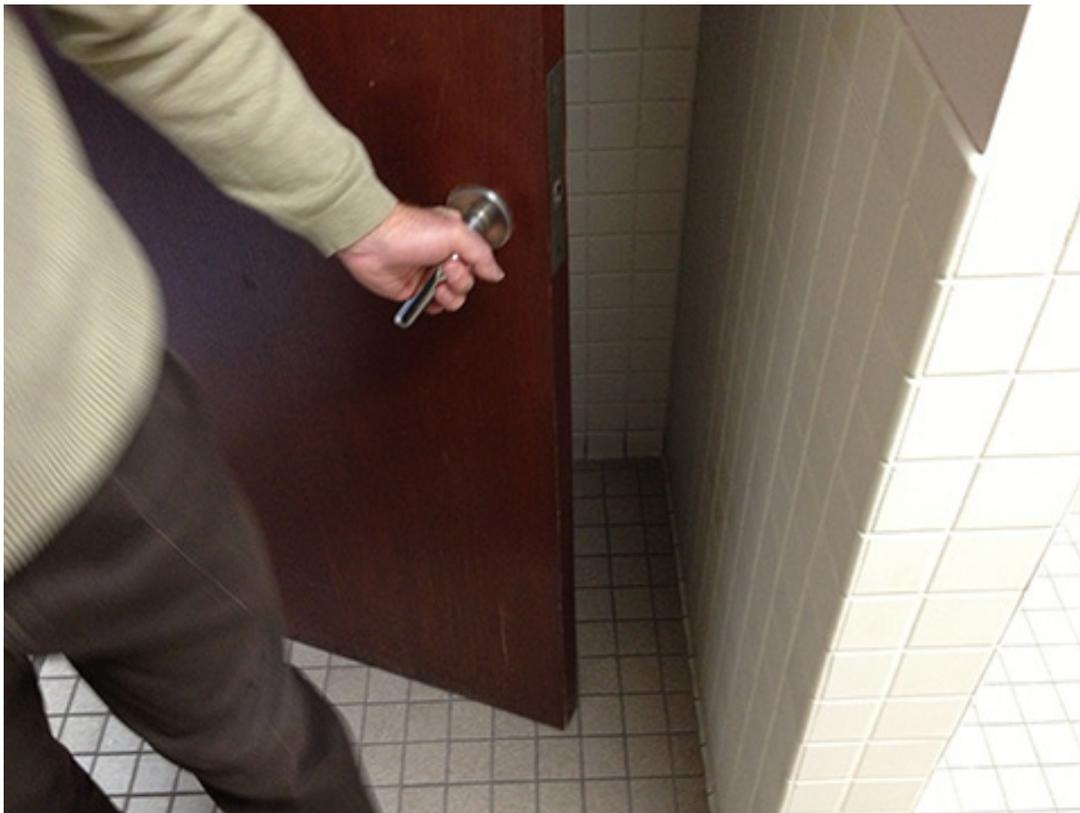
27

General ADA Non-Compliance: Inadequate clearance on pull approach, latch side of door

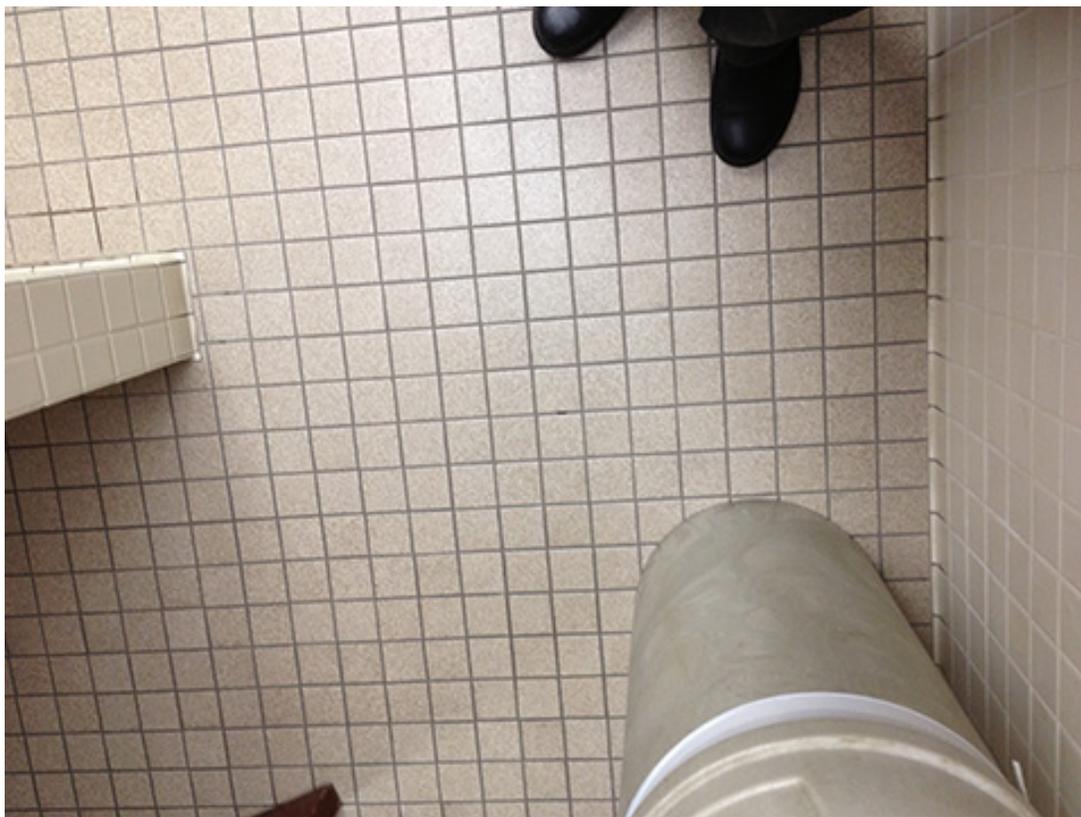
28

General ADA Non-Compliance: Inadequate door swing clearance

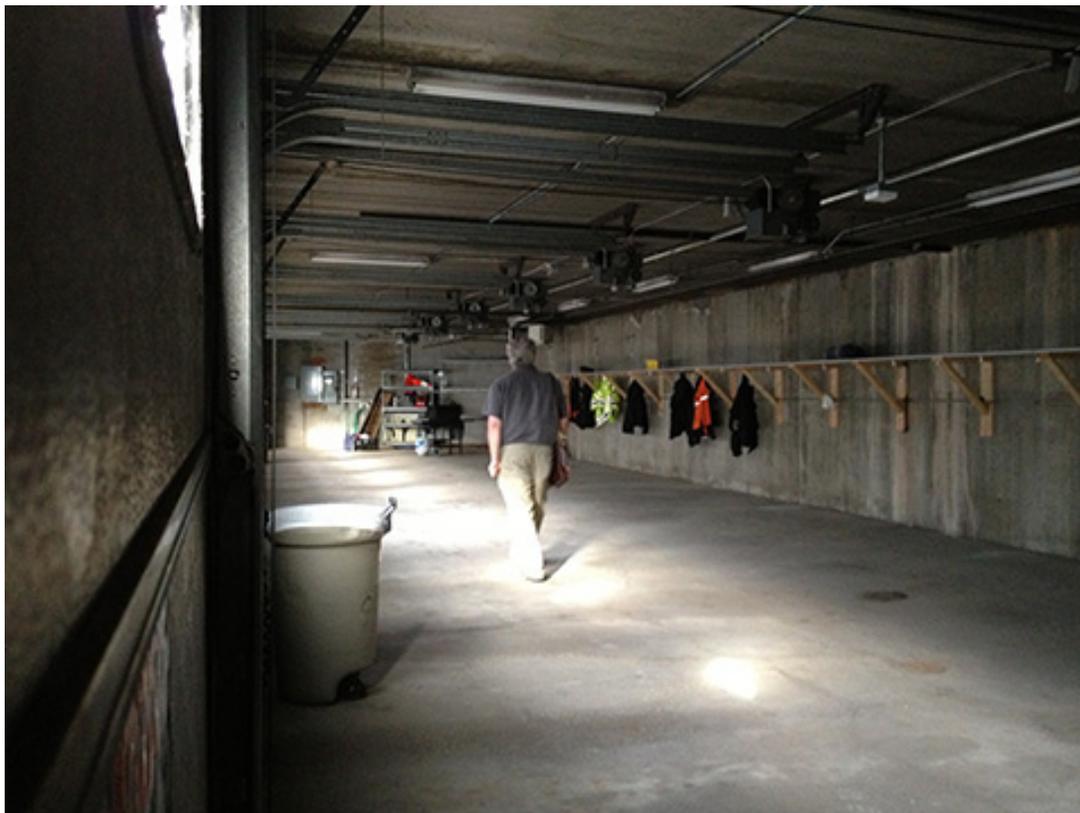
40

- Mechanical room does not have adequate service clearance space (photo 40).
- Asbestos floor tile at the storage room (photos 48, 91).
- Water damage and patching is evident (photo 92).

Clty Hall- Mechanical Services & Storage space: Inadequate service clearance space

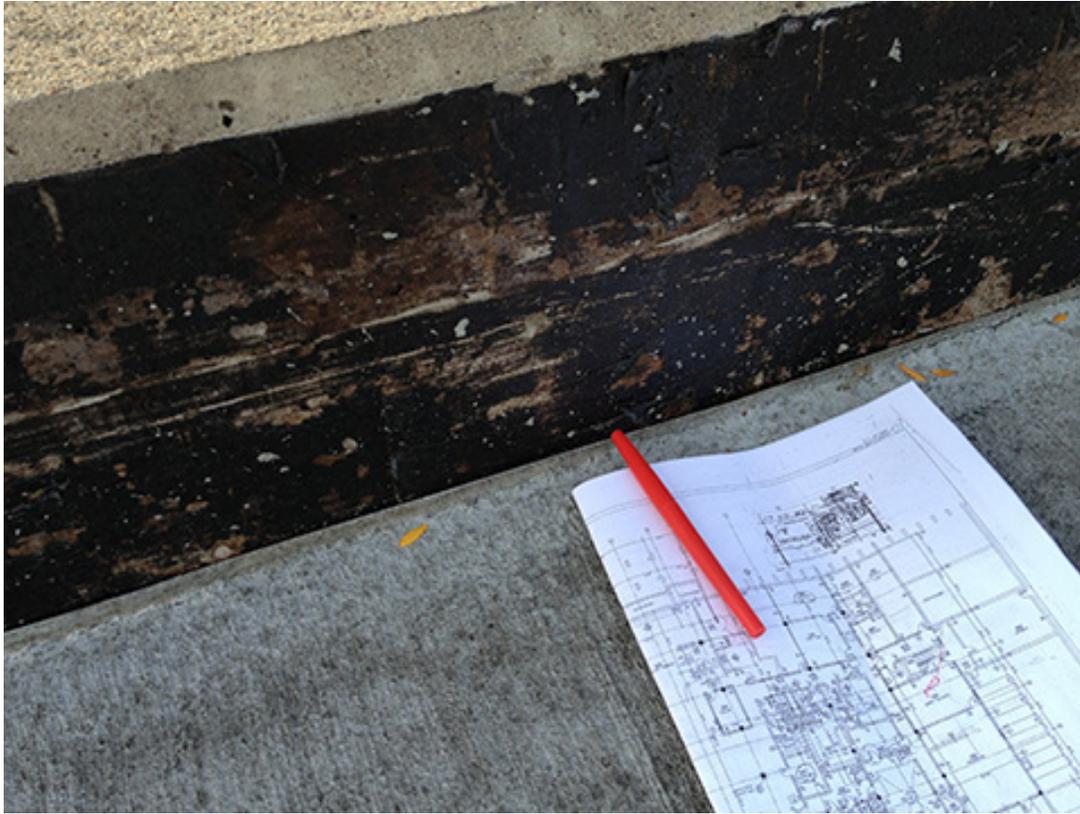
46

Wall finish missing at base.....?

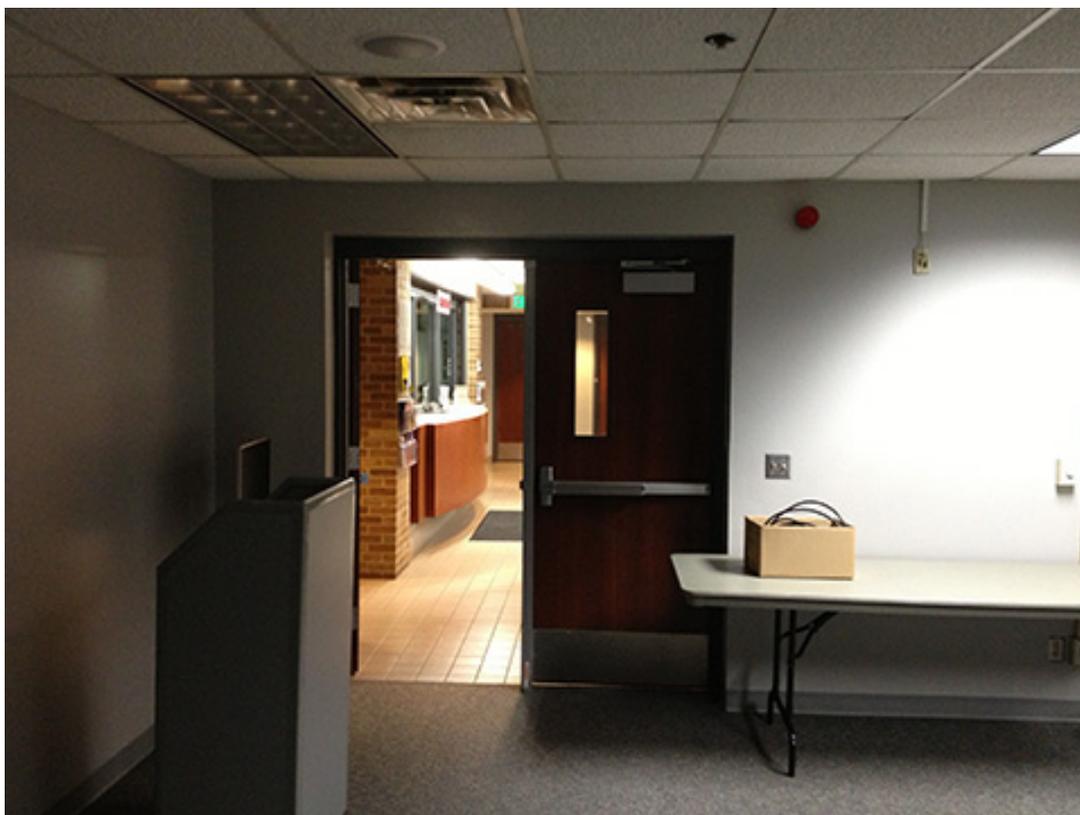
49

- Toilet Rooms are not accessible, see general comments (photos 94, 95).
- Counter is not accessible (photo 49).
- Potential security or ricochet risk with pass through (photos 49, 107).
- Locker room space is crowded and inadequate (photo 99).
- Sink is not accessible (photo 98).

Police Dept: Non-Compliant ADA counter height, potential security risk at pass-through  
General ADA Non-Compliance: Inadequate accessible height at counters

**Public Service Counter.** The counter is not accessible and should be replaced / modified for accessibility.

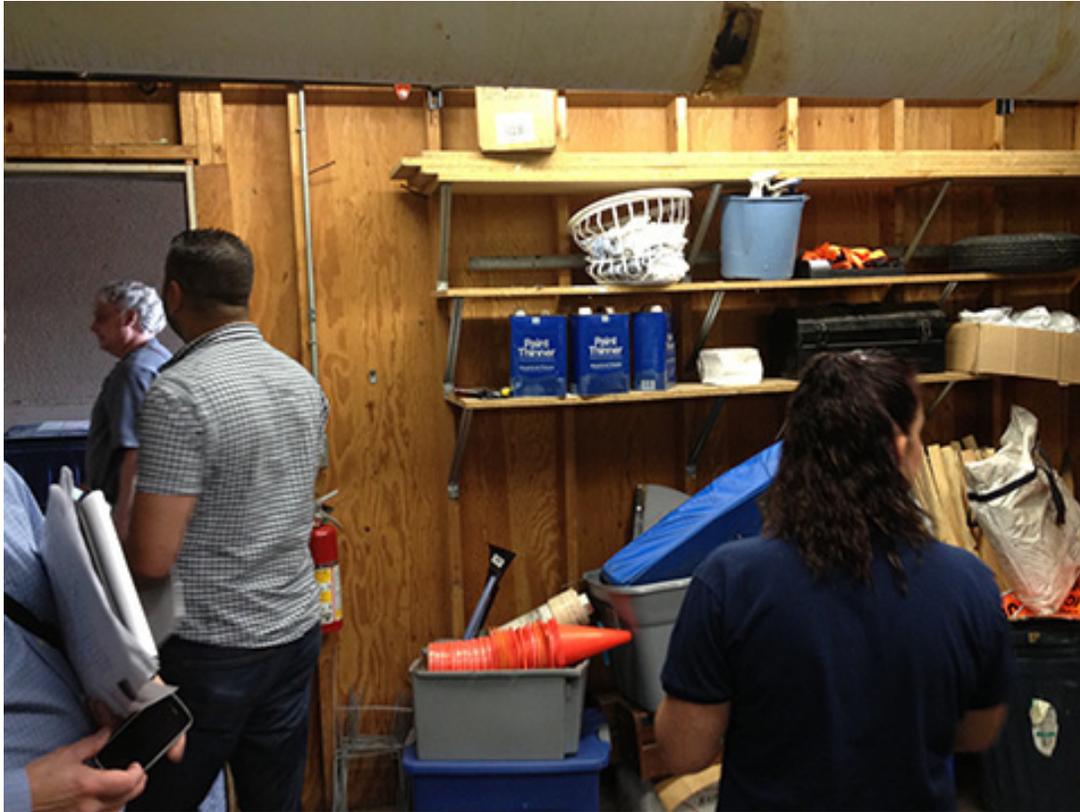
56

- Exposed wood framing (photos 56, 57).
- Low head clearance.
- Insufficient clear floor space to access electrical room (photo 59).
- Inadequate, shared storage (photo 57).
- Missing pipe insulation (photo 115).
- Water damage, ceiling sections falling in (photo 115).
- Piping clearance, access and space conflicts (photo 116).
- Lack of safe circulation space at fitness equipment (photo 117).
- General mildew smell throughout fitness area (photos 118, 119, 120, 121).
- Locker / shower rooms do not meet accessibility code; do not have adequate clearances (photo 119).
- Circulation spaces as narrow as 14" wide were documented (code minimum is 32").
- Women's shower room door cannot close all of the way (photo 119).
- Peeling paint (photo 119).

Fire Station: Exposed wood framing

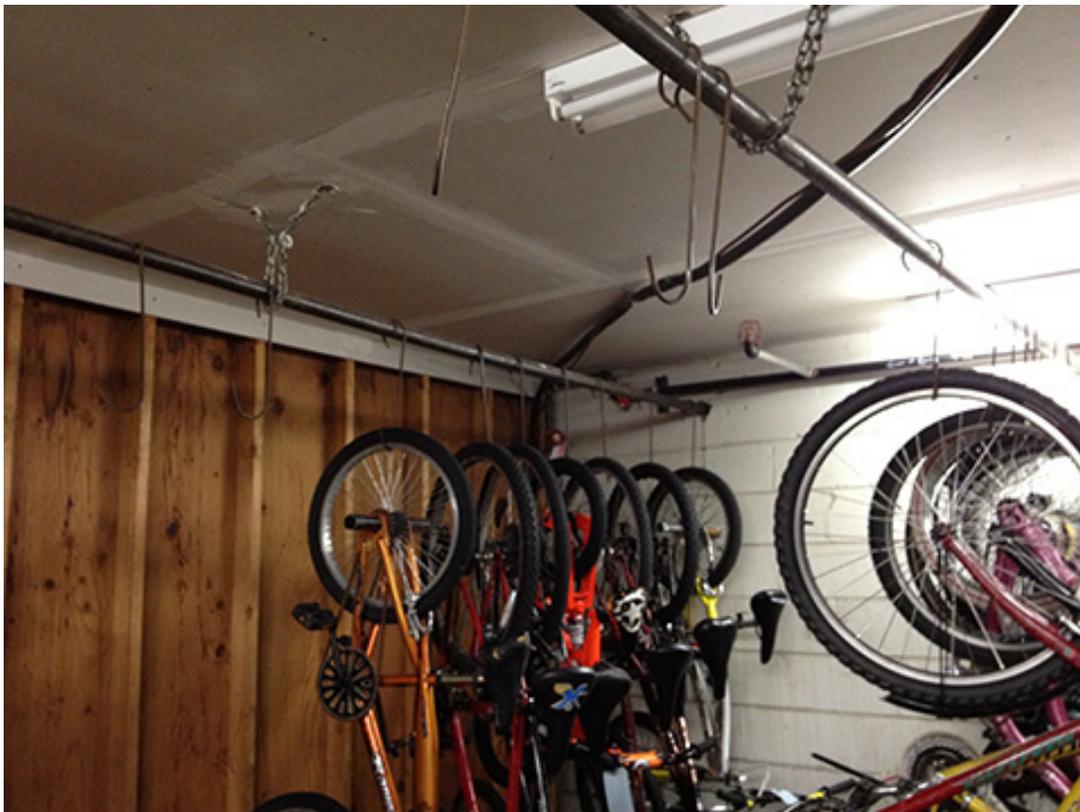
57

Fire Station: Inadequate shared storage

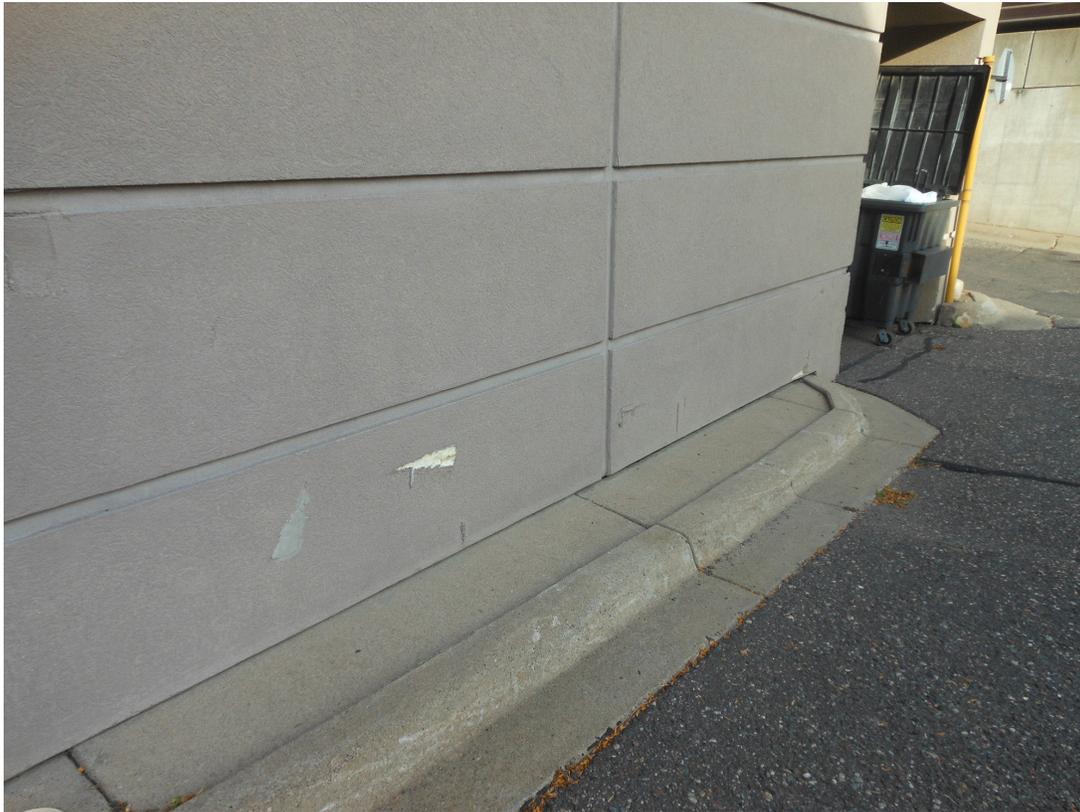
72

Fire Station: Damaged exterior EIFS stucco

**EIFS Stucco.** Stucco finish should be patched and repairs at all locations on facility. No areas of severe damage exist, but nearly all surfaces with this finish have multiple areas of damage.

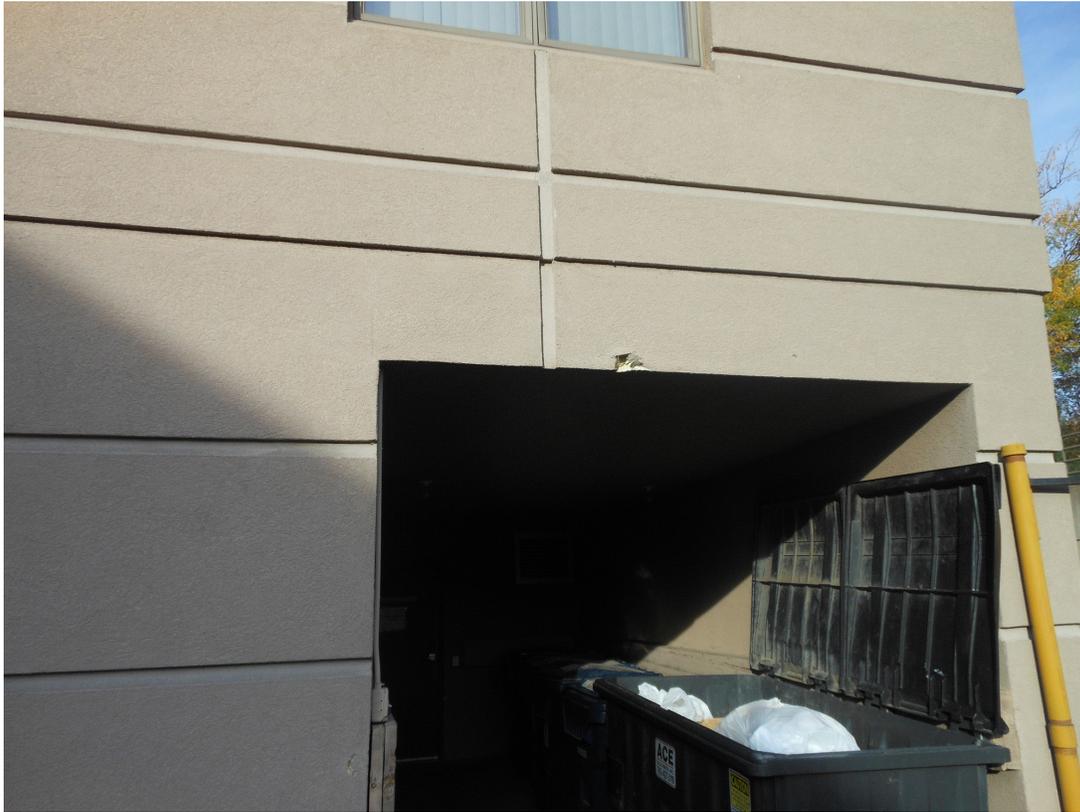
74

Fire Station: Damaged exterior EIFS stucco

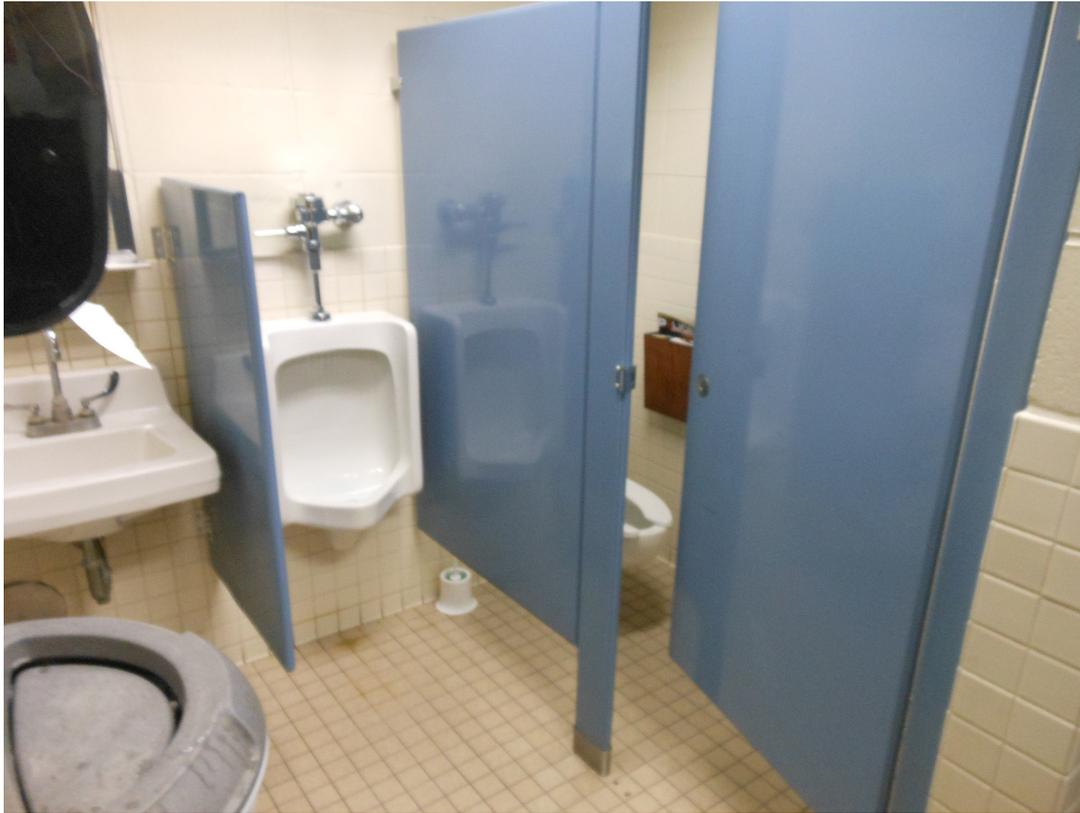
94

Restroom ADA Non-Compliance: Inadequate accessible clearance at showers, grab bars required

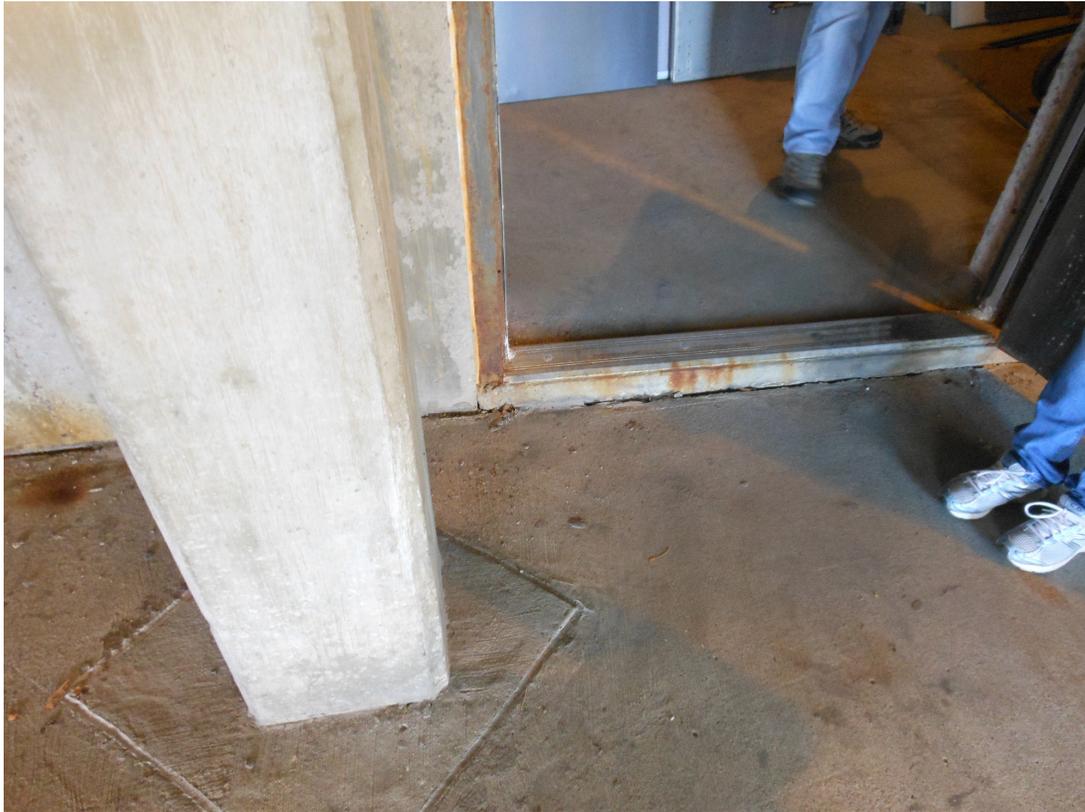
108

Lower Level Public Entrance: Rusty doors and frames

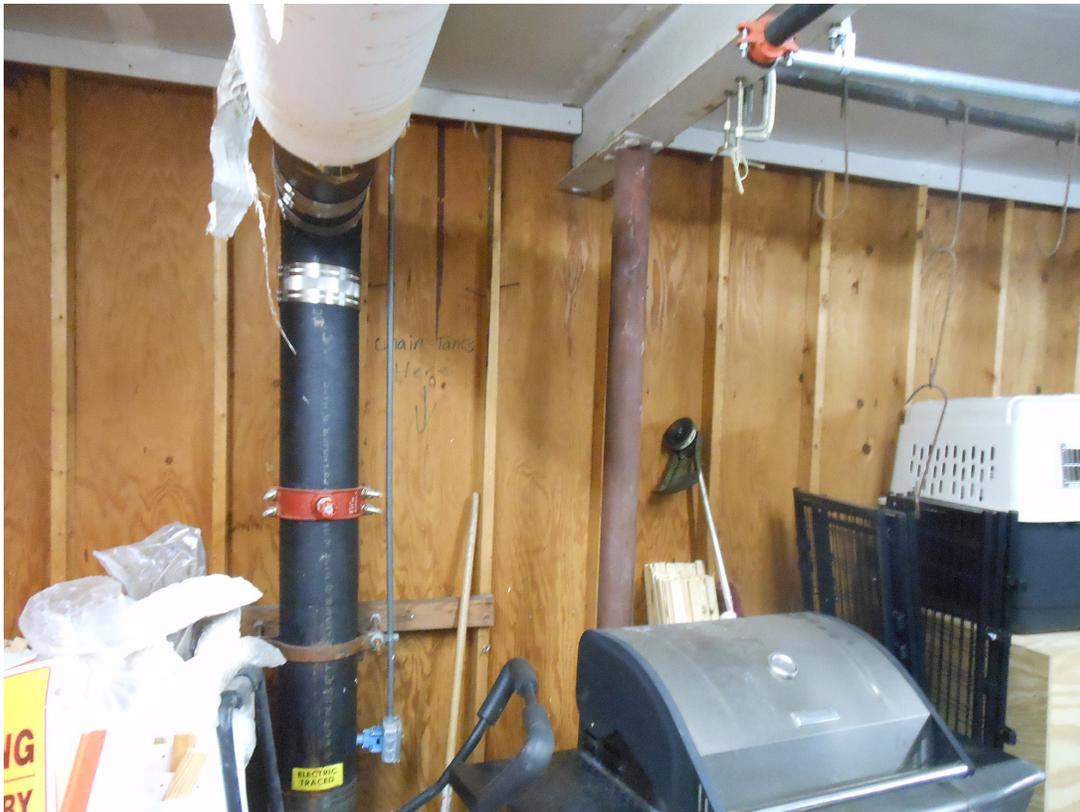
113

Police Dept: Inadequate storage space

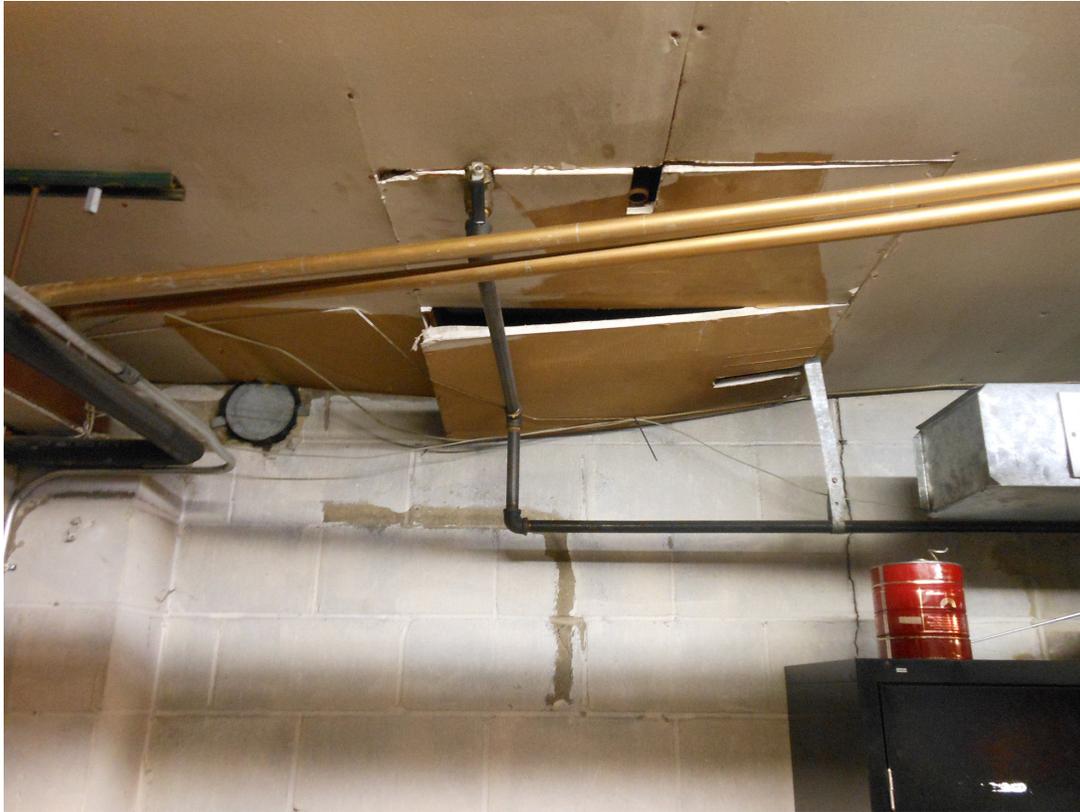
114

Inadequate storage and inadequate insulation at main standpipe

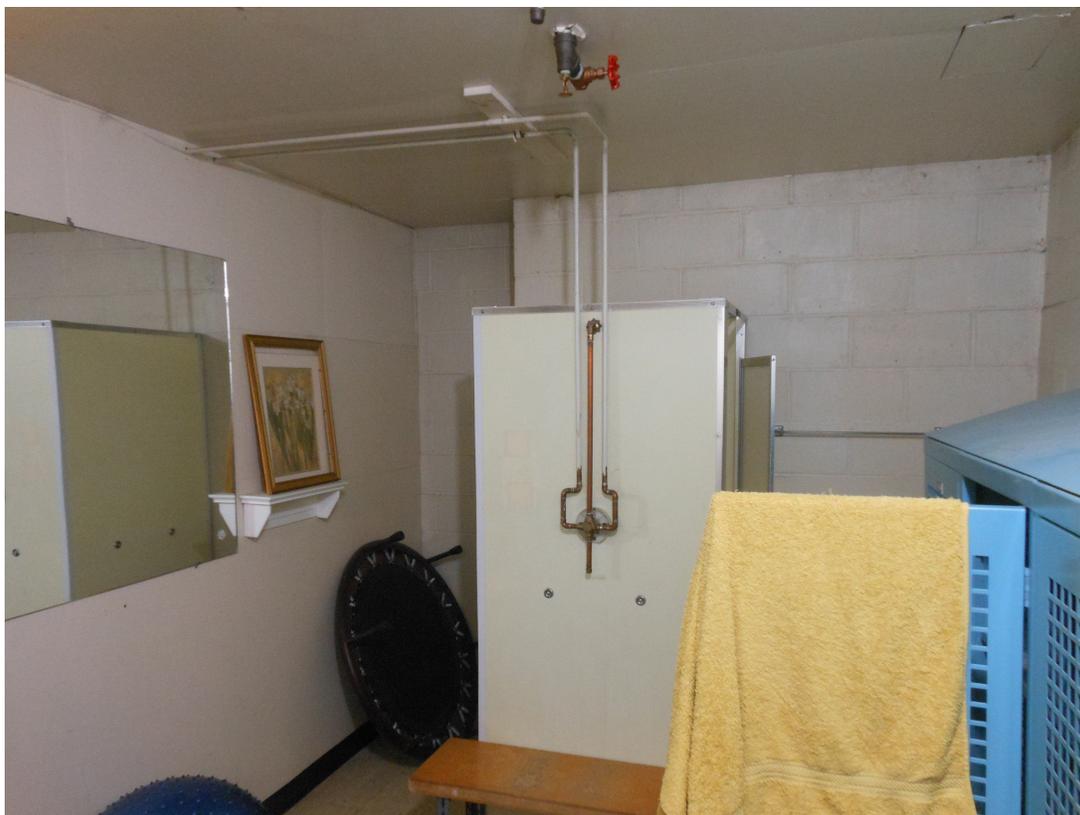
120

Shared Fitness Center: Locker room spaces non-accessible, inadequate clearances, general mildew smell 5-60

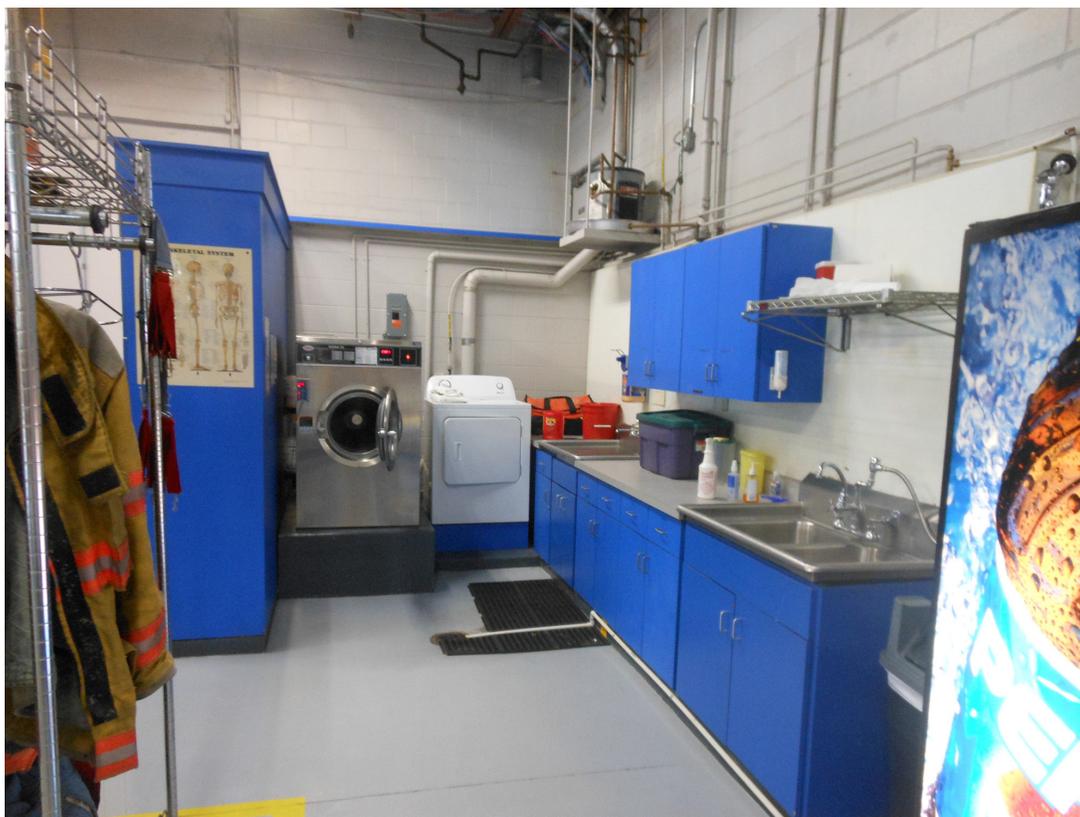
133

Fire Station: Hose tower inadequate ventilation & storage space

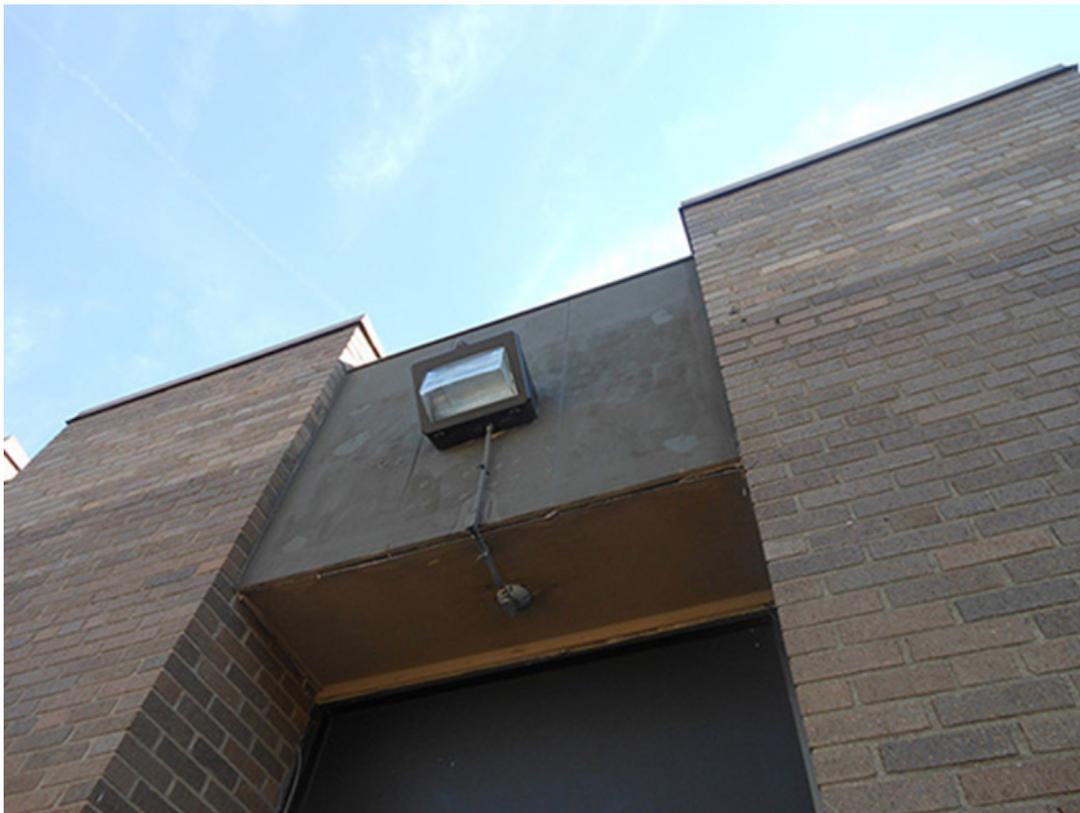
141

Municipal Center: Sealant at exterior window frames needs replacement, brick efflorescence

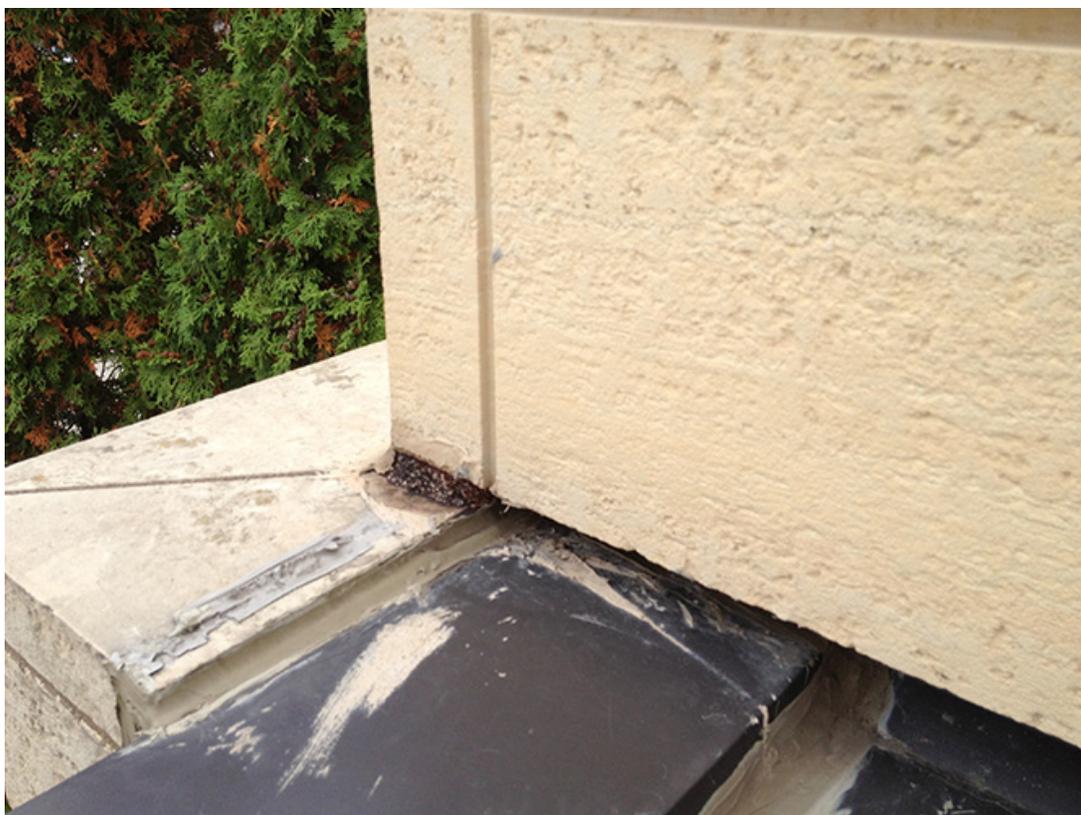
152

Municipal Center Roof: Stone veneer to higher roof area has cracked sealant

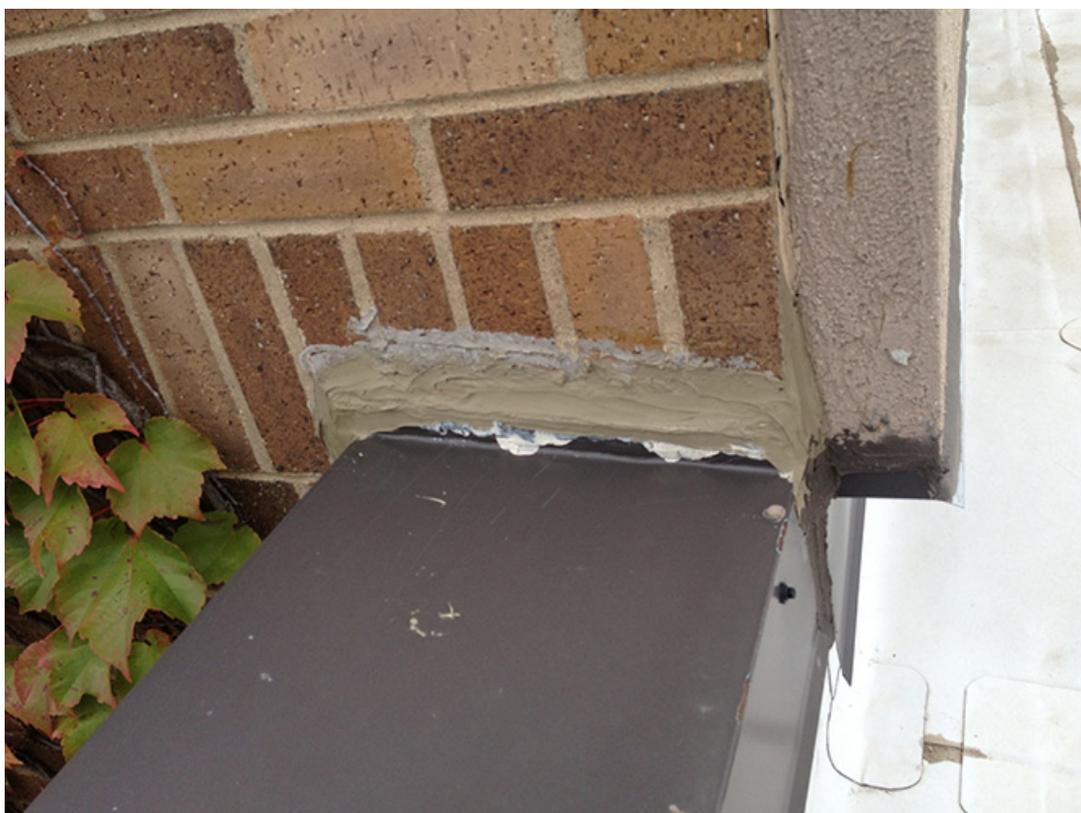
153

Municipal Center: Joints/sealants at wall base need replacement

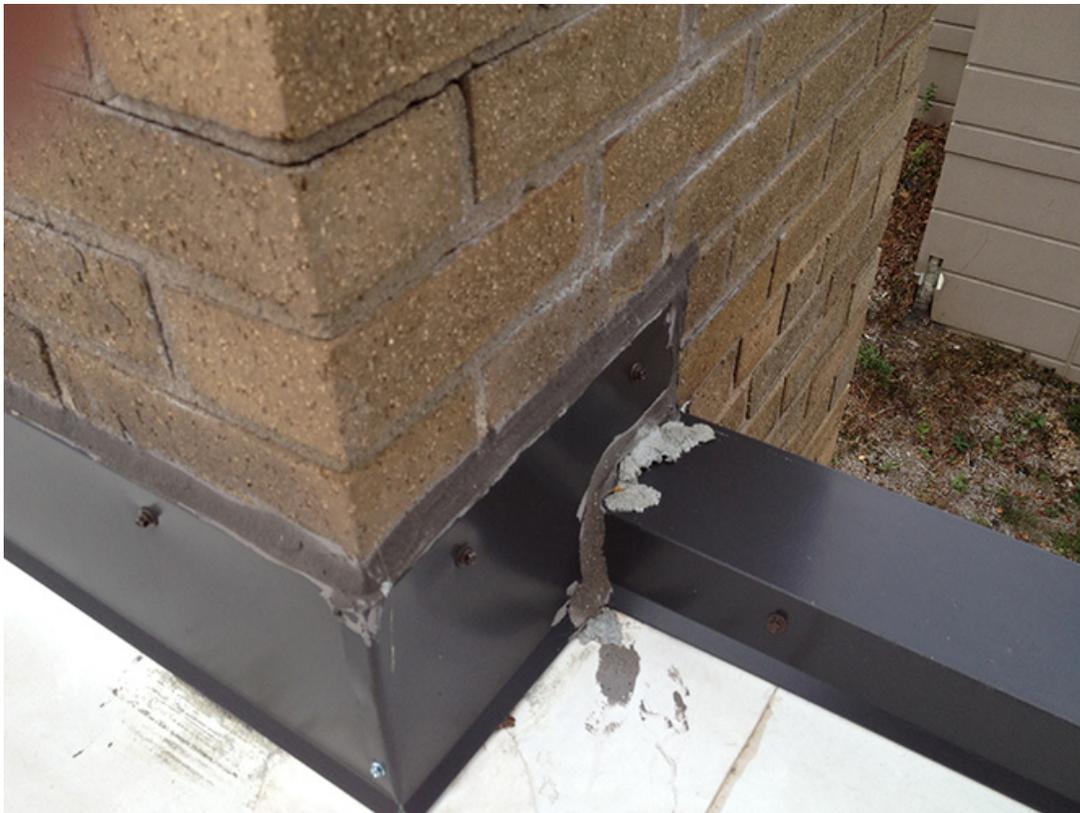
155

Municipal Center Roof: Joints and sealants of lower roof areas need replacement
