**Building Audit/Assessment**

**City of Fridley  
Municipal Center  
6431 University Avenue NE  
Fridley, MN 55432**

**December 6, 2013**

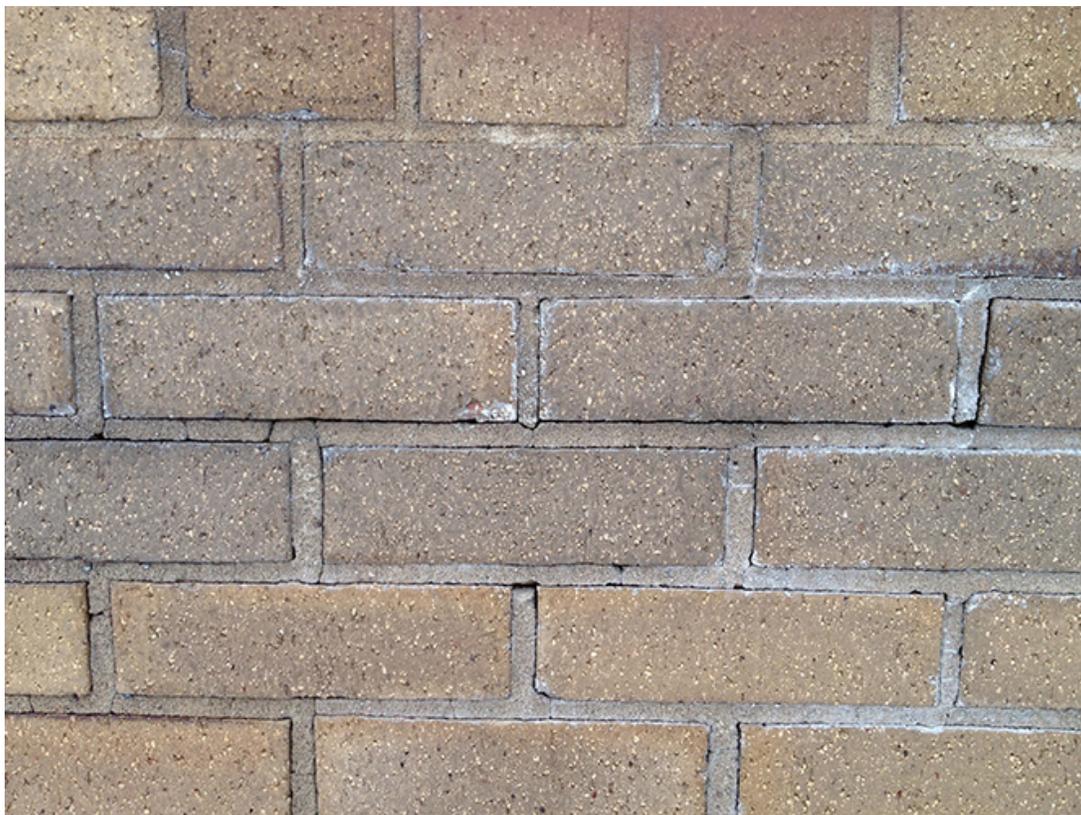
156

Municipal Center Roof: Joints and sealants of lower roof areas need replacement

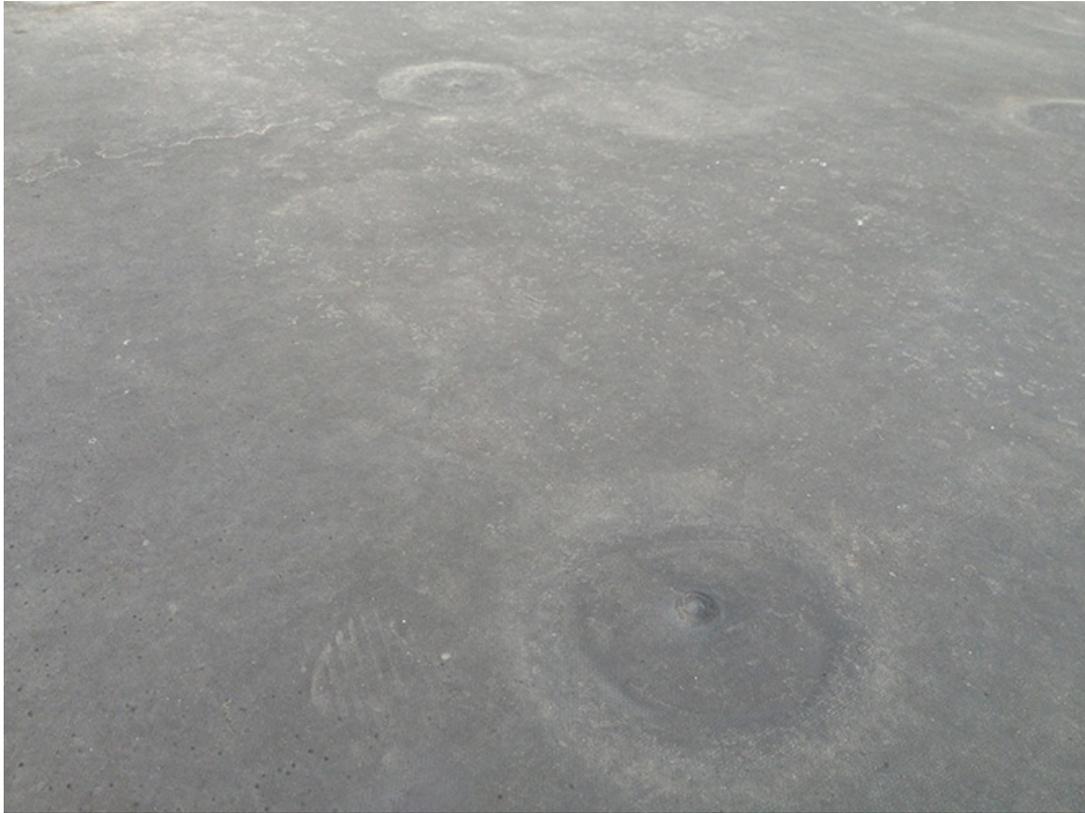
162

Fire Station Roof: Ponding in areas

**Roofing.** Numerous smaller roofs on the City Hall building should be considered for replacement. The Fire Station roof is beyond its serviceable life and has numerous patches and areas of ponding. It should be replaced. Scuppers should have proper extensions installed and open faced downspouts should be considered.

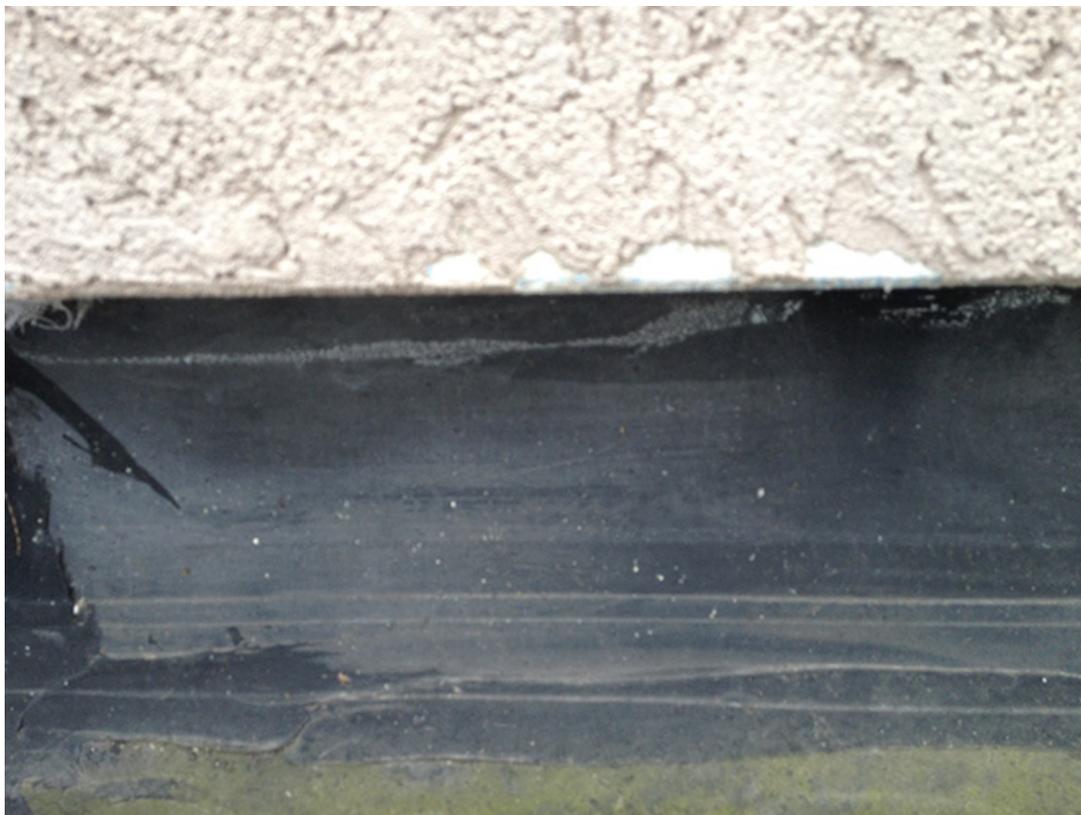
184

Fire Station Roof: Damaged stucco finish on roof

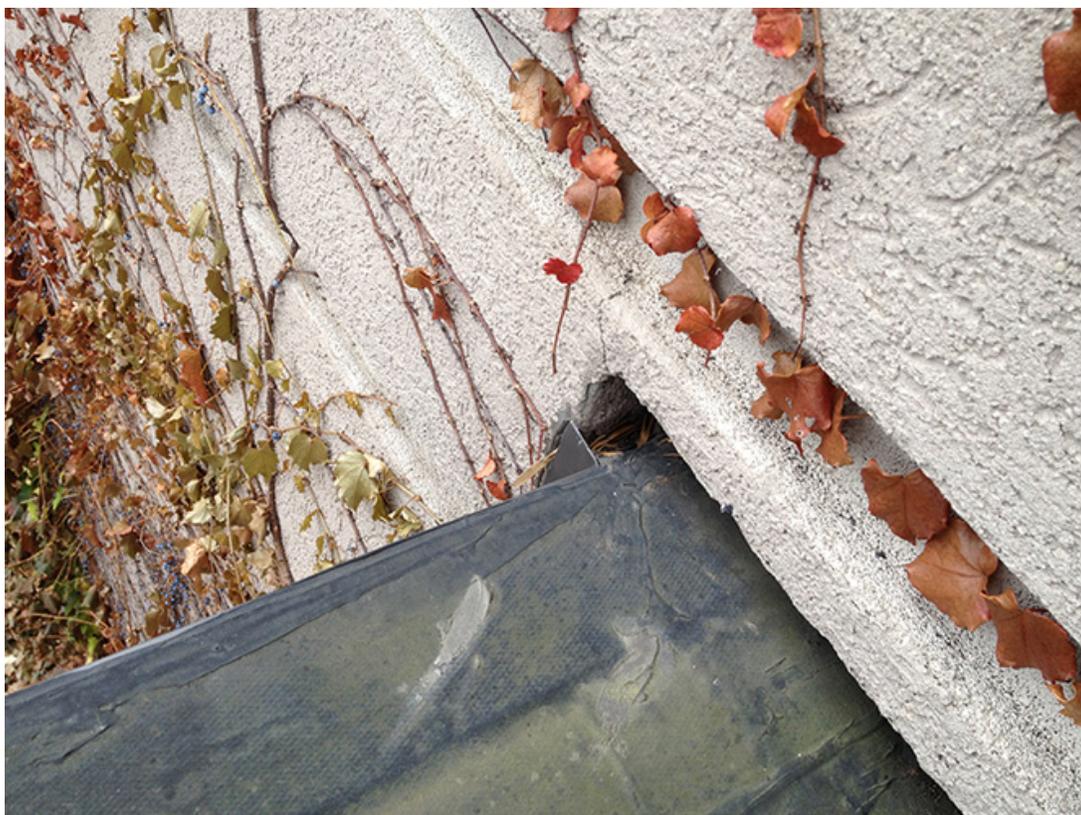
185

Fire Station Roof: Damaged stucco finish on roof

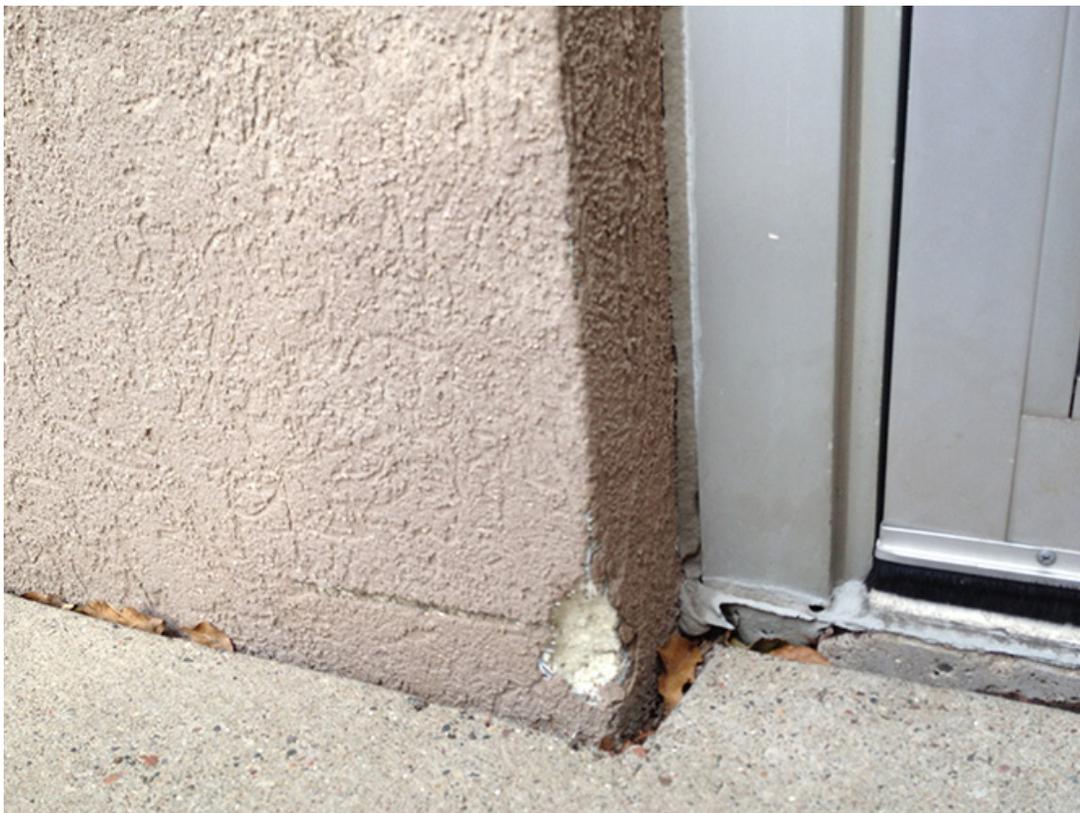
189

Fire Station: Damaged EIFS exterior panels.

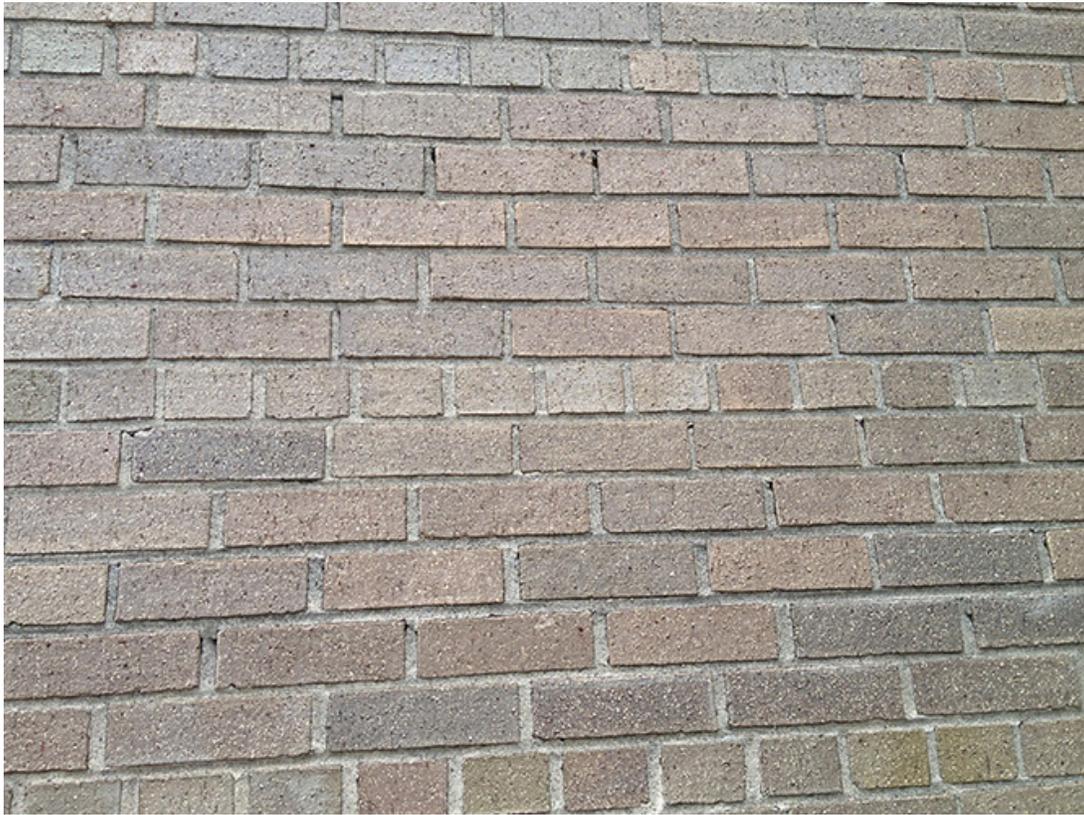
194

Municipal Center: Damaged exterior brick

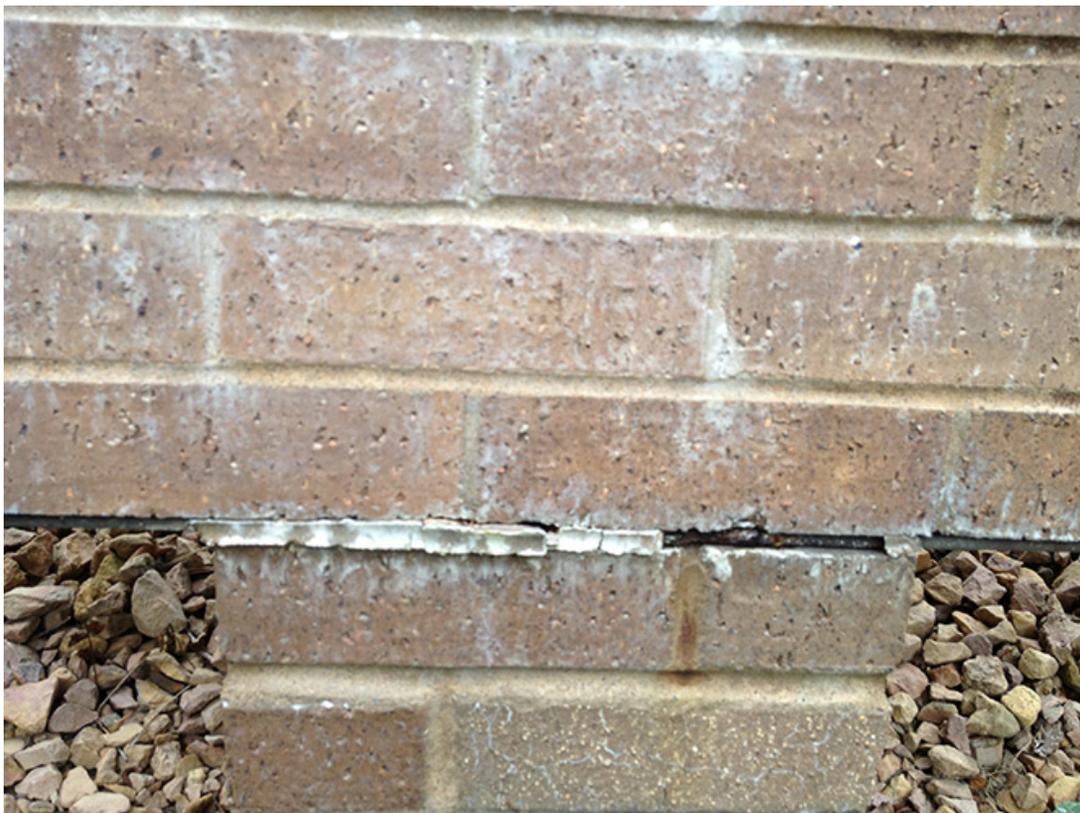
199

Municipal Center: Sealant at exterior window frames needs replacement

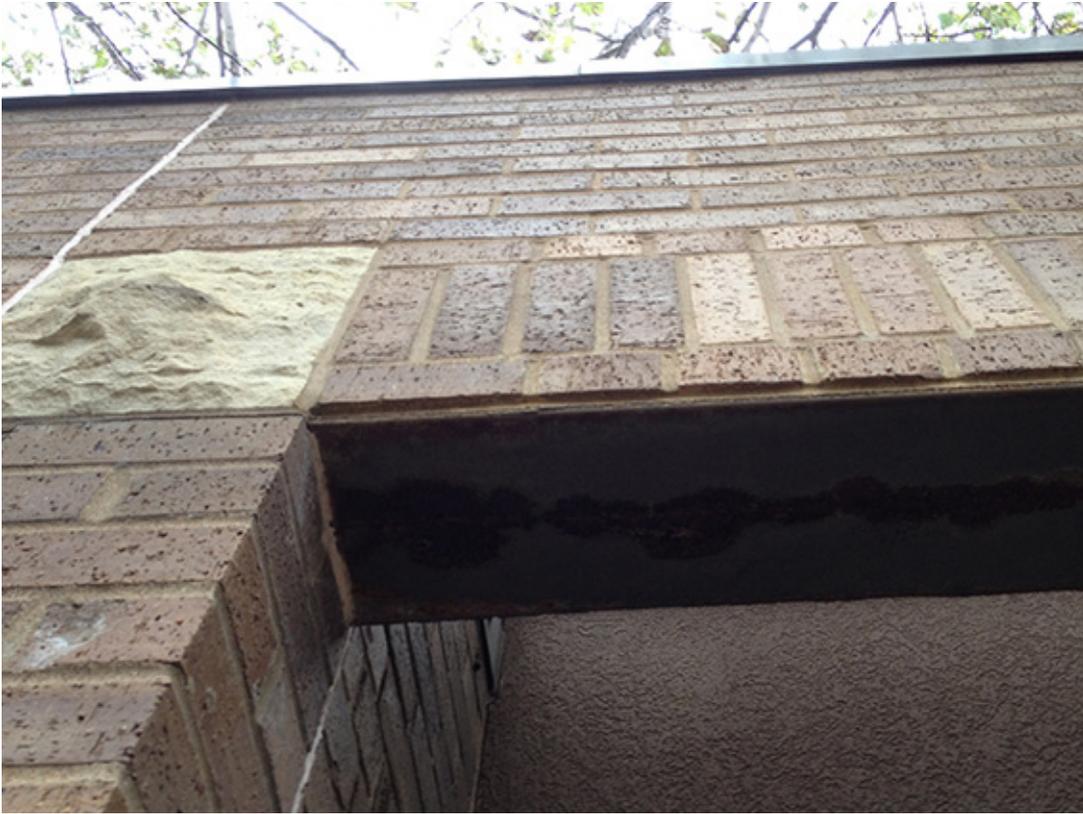
204

Municipal Center: Exterior window frame failing, air infiltration issue

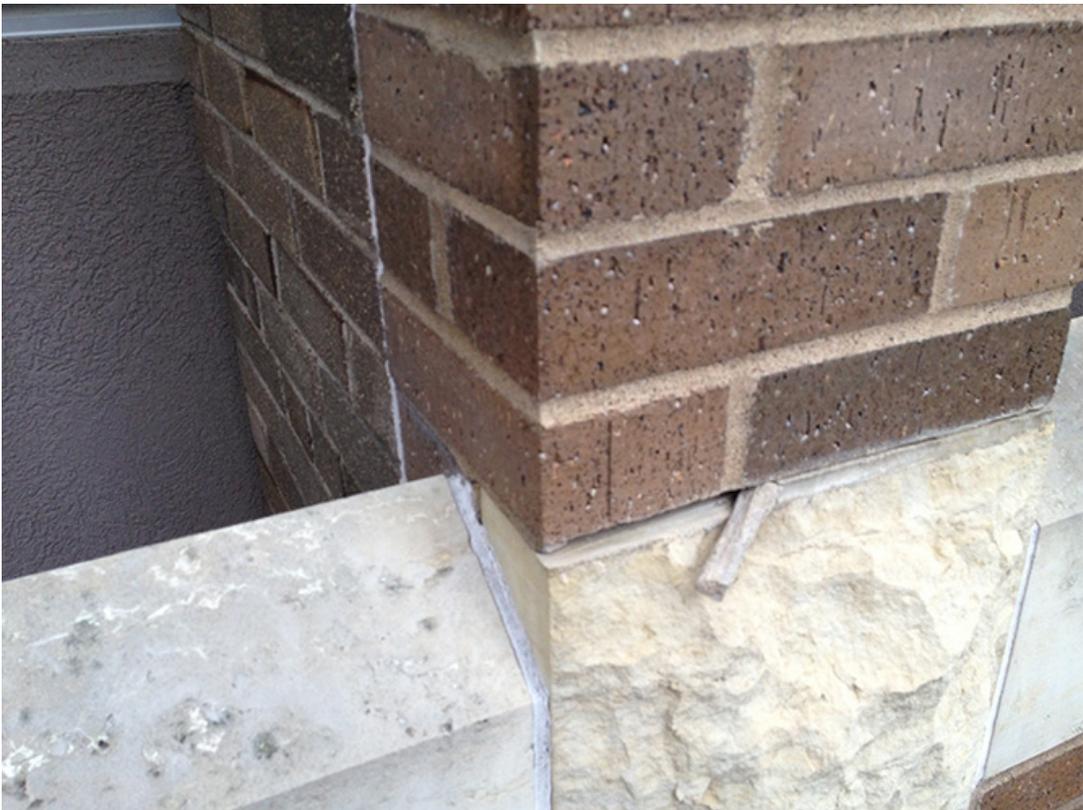
205

Municipal Center: Sealant at window lintel needs replacement

**Lintels.** All exposed lintels should be cleaned, rust removed and repainted. Lintels covered by damaged or partially missing mortar or caulking should be have their joints cleaned out and be re-caulked.

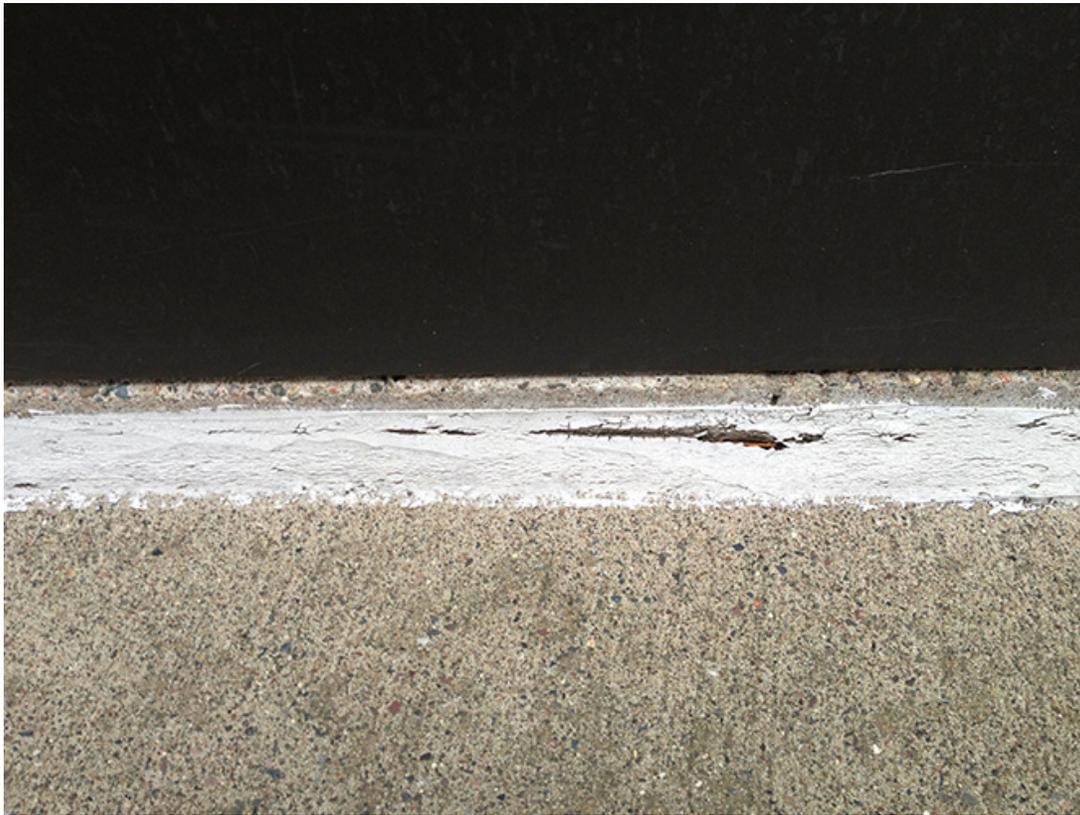
216

Municipal Center: Sealant needs replacement at window frames

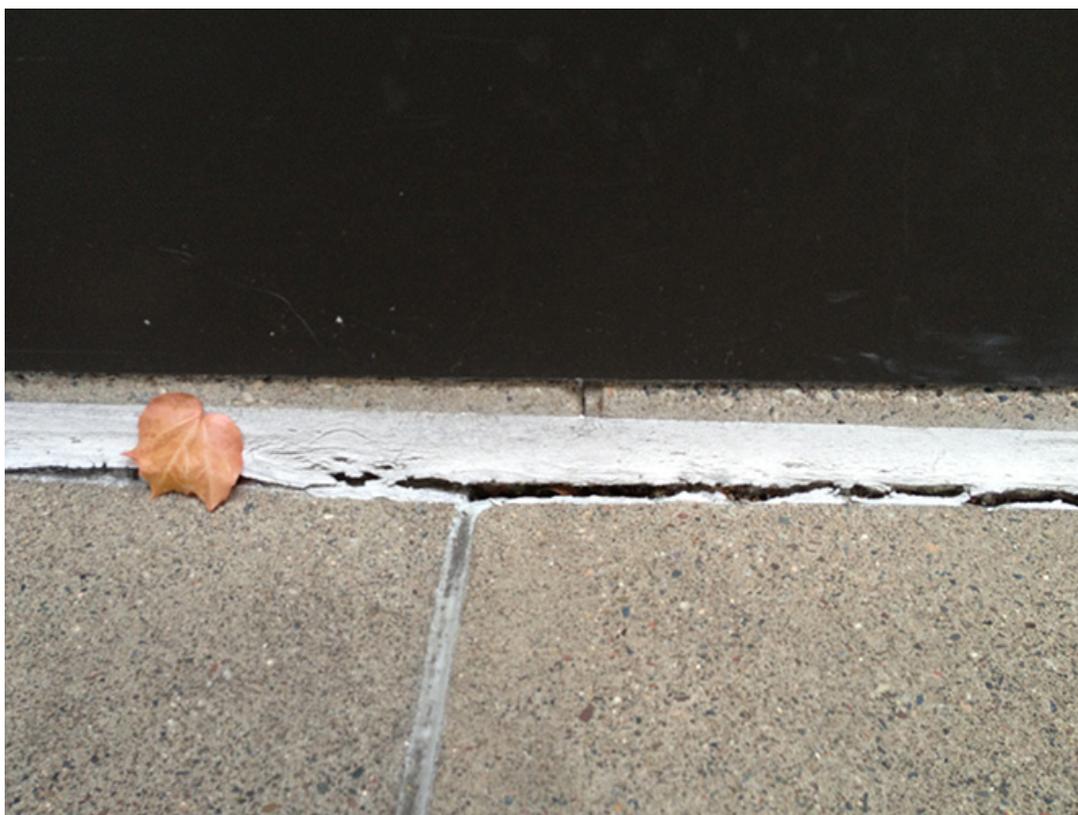
221

Municipal Center: Window assembly damaged

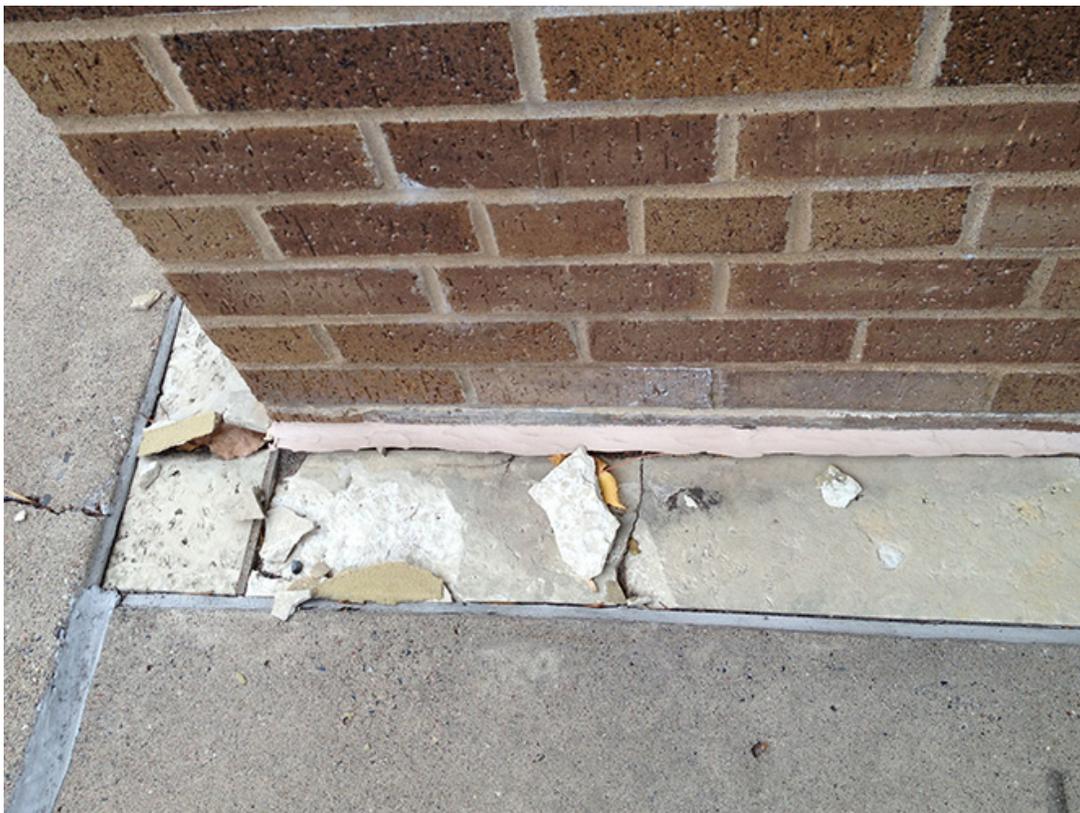
223

Municipal Center: Settled pavement at wall base, potential water infiltration

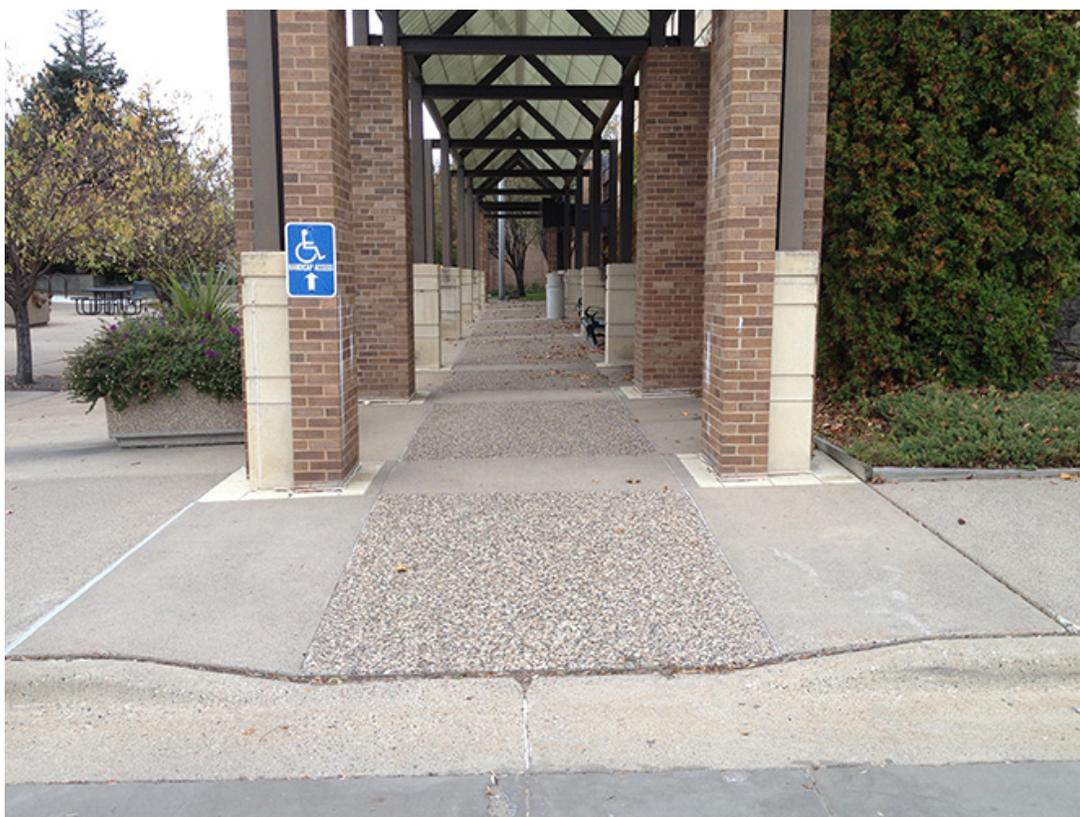
225

Municipal Center: Pavement slabs uneven, hazardous

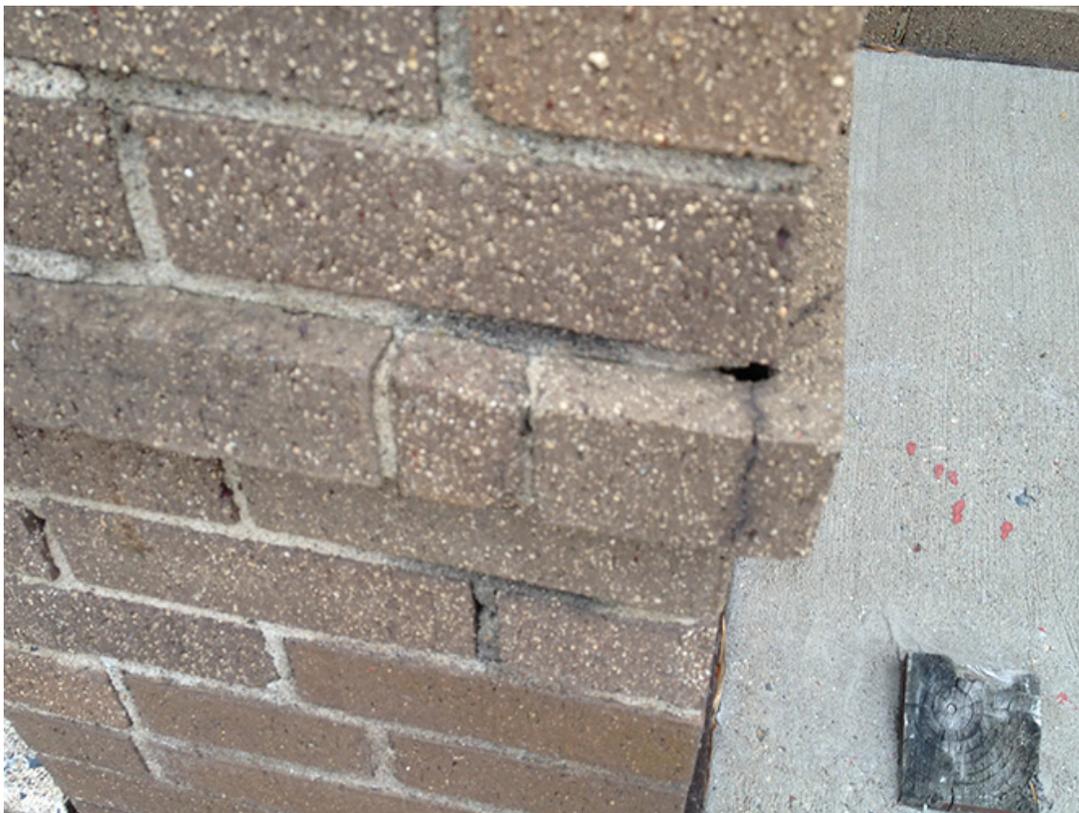
243

Municipal Center: Exterior brick damaged, needs re-tipping

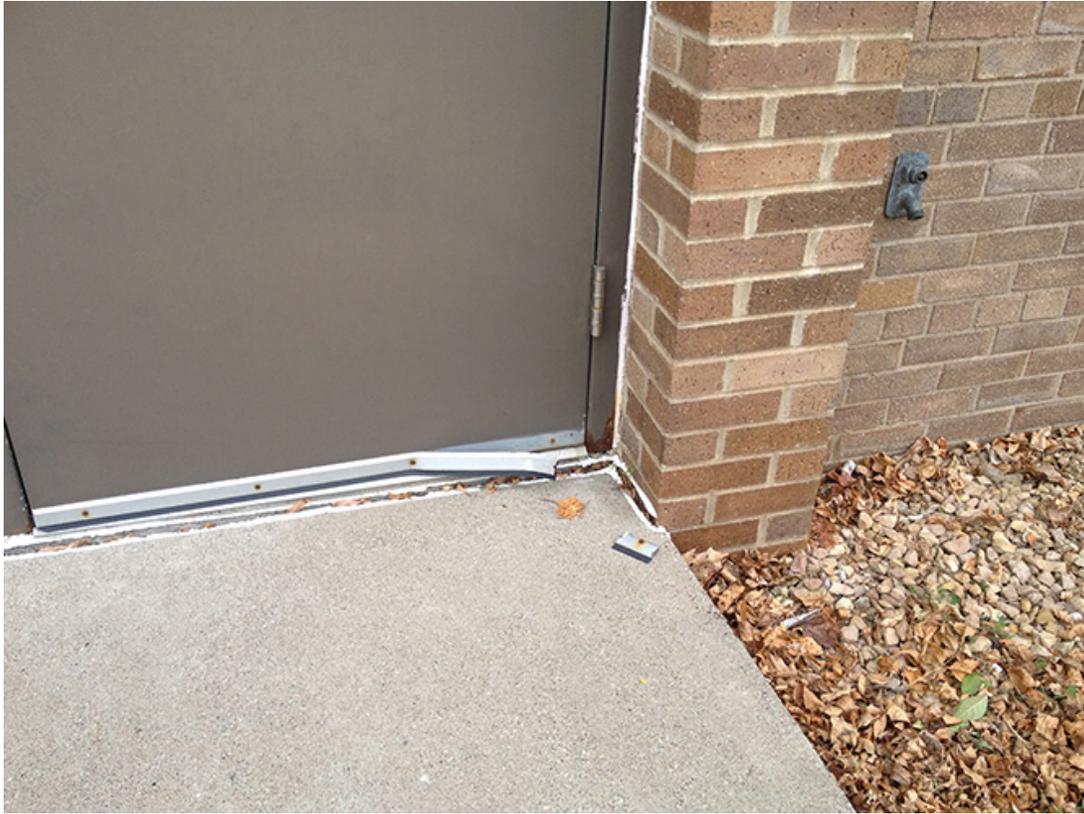
252

- Side entrance has damaged weather stripping kit (photo 253).
- The brick masonry veneer that is showing its age and the building as a whole is in need of re-pointing of the mortar joints (photo 252).

Municipal Center: Exterior brick needs re-tipping

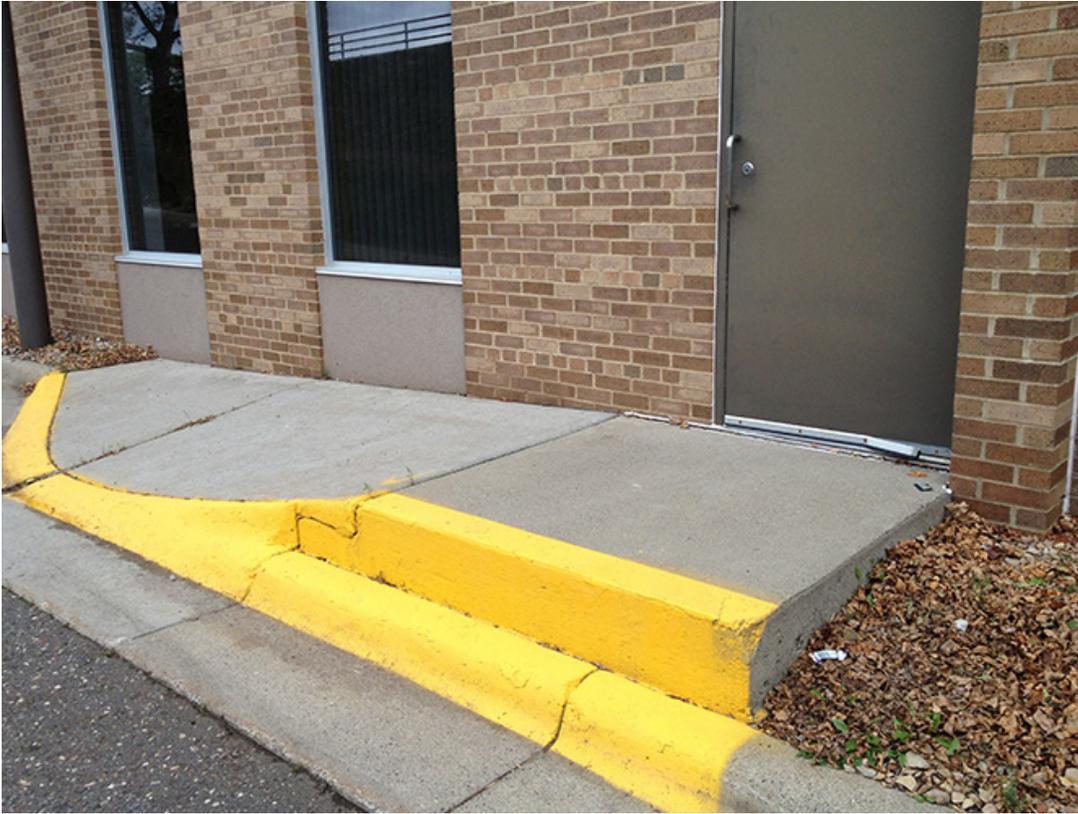
254

- The brick masonry veneer has some spalling and missing finished faces (photo 254).
- The sealant joint along the exterior wall to hard surface paving and deteriorated or missing, allowing moisture to enter at the building wall (photo 256).

Municipal Center: Damaged/deteriorated exterior brick

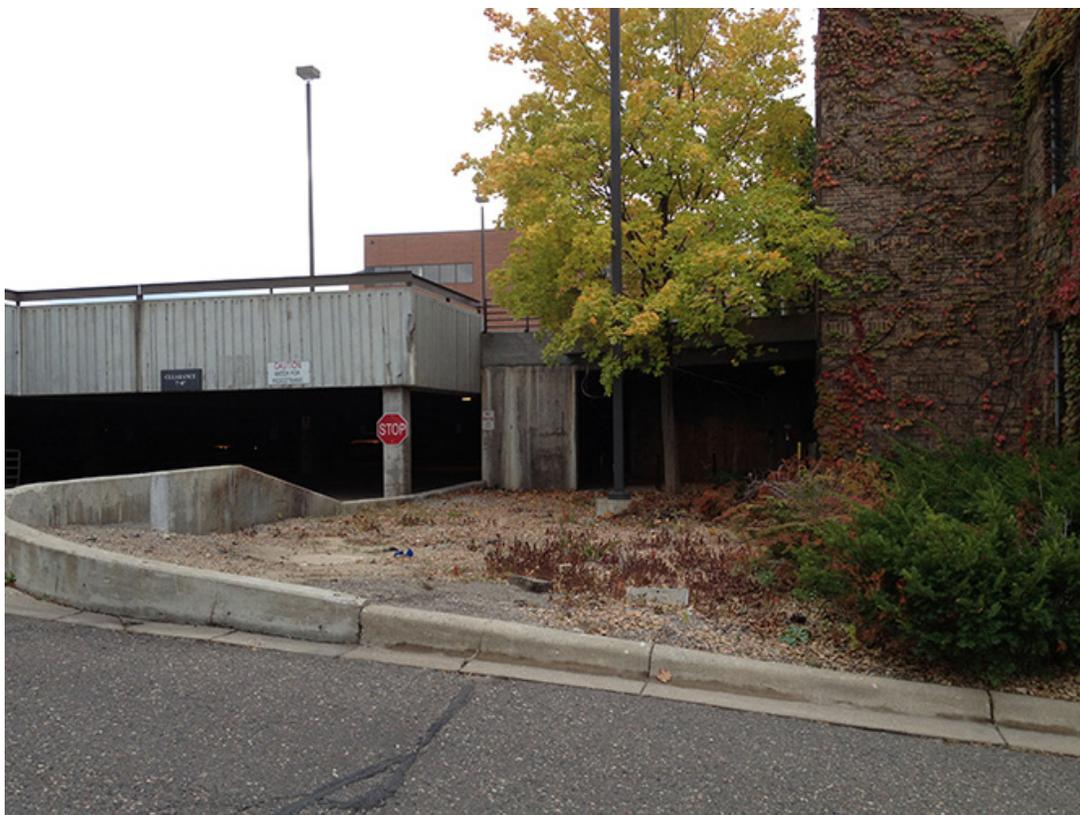
256

Municipal Center: Sealant at pavement and wall needs replacement
