**City of Fridley
Summary of Building Assessment Report
Prepared by HCM Architects 4/14/2014**

Conditions of the Existing Public Works Garage

Conditions of the Existing Municipal Center

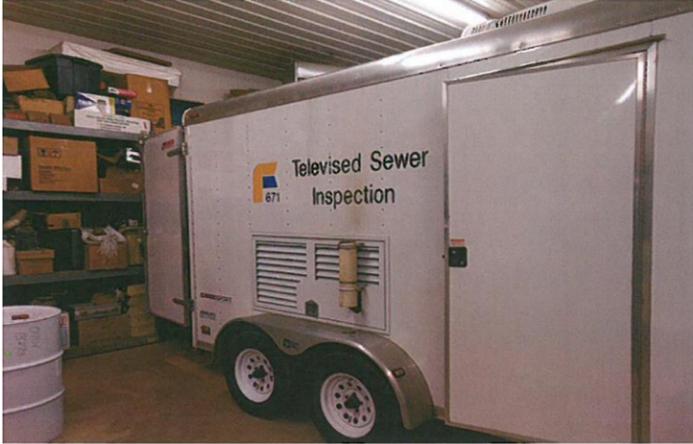
- Storage and maintenance bays are significantly undersized for modern vehicle sizes, creating tight working spaces and unsafe conditions.

Inadequate safe circulation space

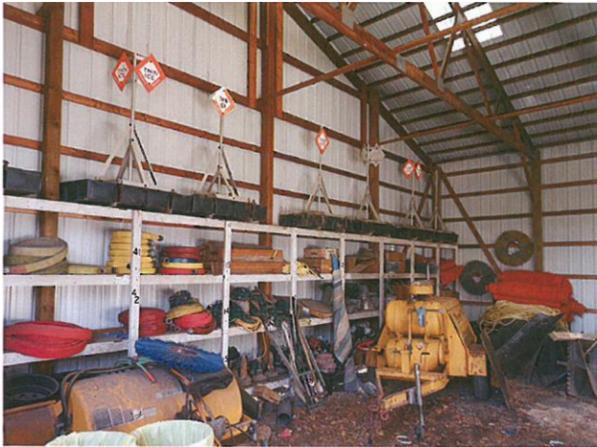
Storage Building: Dirt floor and lacking storage racking

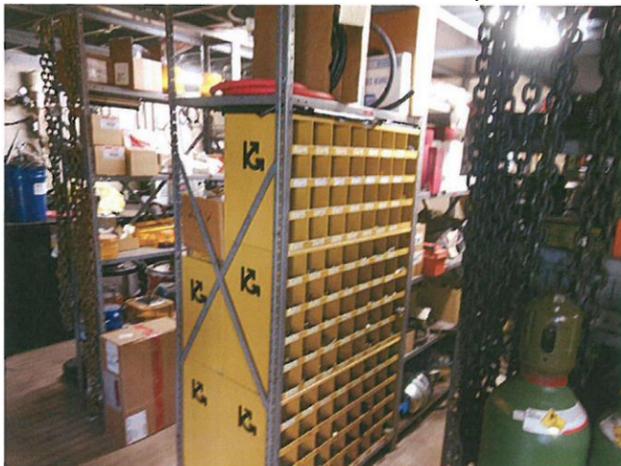
- Most of the cold storage buildings are very old and nearing the end of their serviceable life.
- Inadequate space for safe storage of fluids
- Storage room undersized for maintenance department needs

Undersized maintenance space

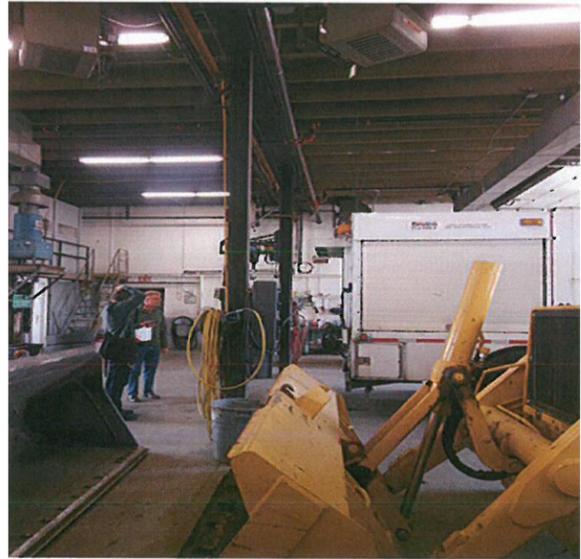
Lack of safe circulation space

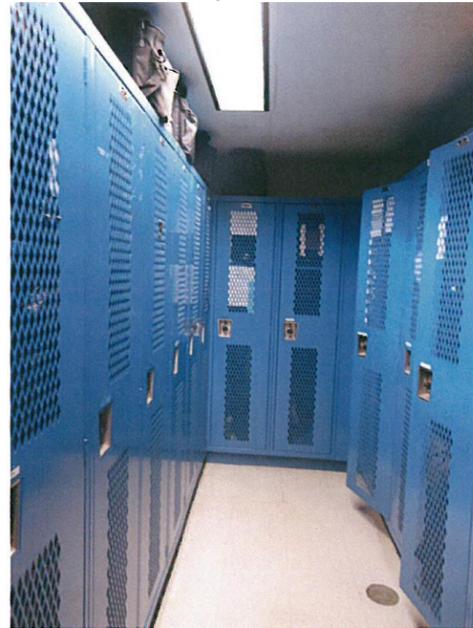
- Police and Fire Department locker and shower rooms do not meet accessibility code and do not have adequate clearances.

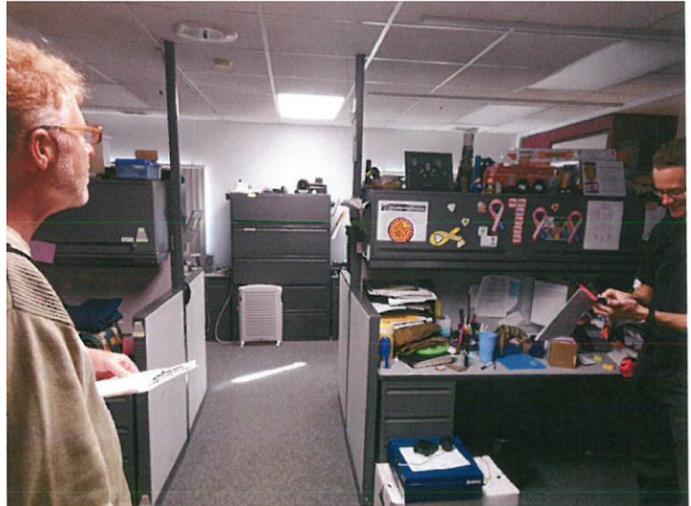
- Fire department has work space, office, living and sleeping areas sharing space. Fire department kitchen is too small and lacking accessibility.

Fire Station: Work, office, living and sleeping space all shared.
