**City of Fridley
Summary of Building Assessment Report
Prepared by HCM Architects 4/14/2014**

Conditions of the Existing Public Works Garage

Conditions of the Existing Municipal Center

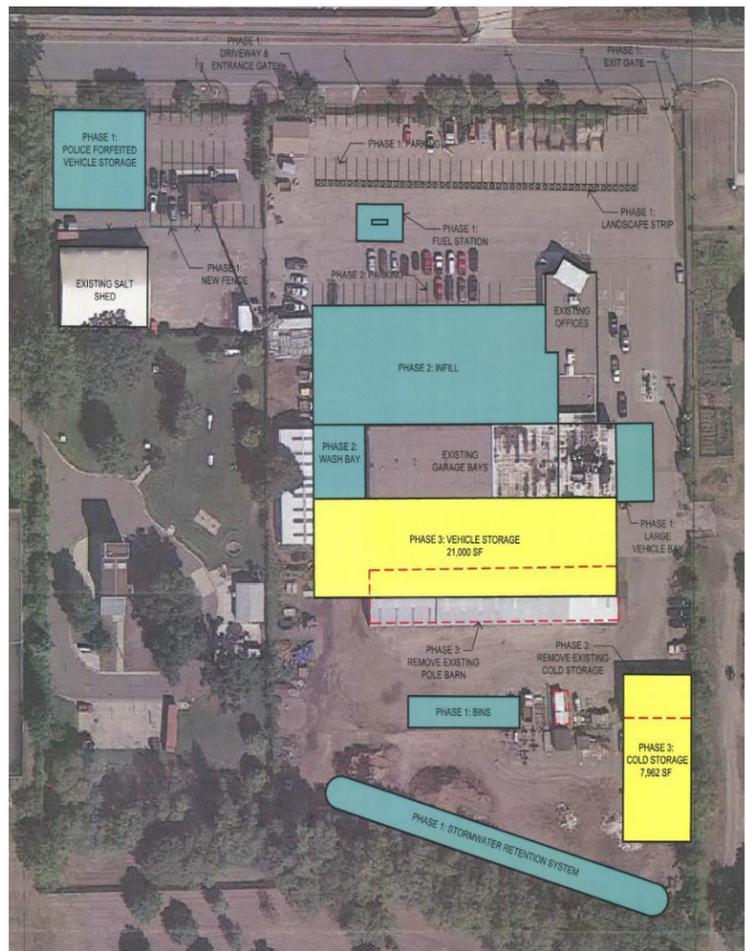
The existing Fridley Public Works Garage does not serve the modern needs. A large portion of the square footage is constructed under building additions and the addition of outbuildings, and the layout does not lend itself to efficiency. A space needs analysis was performed that determined 77,000 square feet are needed for future Public Works Garage on its existing site. A conceptual layout was prepared for three phased expansion from the existing 36,000 square feet as shown.

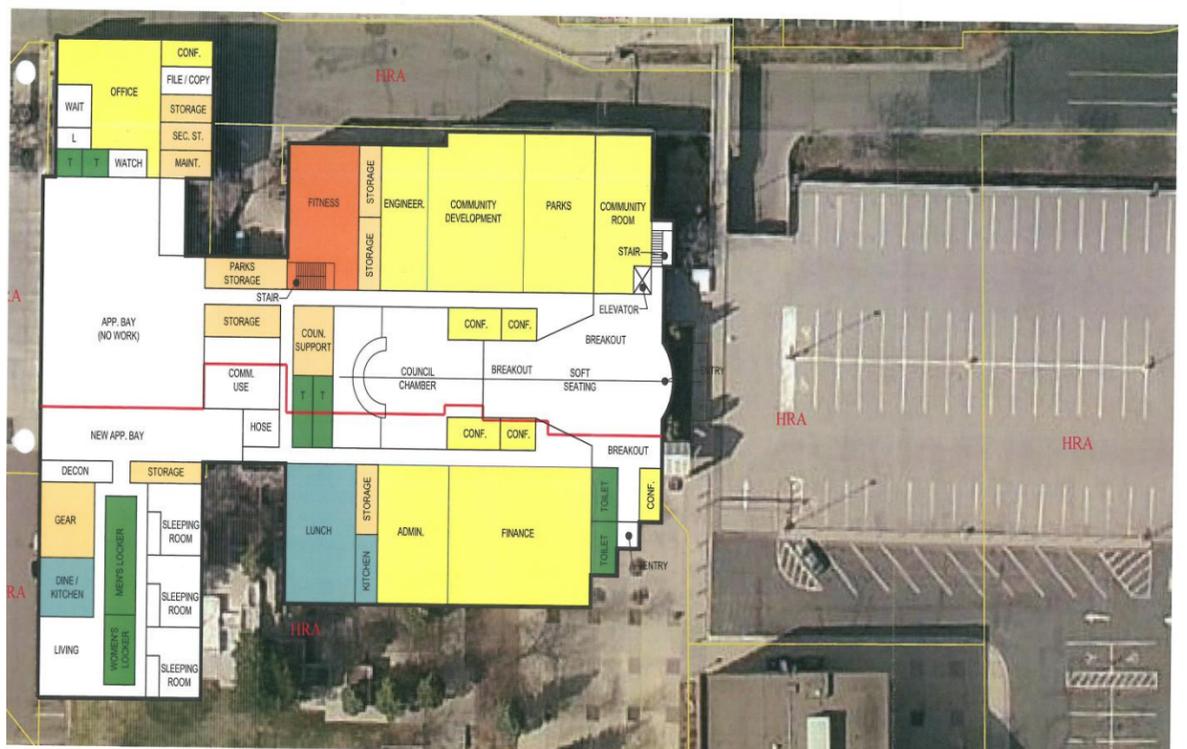
The existing Fridley Municipal Center also does not serve the modern needs for efficient service to the public. As much of the square footage was constructed under building additions, the layout does not lend itself to efficiency and appropriate collaboration (and separations) between departments. A space needs analysis was performed that determined 70,000 square feet are needed for future Municipal Center Operations on its existing site. A conceptual layout was prepared as shown.
