**Building Audit/Assessment**

**City of Fridley  
Municipal Center  
6431 University Avenue NE  
Fridley, MN 55432**

**December 6, 2013**

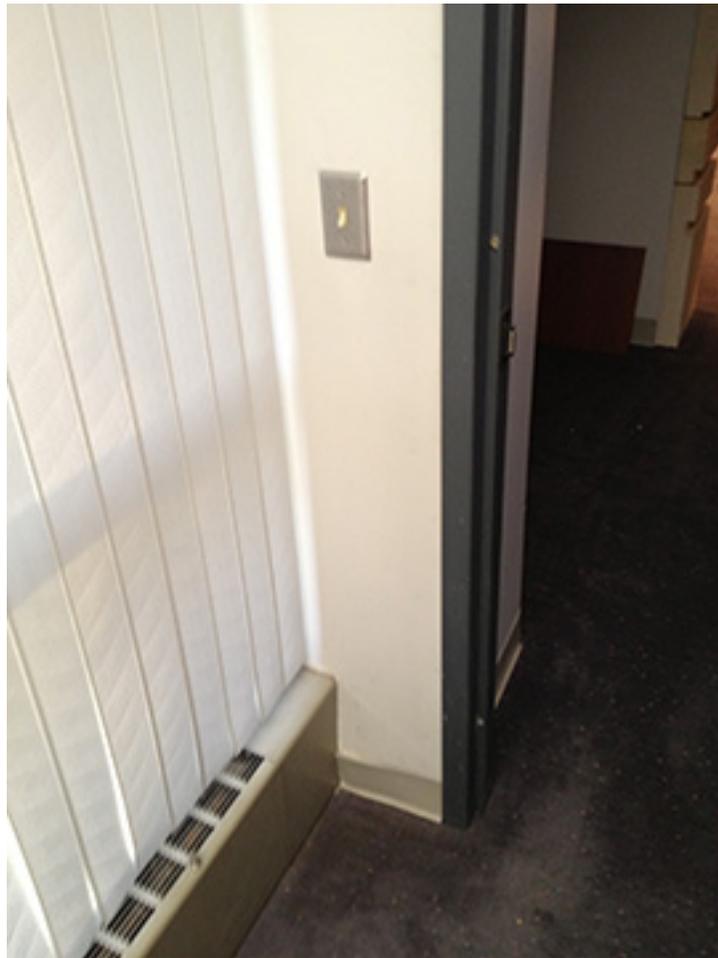
3

City Hall- AV Room: Wall damage & possible water infiltration at wall base

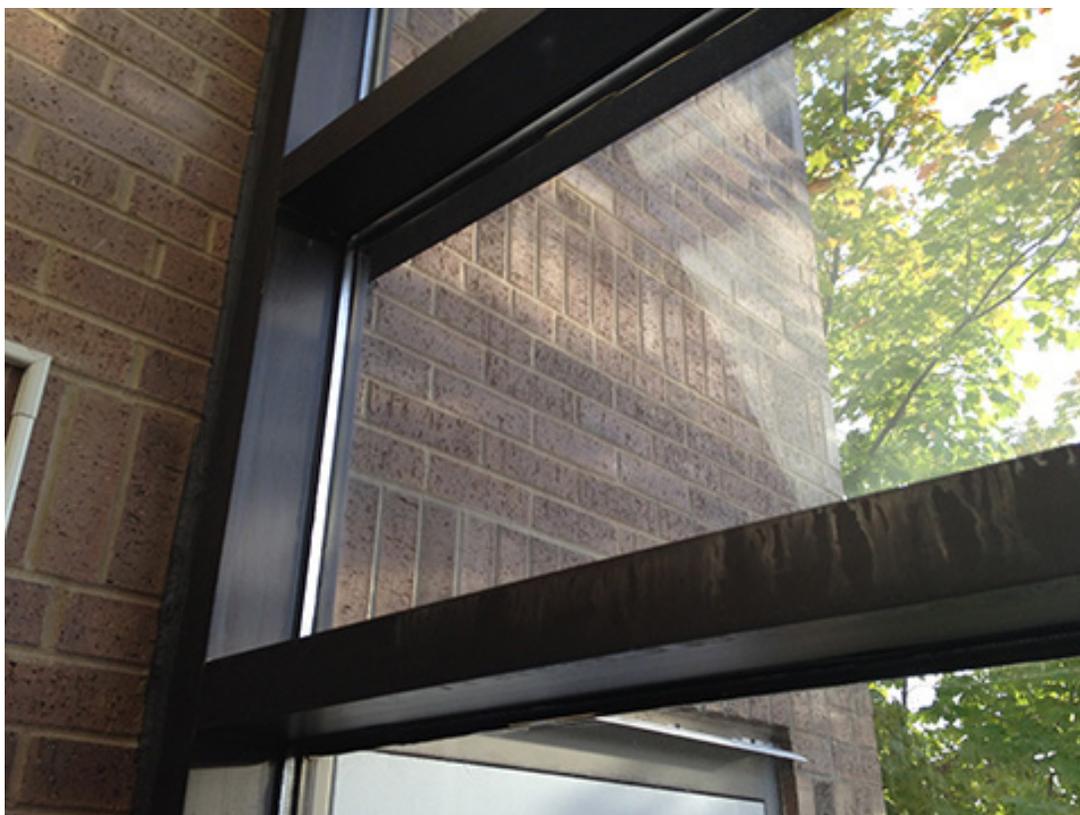
5

City Hall- Control Room: East exterior windows show condensation

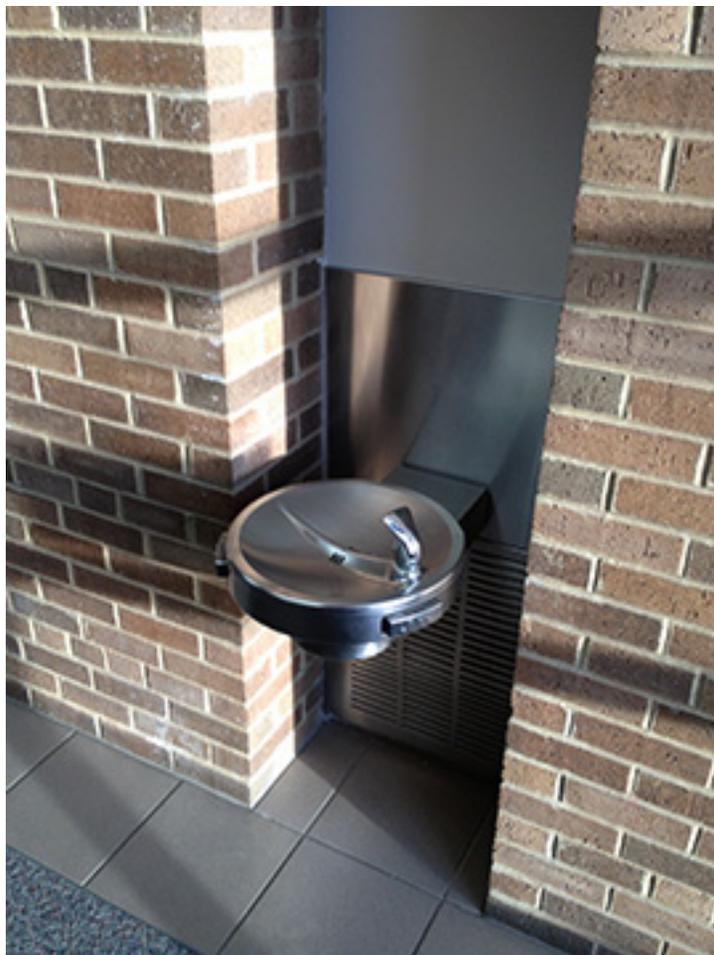
8

City Hall Hallway: non-ADA compliant spout height for drinking fountain

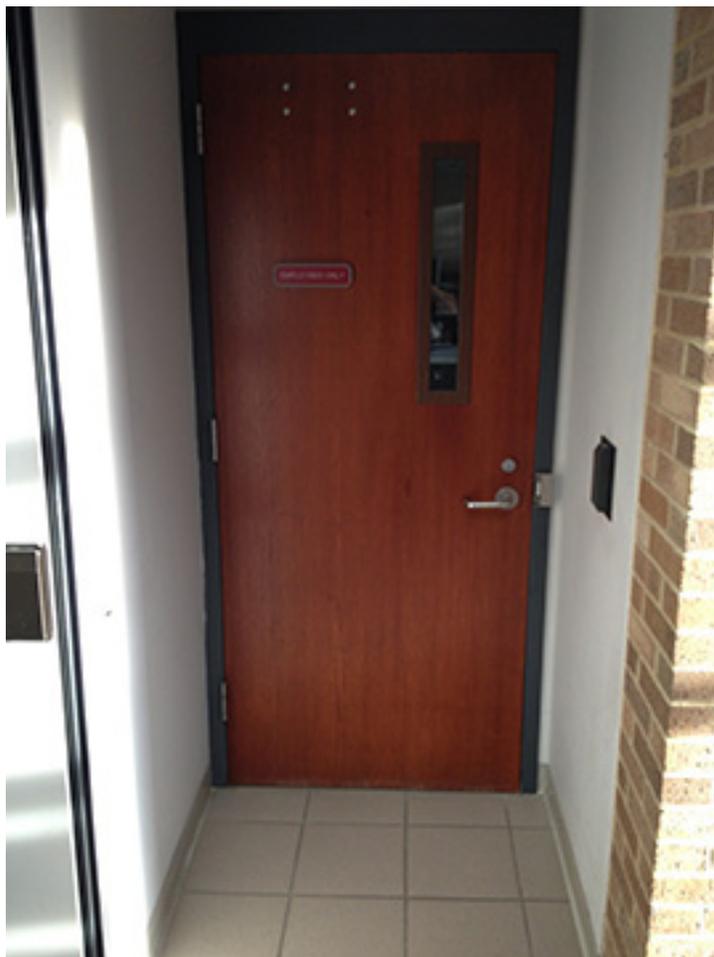
9

City Hall Hallway: non-ADA compliant clearance on pull approach latch side

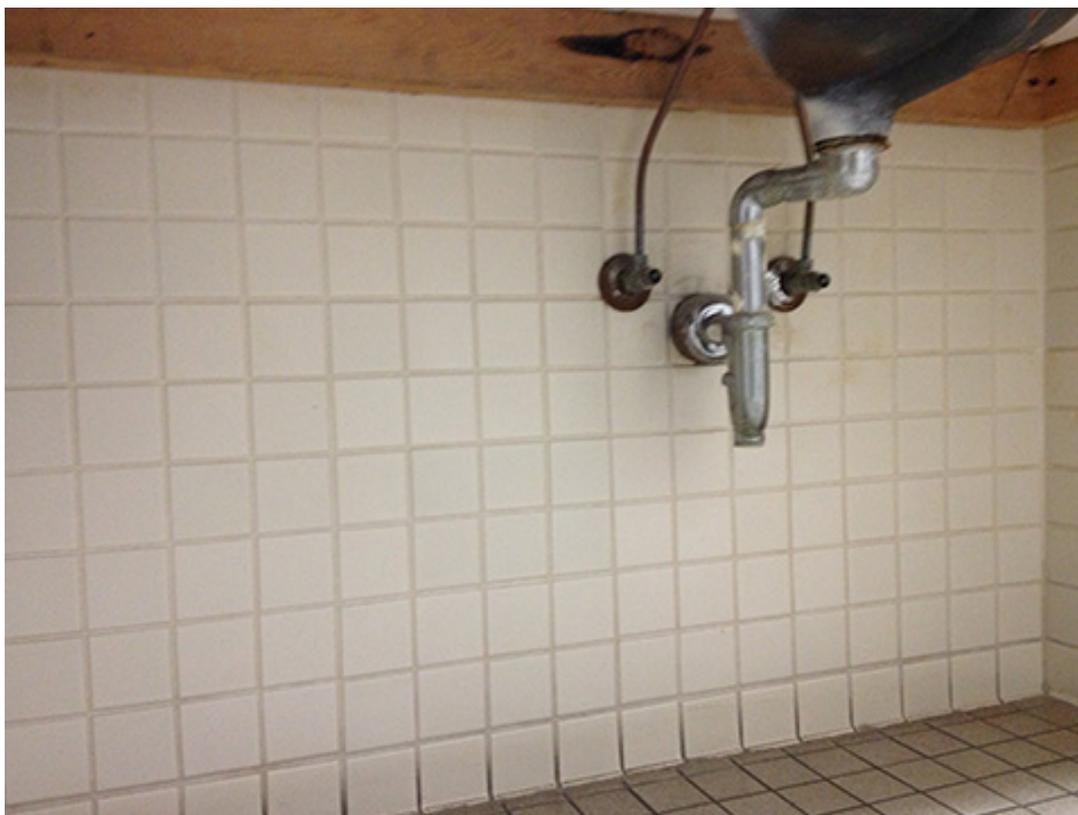
10

City Hall Restrooms: Hot water and waste water piping is not insulated

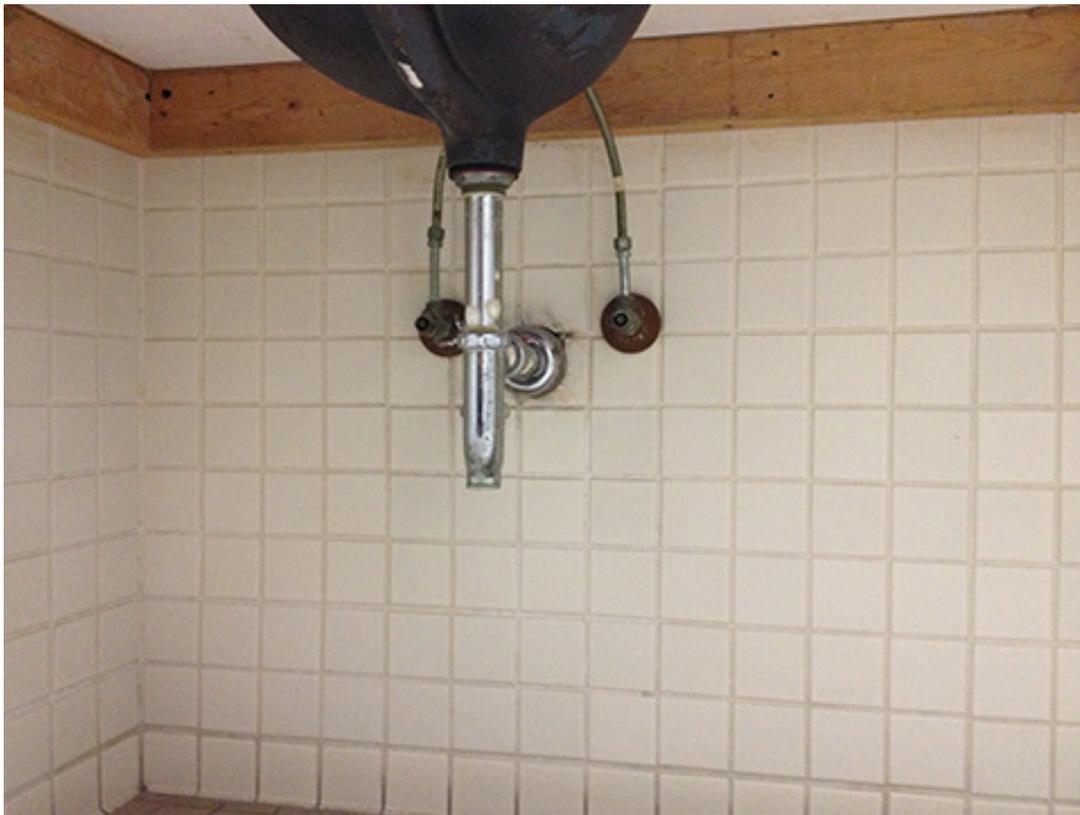
11

City Hall Restrooms: Hot water and waste water piping is not insulated

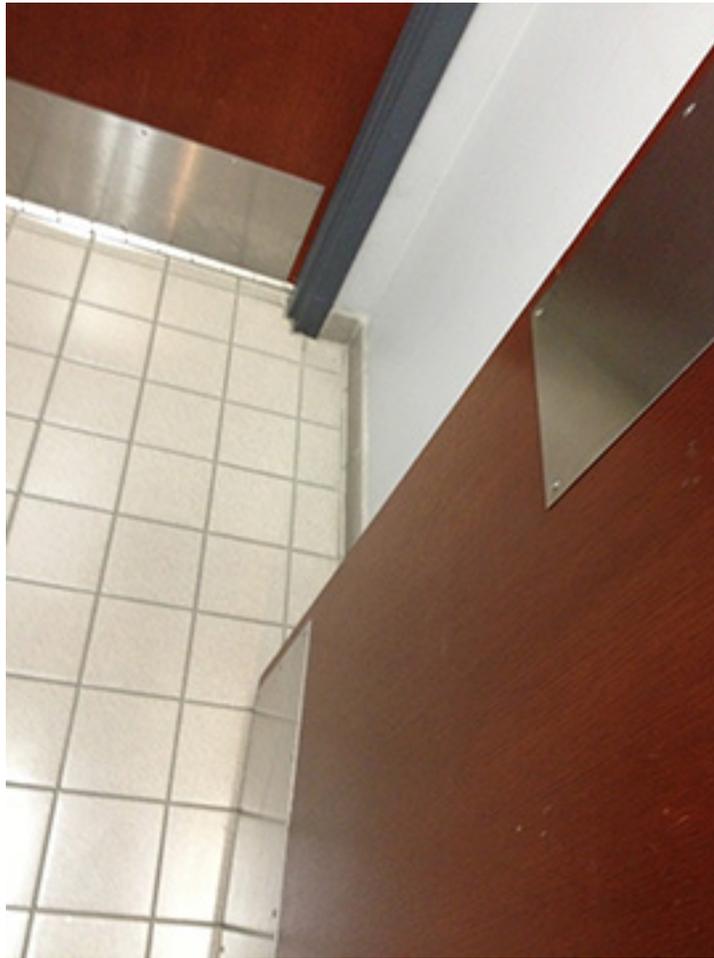
13

City Hall: General ADA non-compliance, door swing clearance

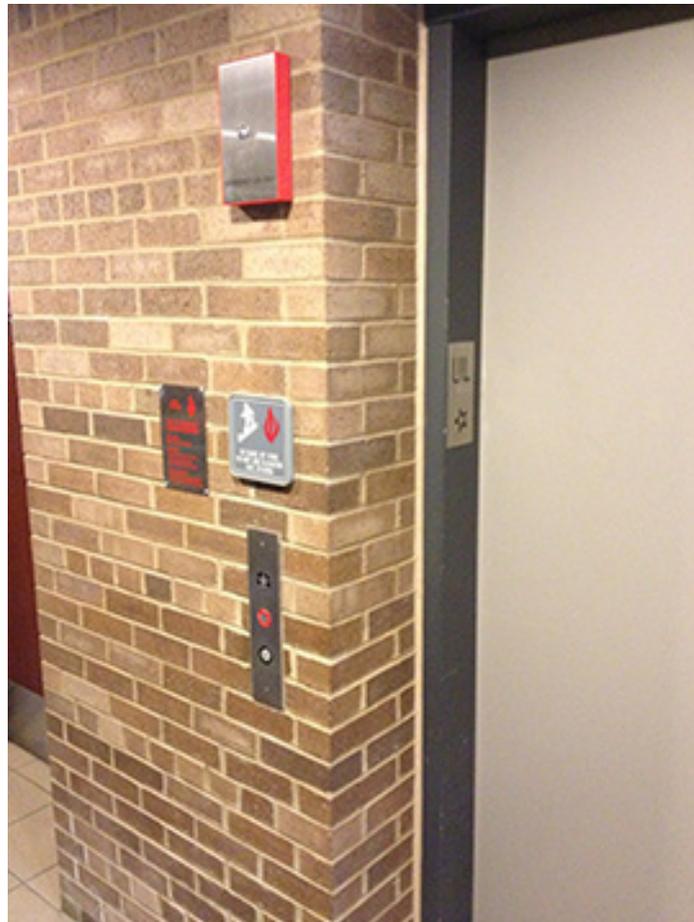
14

City Hall- Public Hallway: Lacks accessible signage at jambs, no audible or visible signal

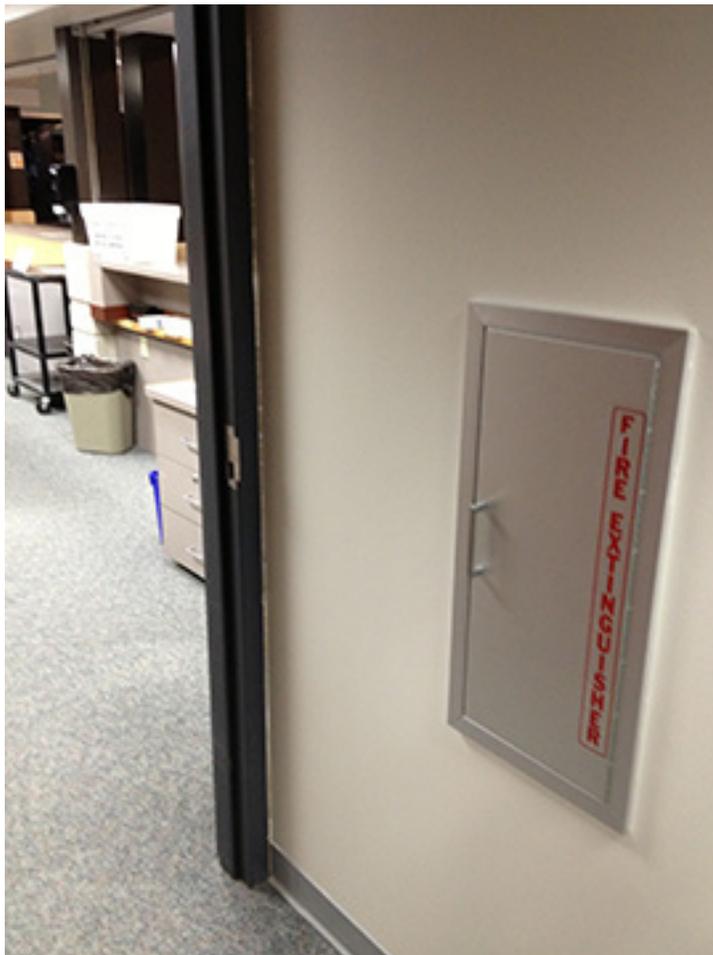
21

General ADA Non-Compliance: Inadequate clearance on pull approach, latch side of door

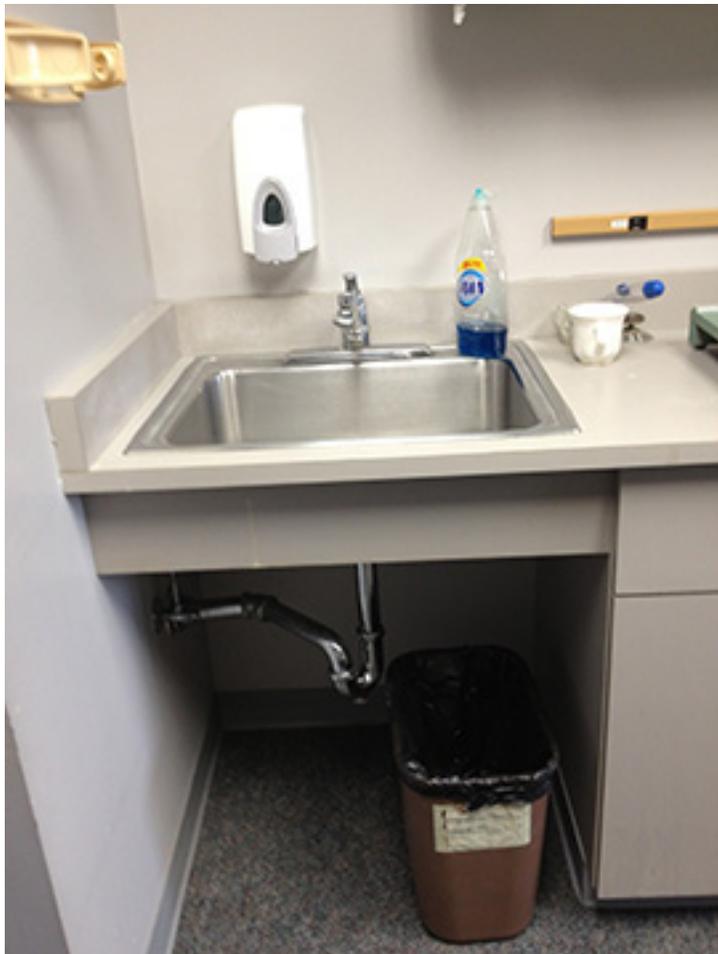
26

City Hall- Breakroom: Hot water & waste water piping is not insulated

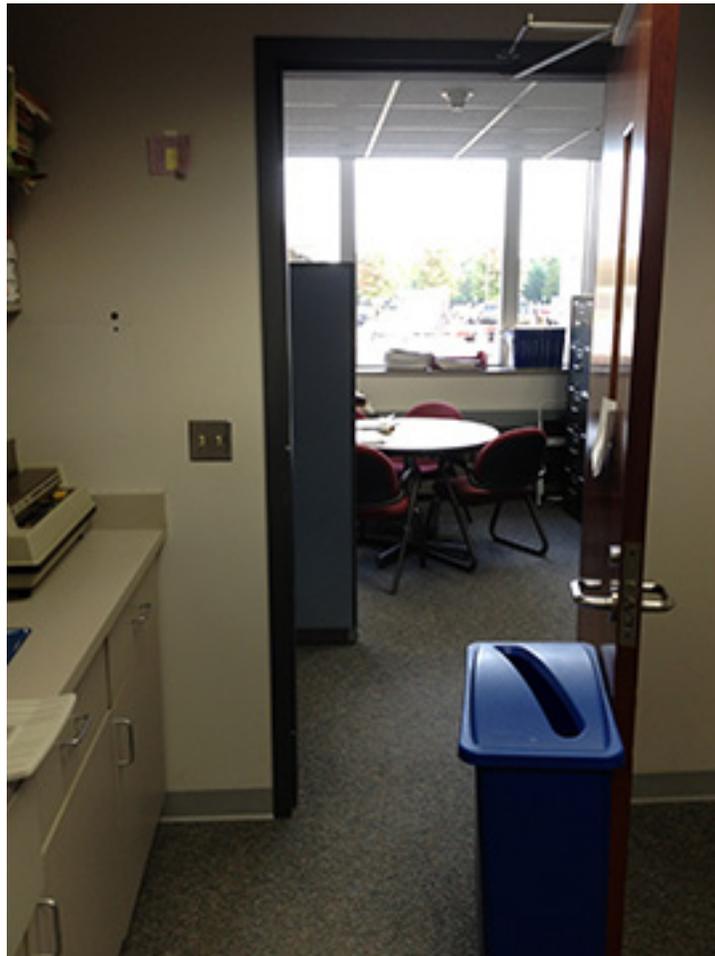
27

General ADA Non-Compliance: Inadequate clearance on pull approach, latch side of door

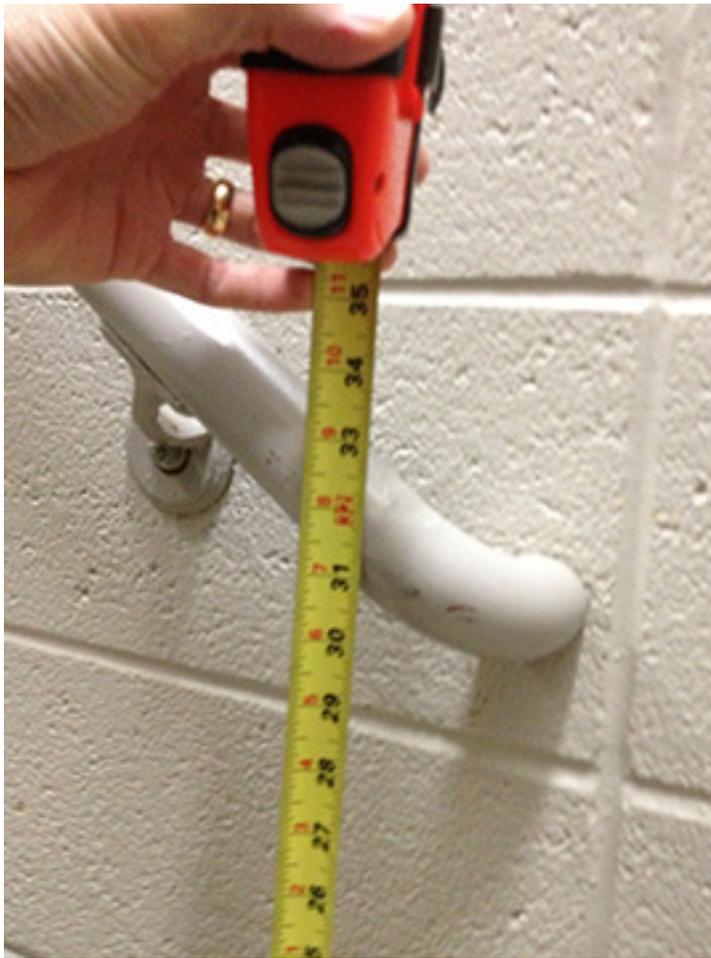
31

General ADA Non-Compliance: Handrail height

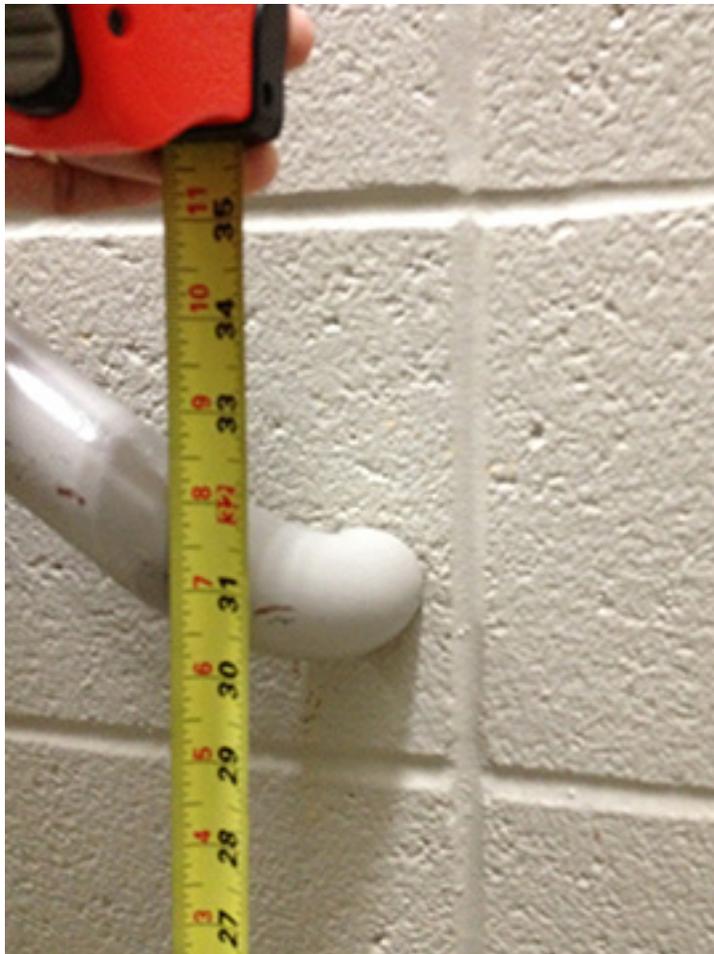
32

General ADA Non-Compliance: Handrail height

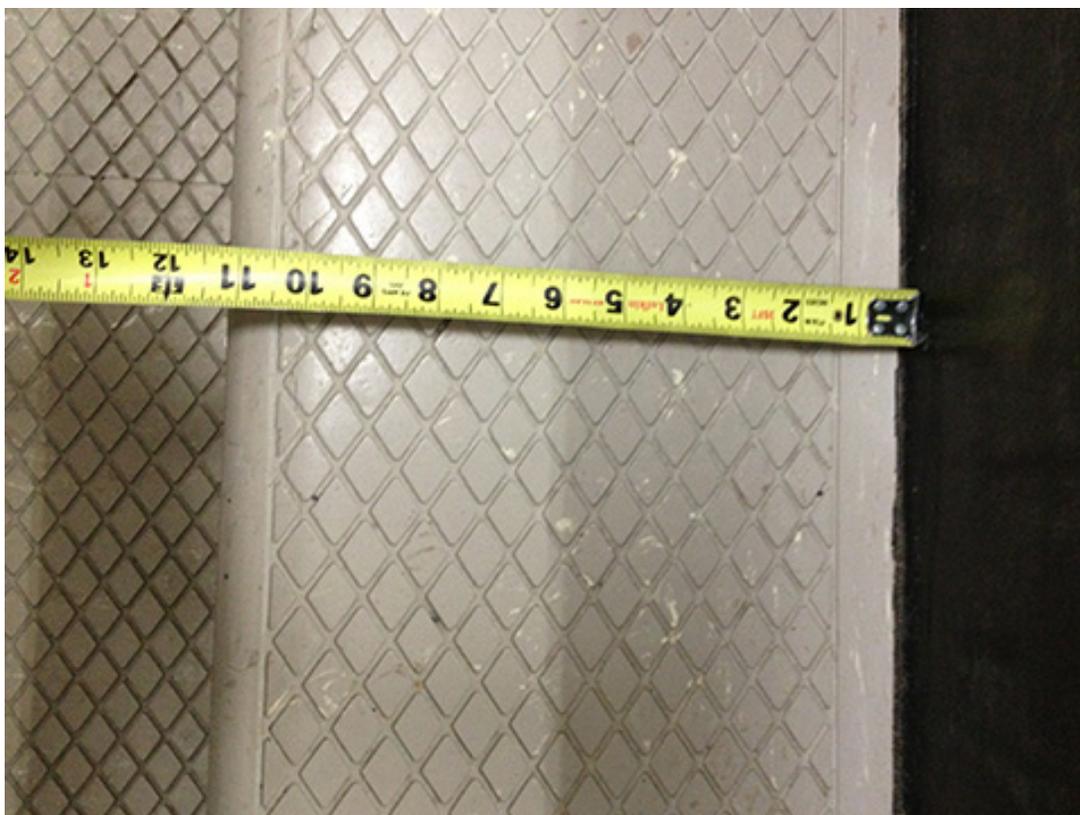
33

General ADA Non-Compliance: Tread depth

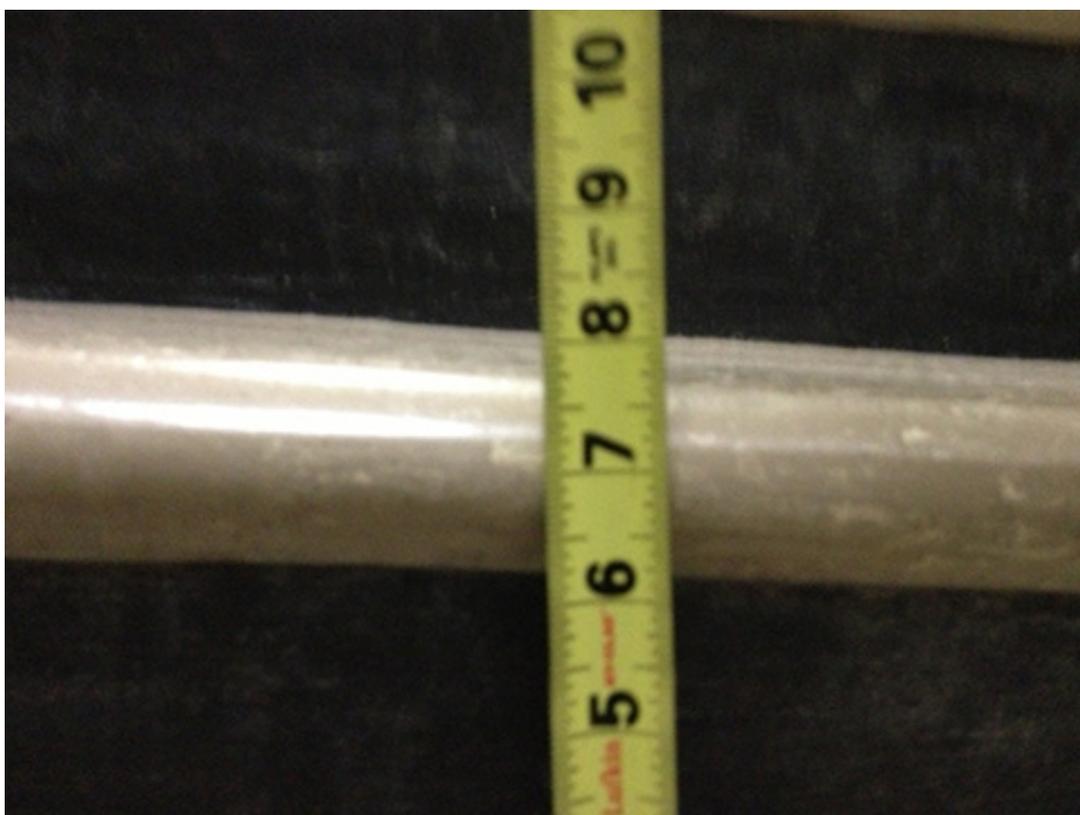
34

General ADA Non-Compliance: Handrail circumference

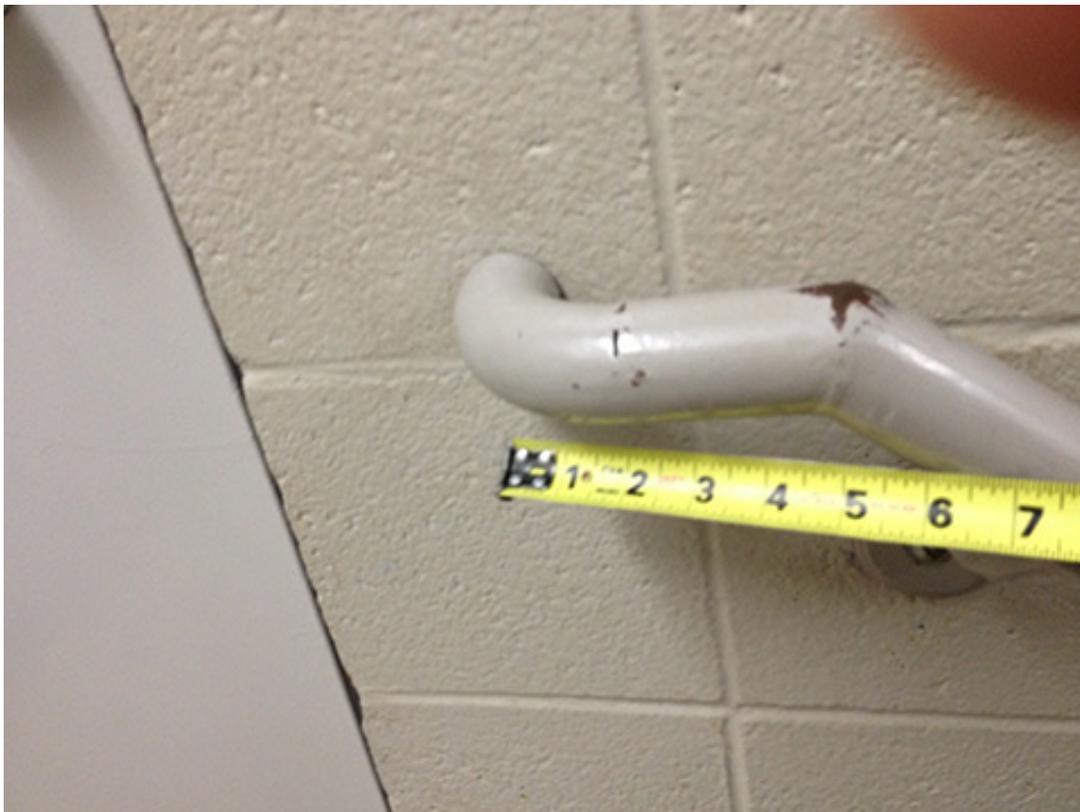
36

General ADA Non-Compliance: Handrail extension

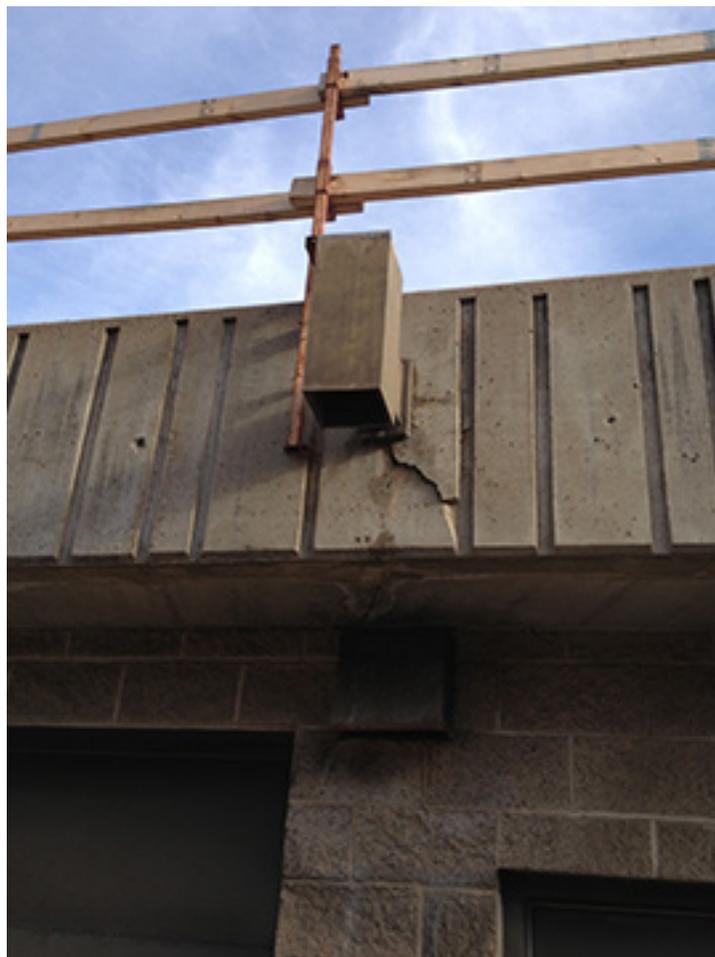
42

Public Entrance: Temporary fencing on parking ramp perimeter, hazardous

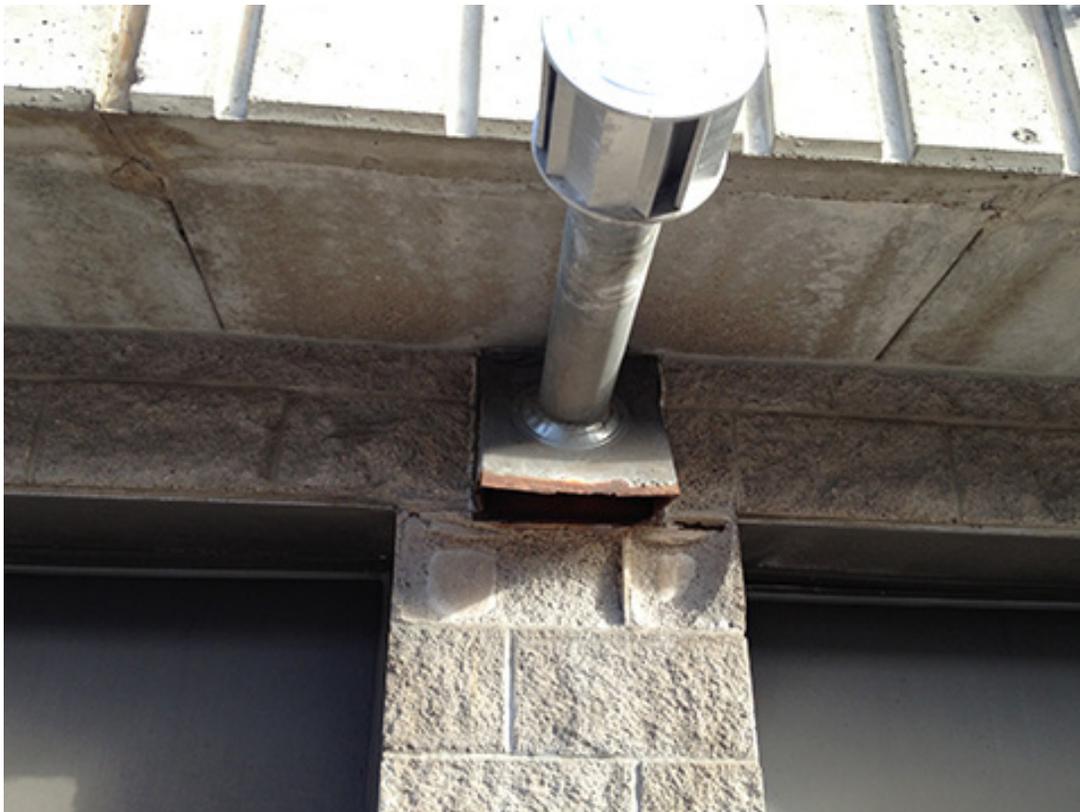
44

Garage exhaust ventilation pipe.....

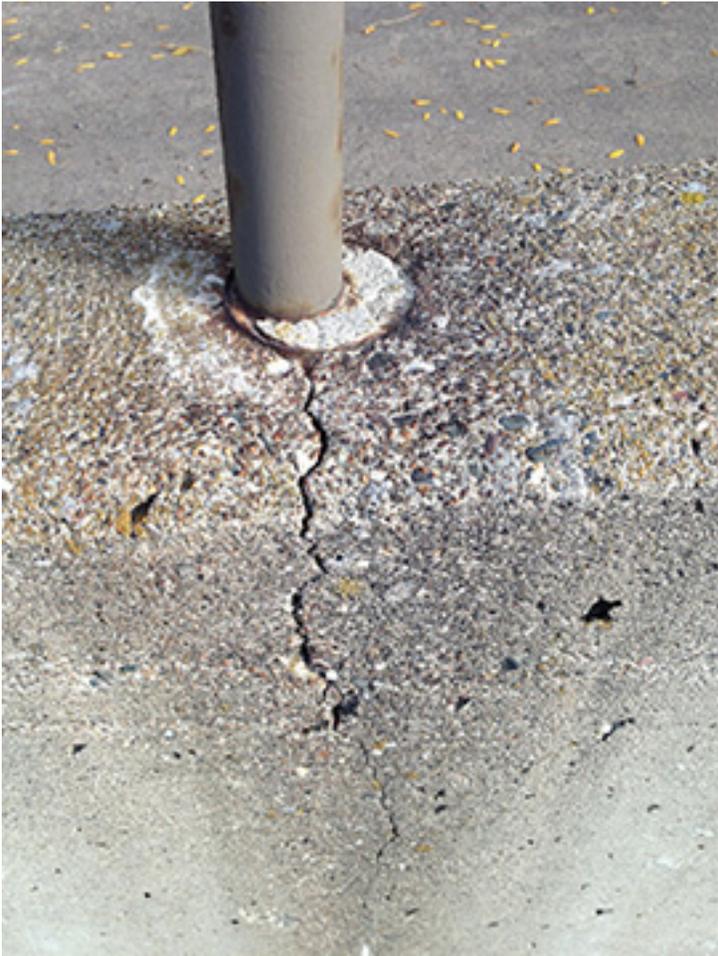
45

Pavement cracking at column base

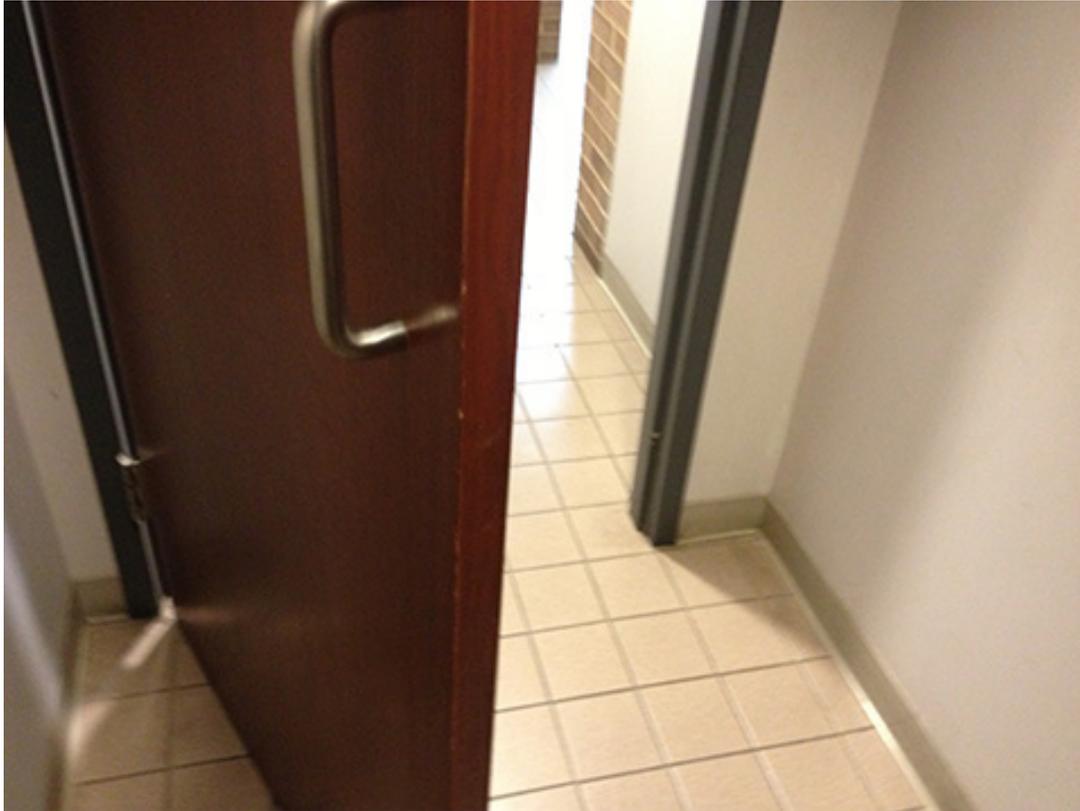
51

General ADA Non-Compliance: Inadequate clearance on pull approach, latch side of door

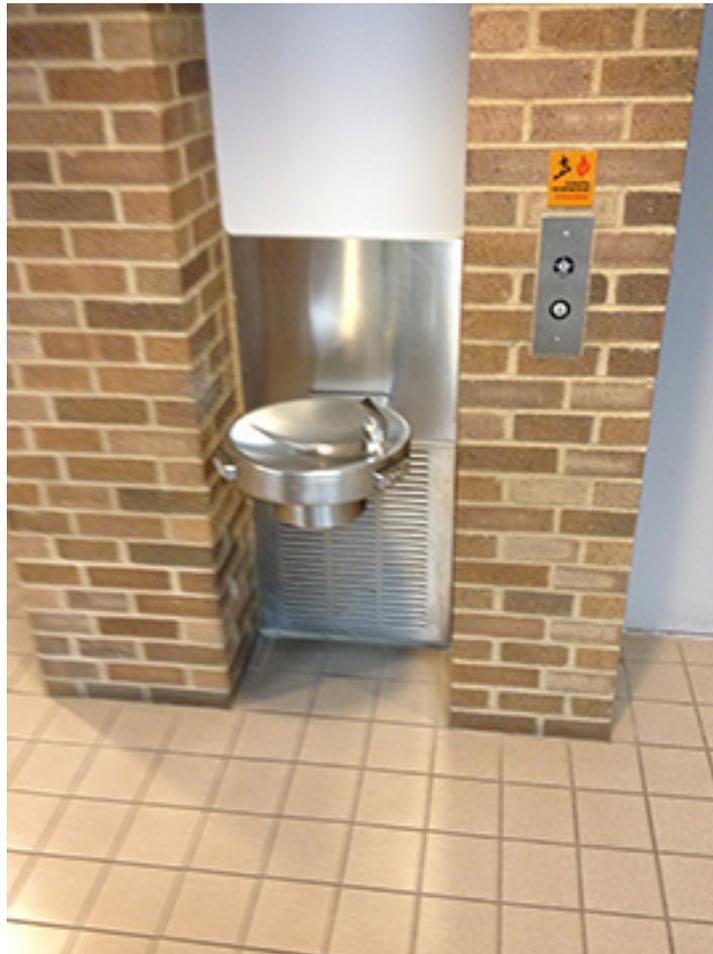
52

General ADA Non-Compliance: Inadequate accessible spout height at drinking fountain

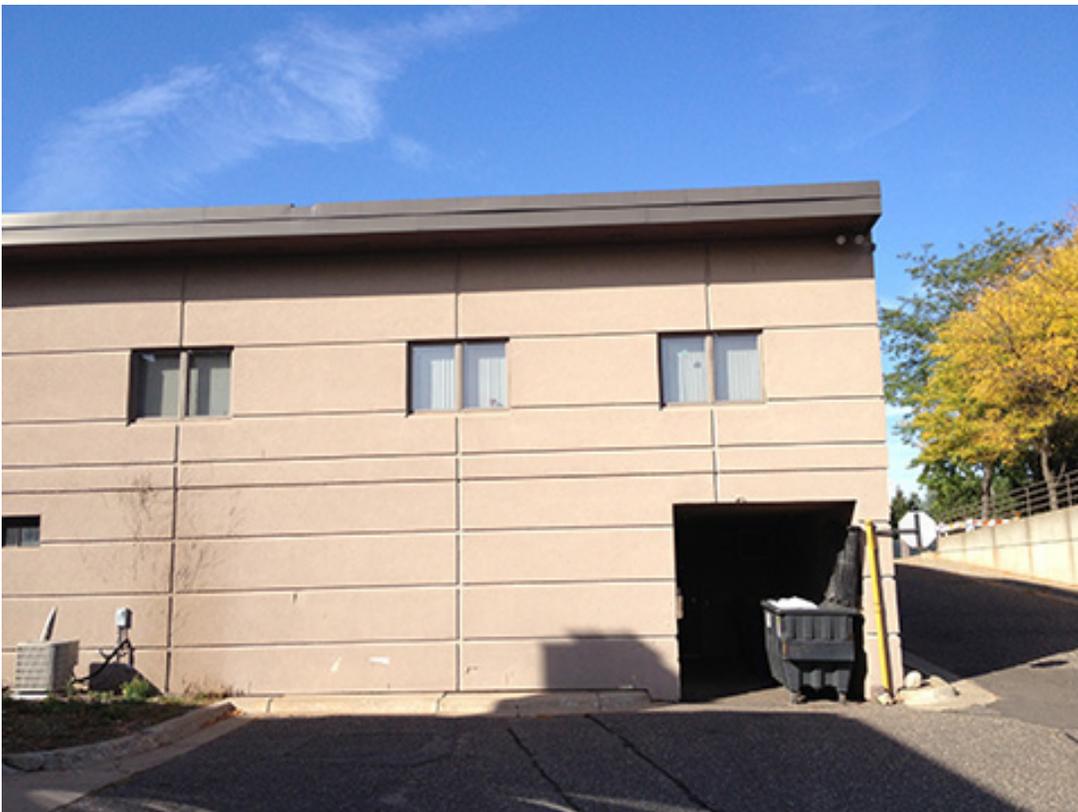
56

Fire Station: Exposed wood framing

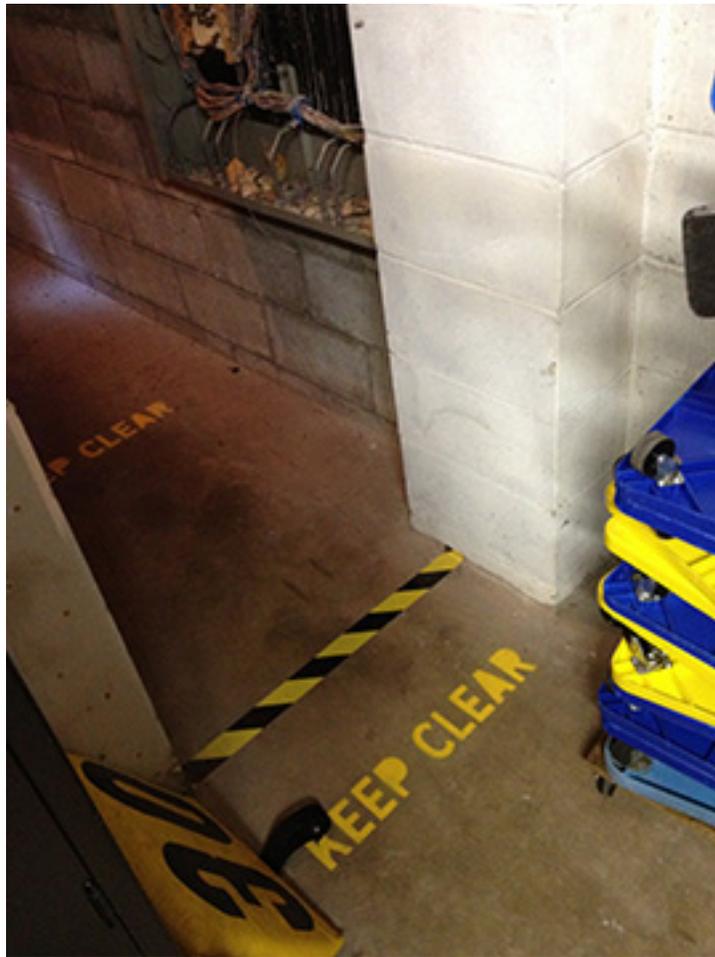
59

Fire Station: Insufficient clear floor space to electrical room

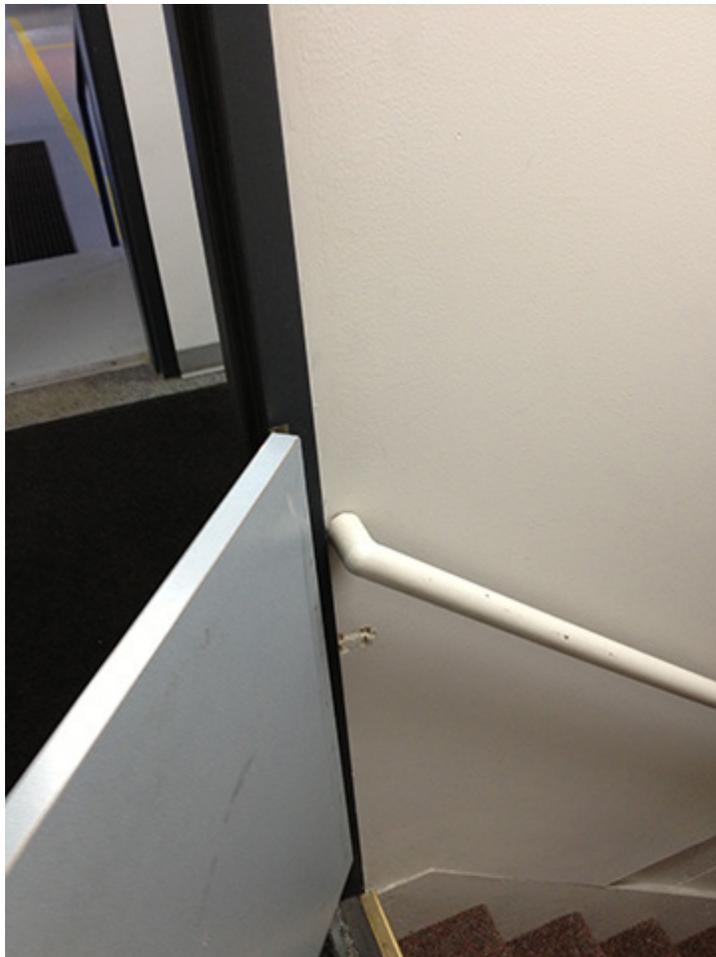
60

Fire Station: Non-ADA compliant stair railing and gate

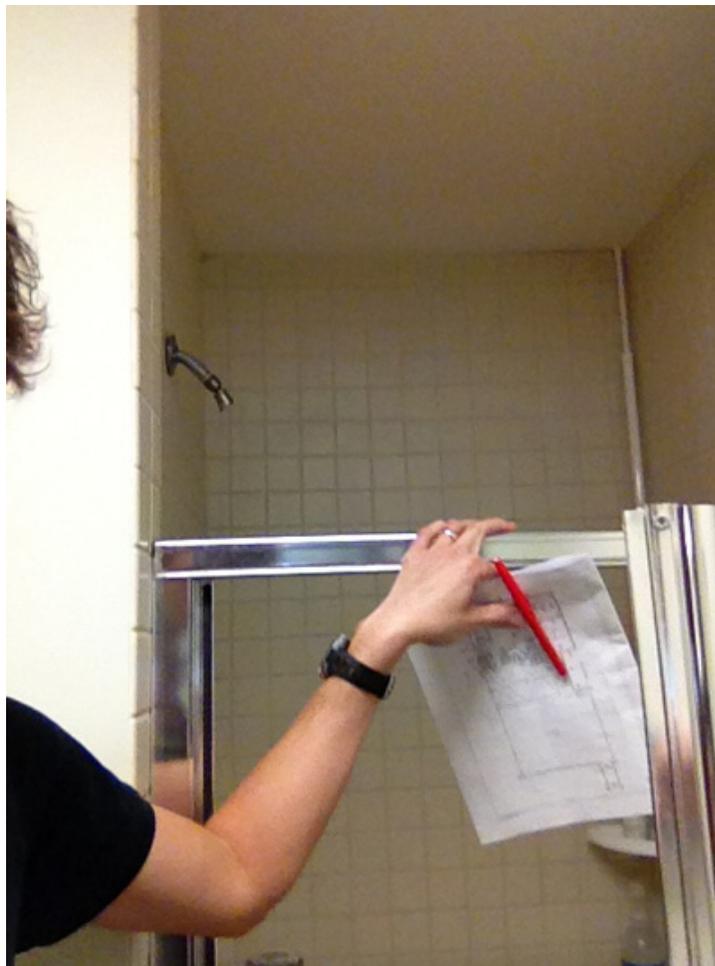
63

Restroom ADA Non-Compliance: Inadequate clearances at water closets, grab bars required

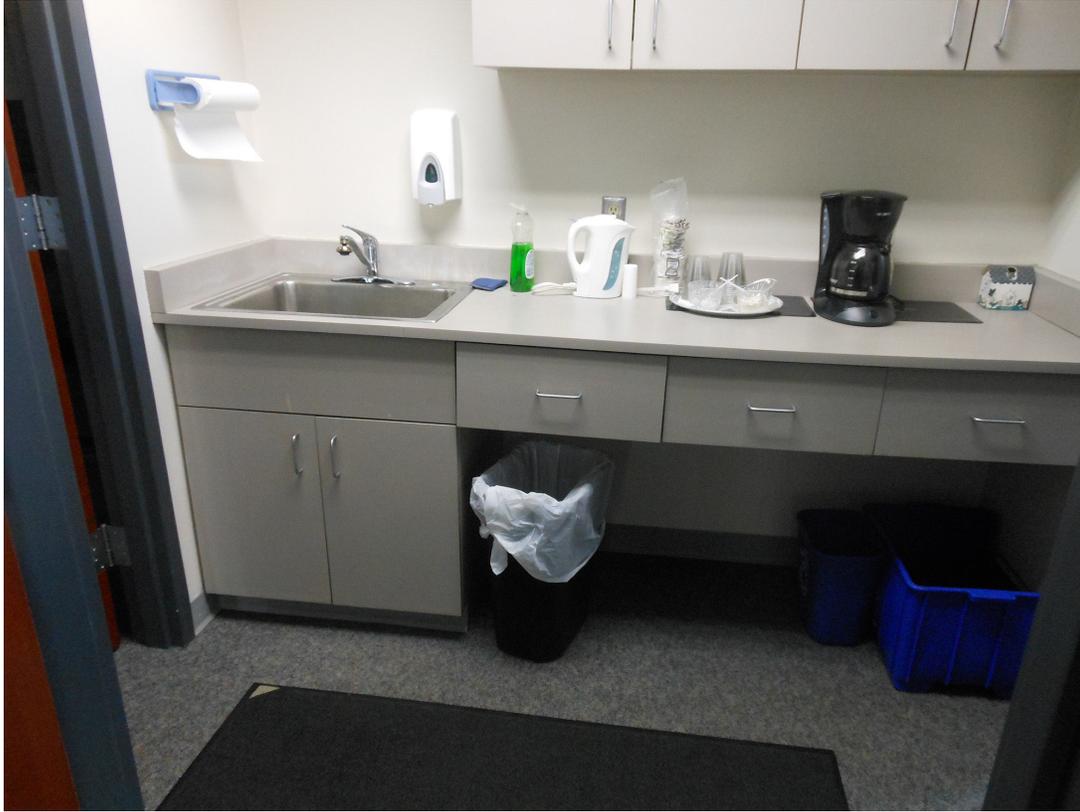
66

General ADA Non-Compliance: Accessible counter height

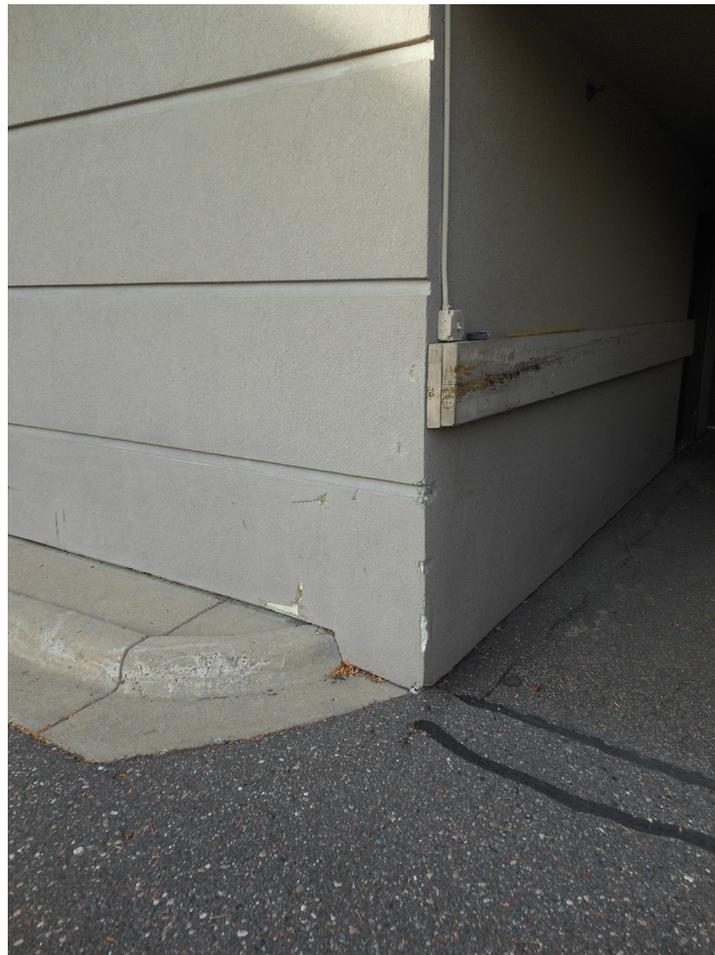
73

Fire Station: Damaged exterior EIFS stucco

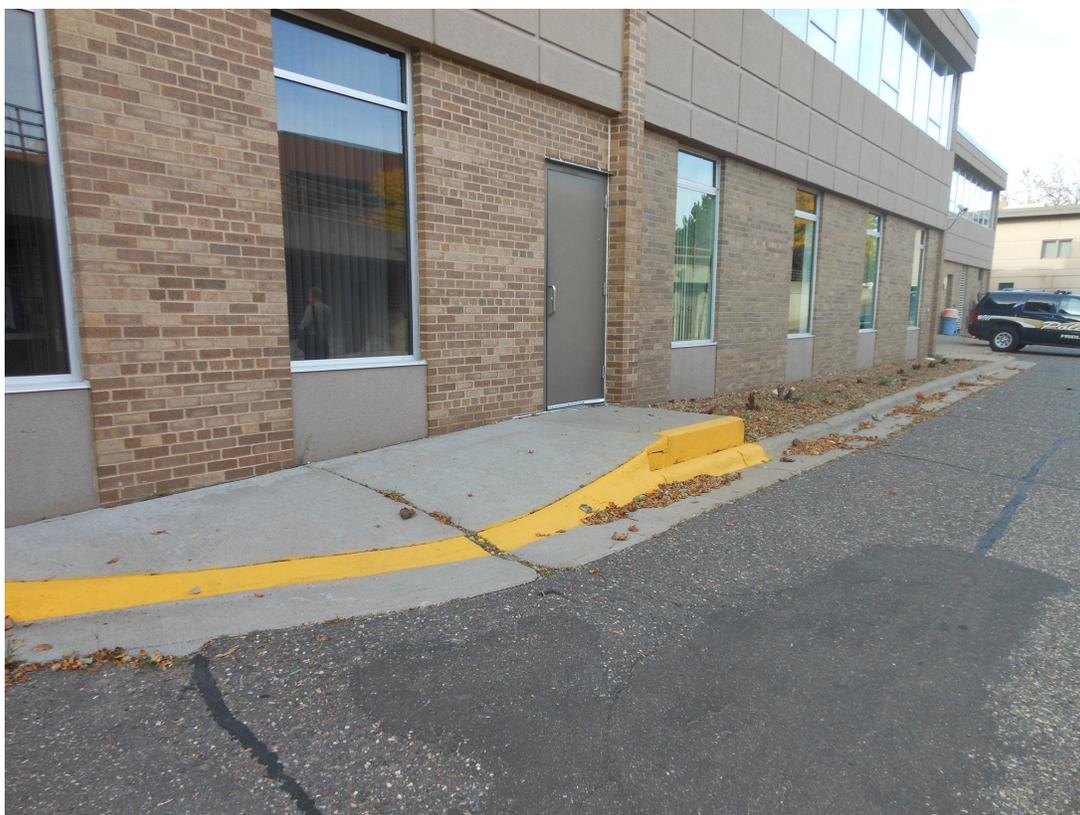
81

Non-ADA compliance: Ramp slope and turning clearance

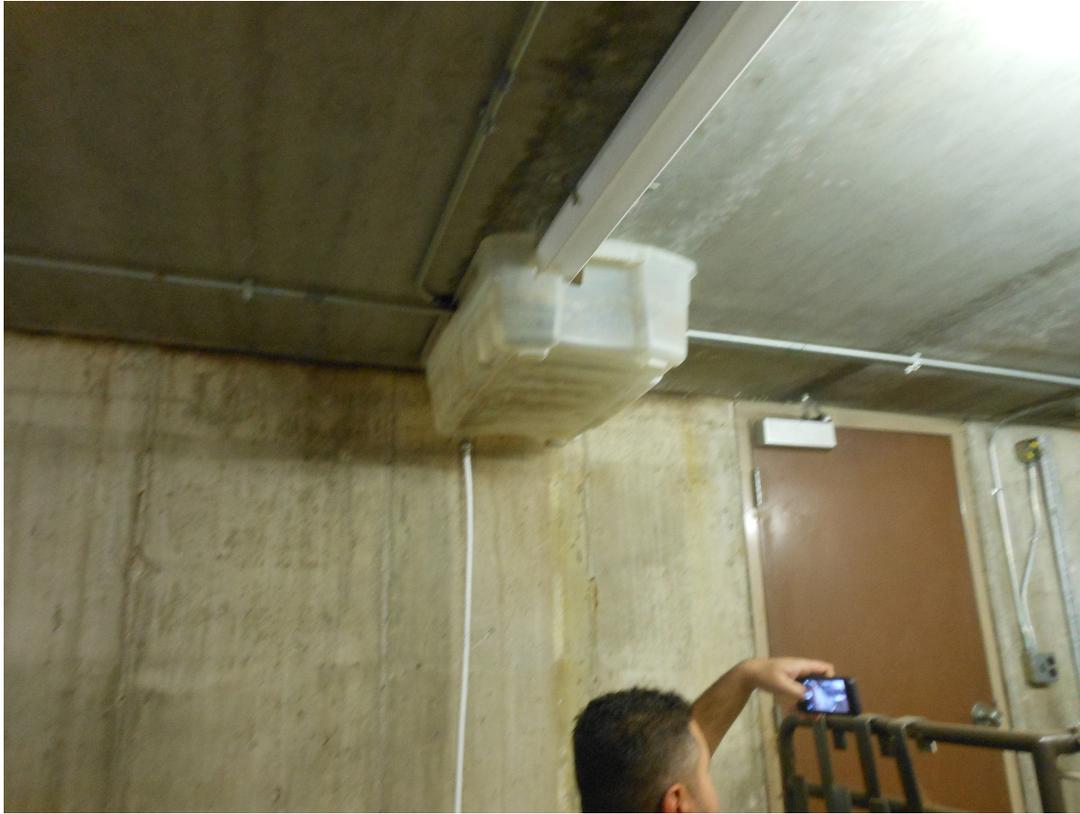
100

Verify functionality of emergency lighting system

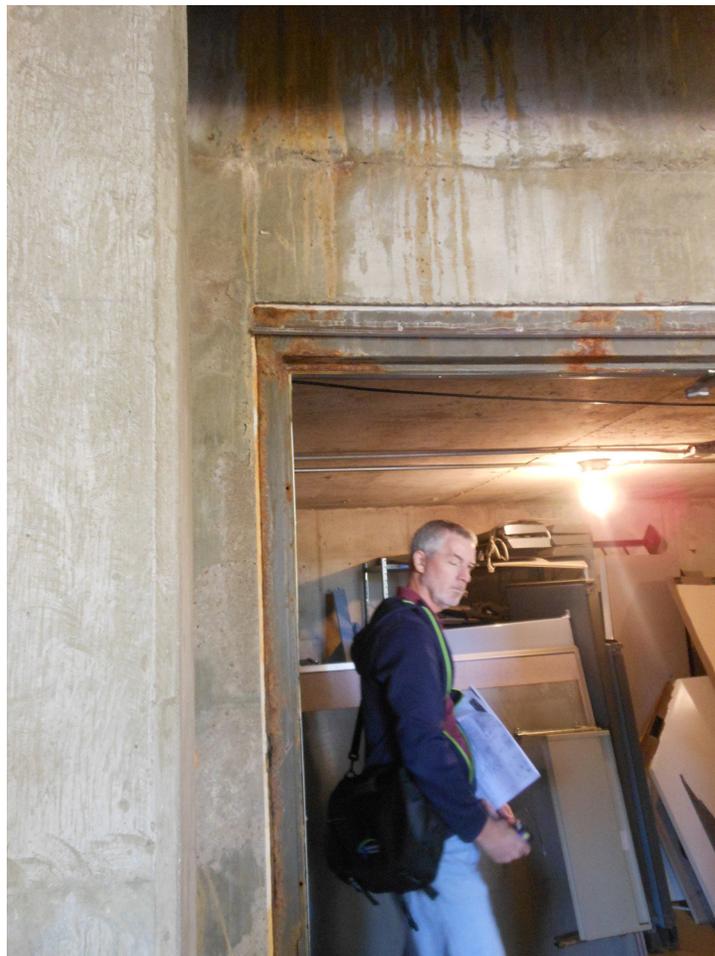
107

Police Dept: Potential security risk or ricochet risk at pass-through
