**Building Audit/Assessment**

**City of Fridley  
Municipal Center  
6431 University Avenue NE  
Fridley, MN 55432**

**December 6, 2013**

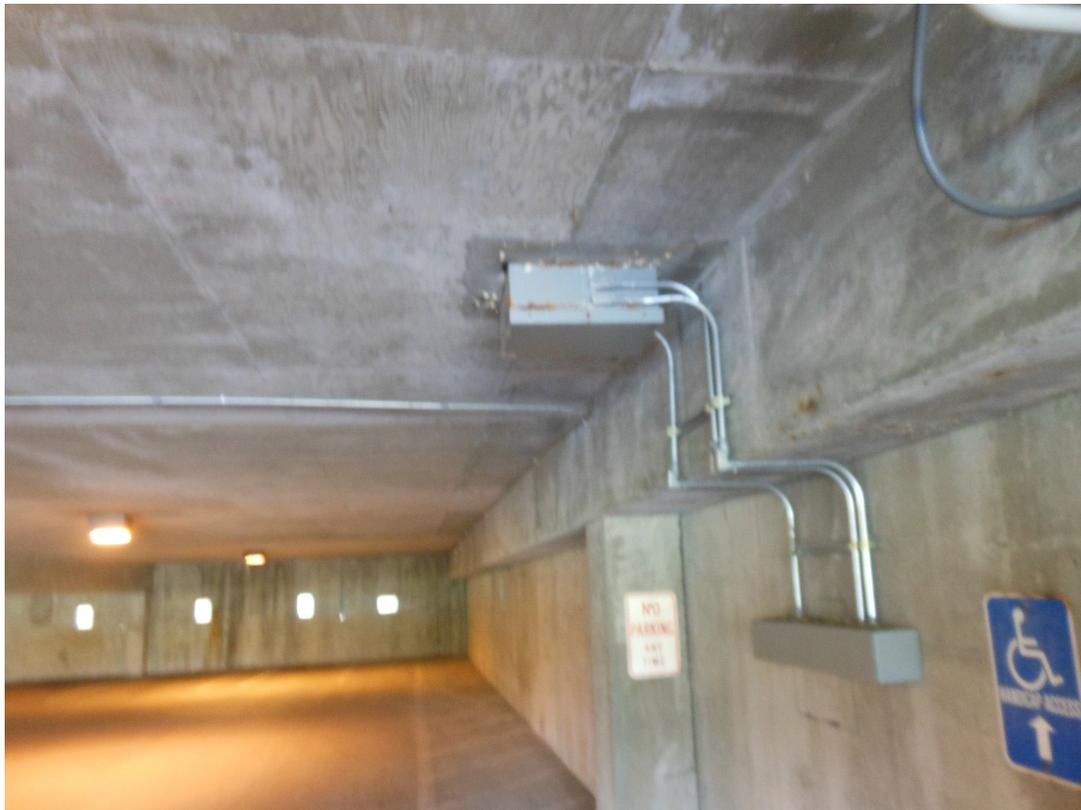
111

Lower Level Parking Garage: Water staining and general appearance

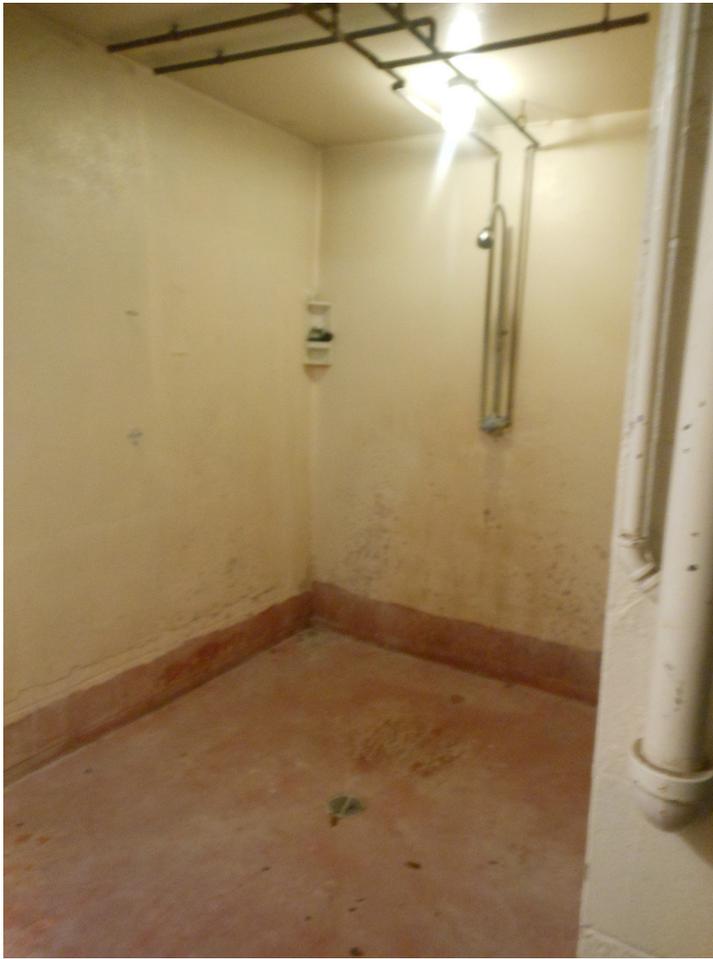
118

Shared Fitness Center Restroom: General mildew smell throughout area

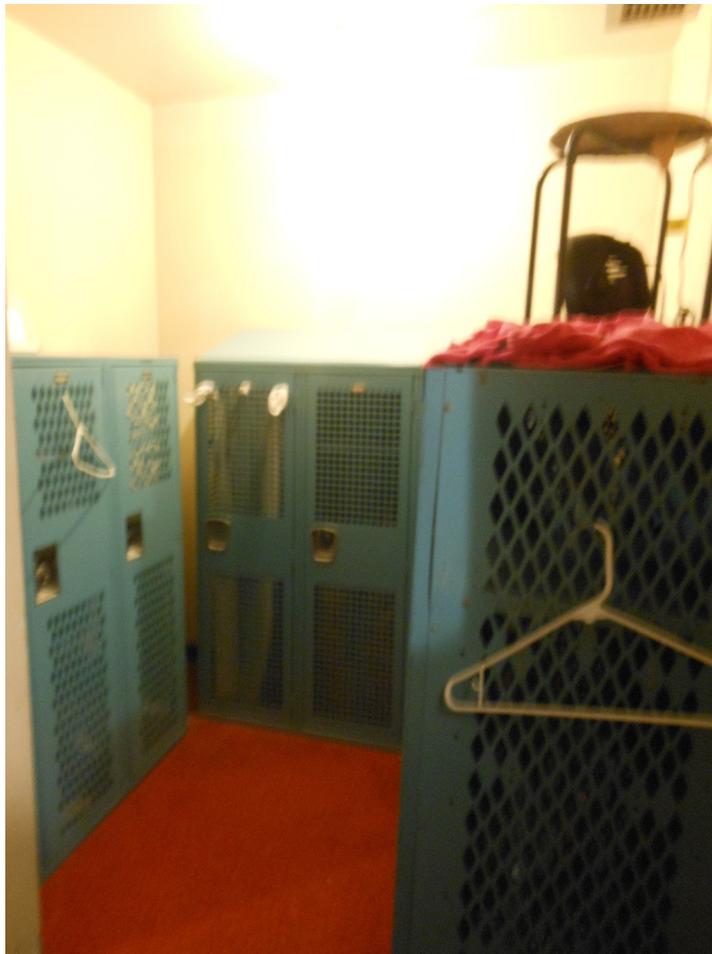
119

Shared Fitness Center Restroom: Non-ADA compliant, inadequate clearances, peeling paint

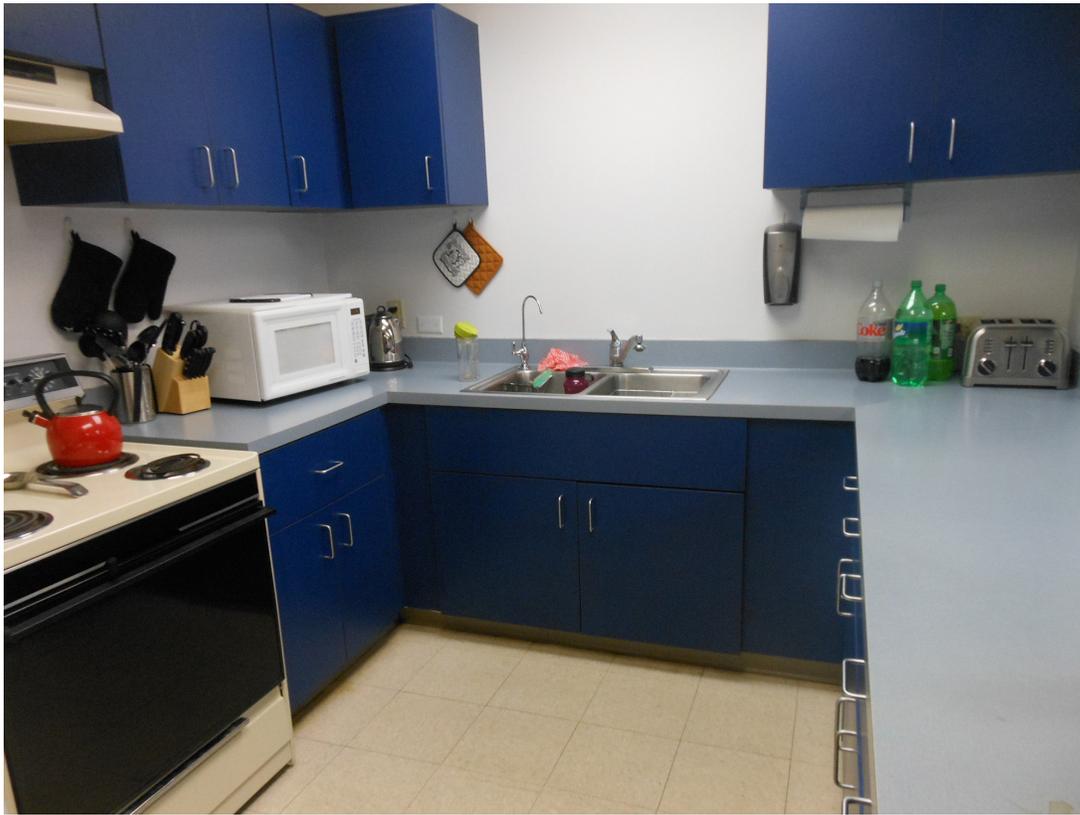
122

Fire Station: Shared work, office, living and sleeping areas; no separate private entrance, no secure lobby

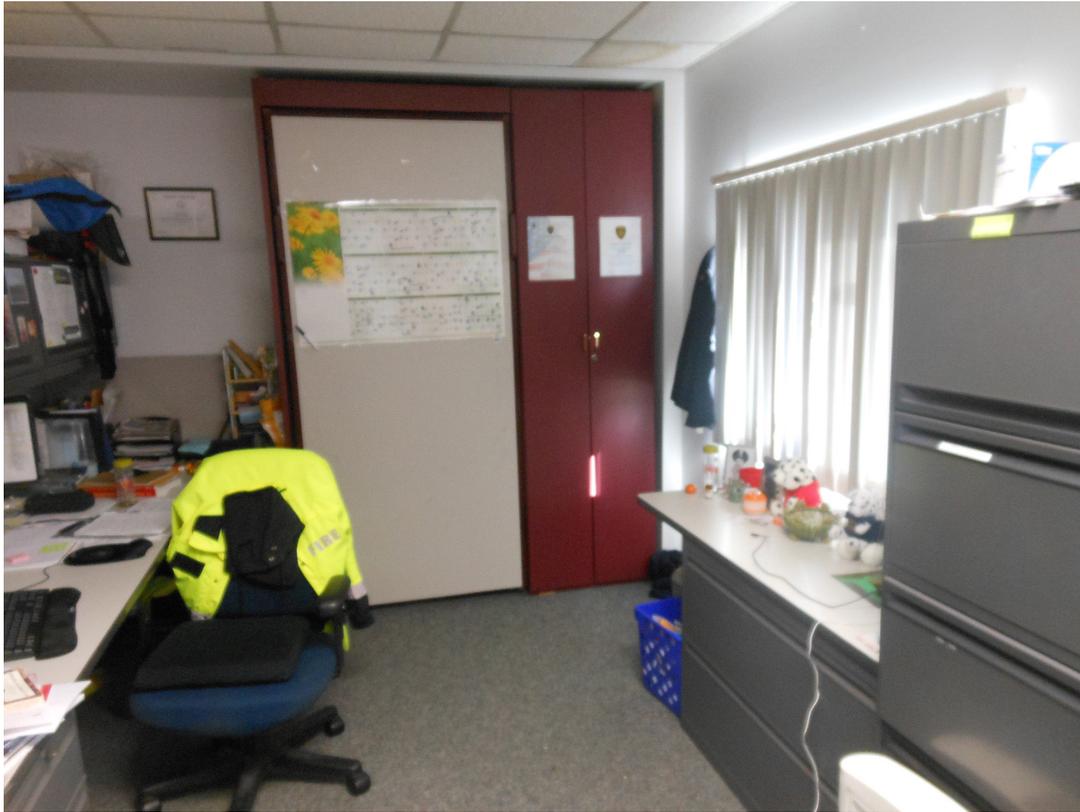
126

Fire Station: Work, office, living and sleeping space all shared.

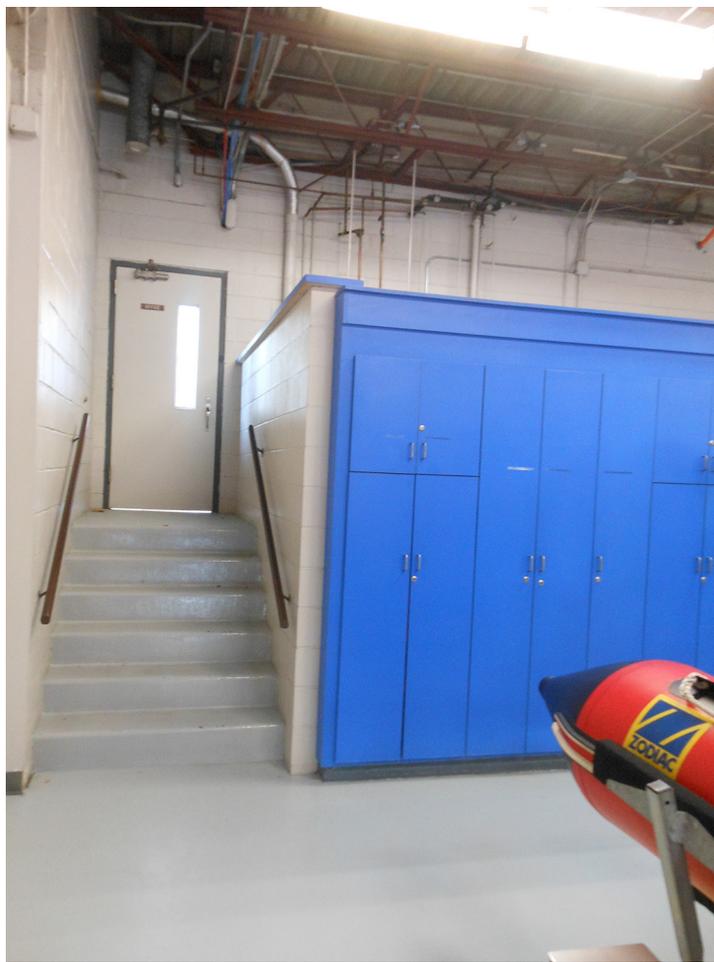
130

Fire Station: Stair from storage/fitness shared space accesses directly to living space.

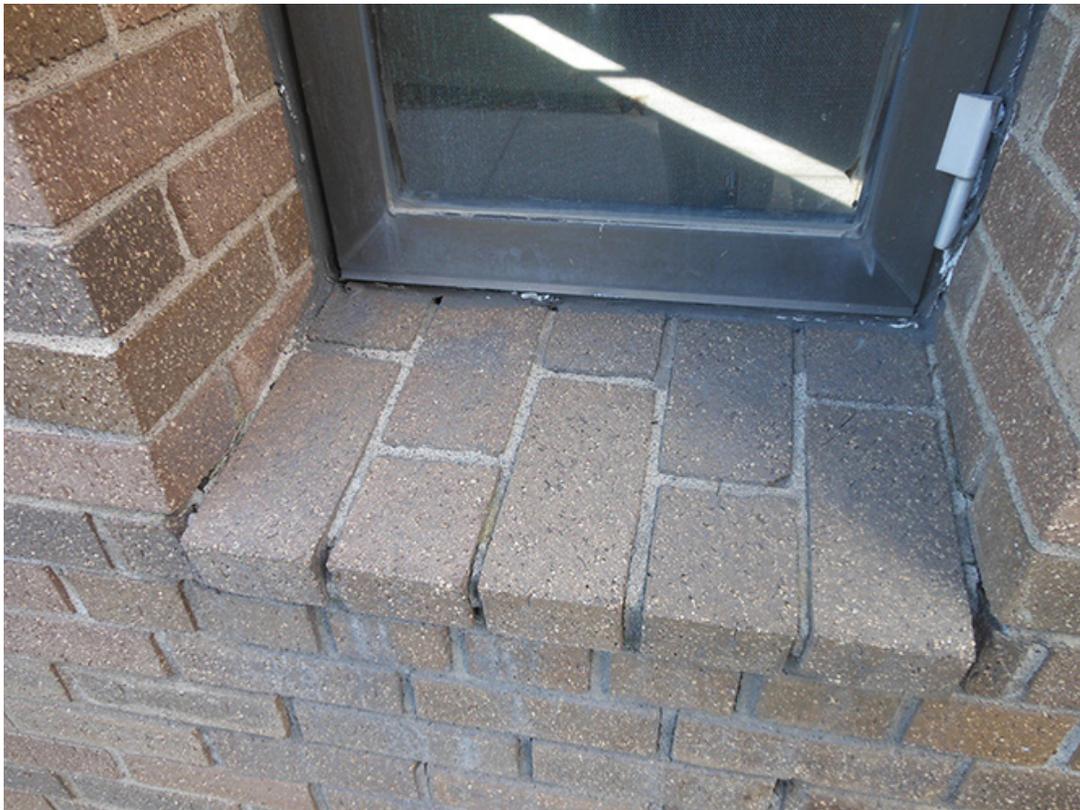
135

Municipal Center: Sealant at exterior windows failing

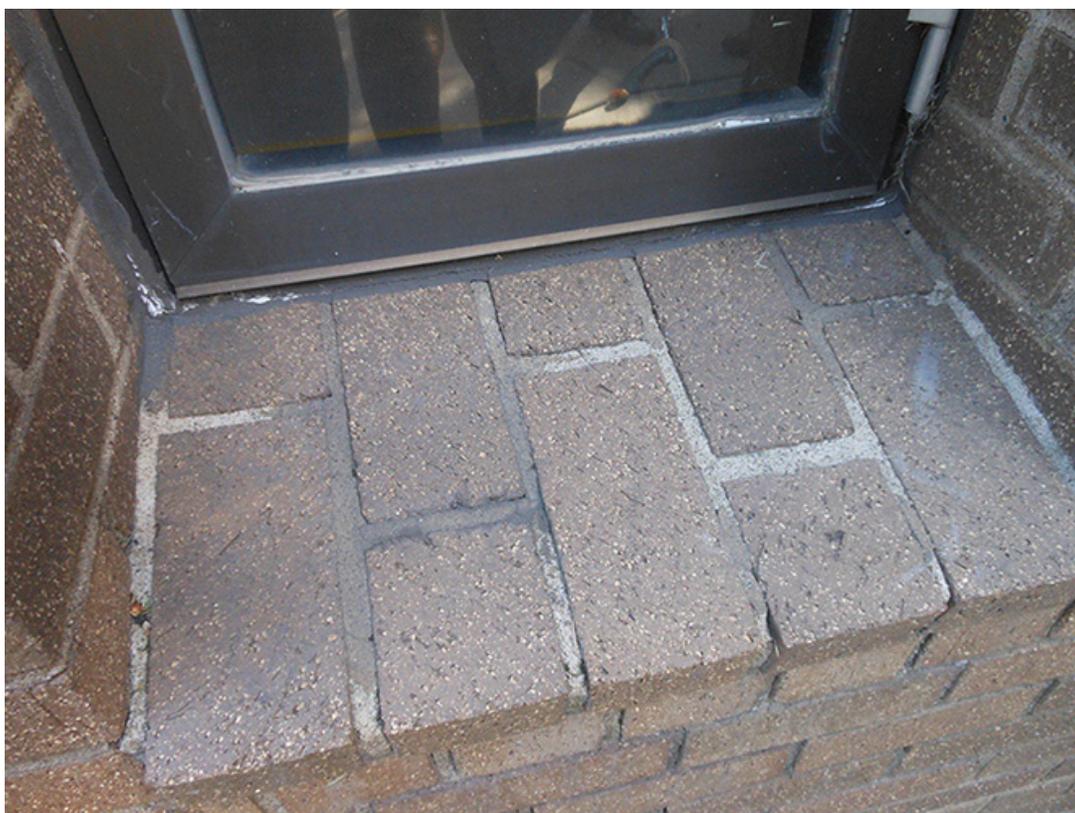
137

Municipal Center: Exterior brick sill needs re-tipping

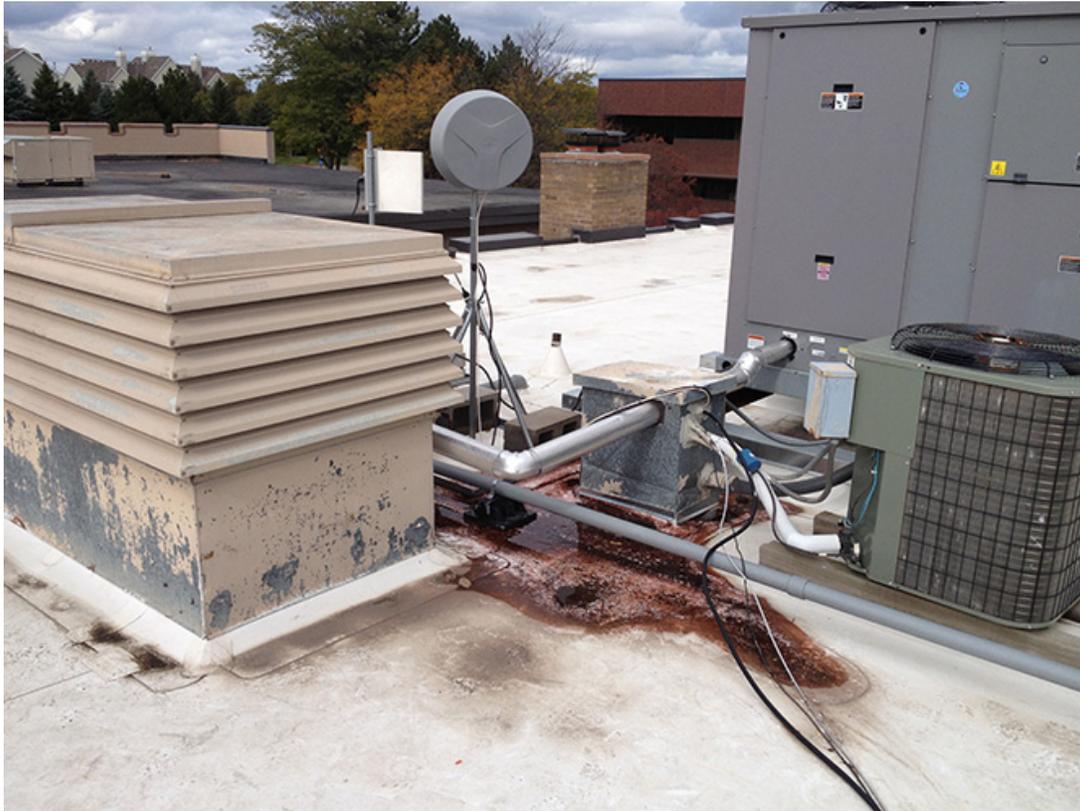
144

Municipal Center: Expanded joints at pavement and wall base, water infiltration probable

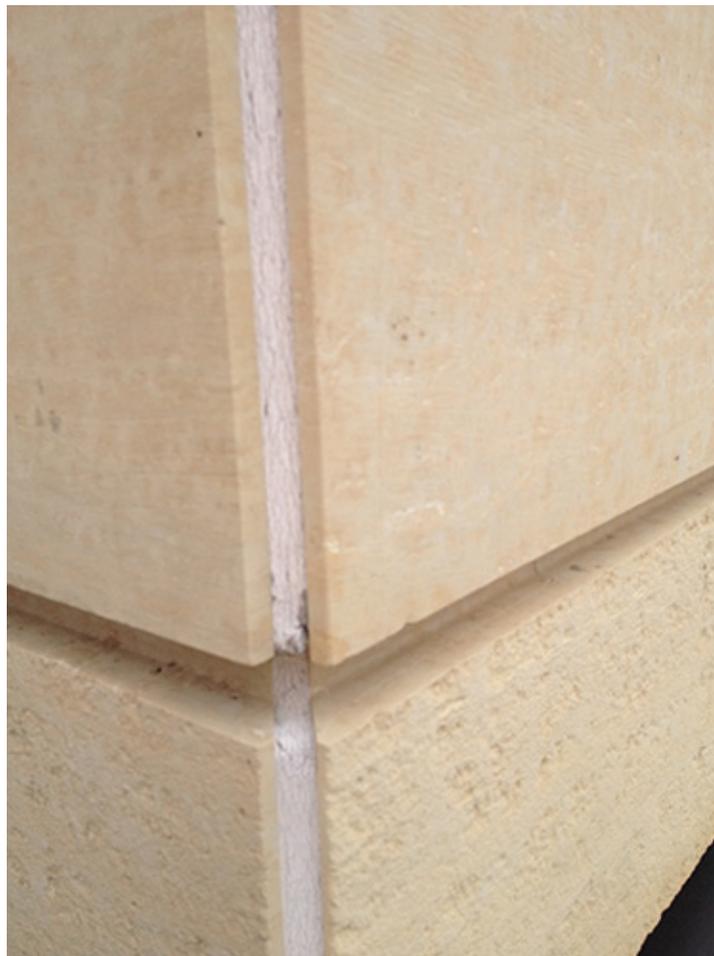
151

Municipal Center Roof: Stone veneer to higher roof area has cracked sealant

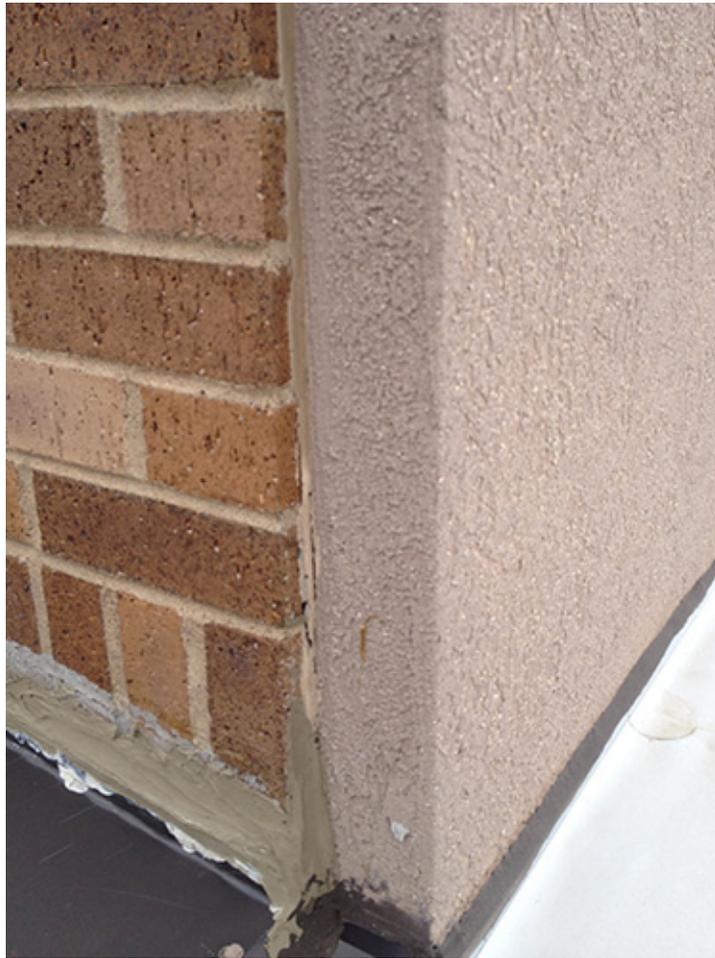
154

Municipal Center Roof: Joints and sealants of lower roof areas need replacement

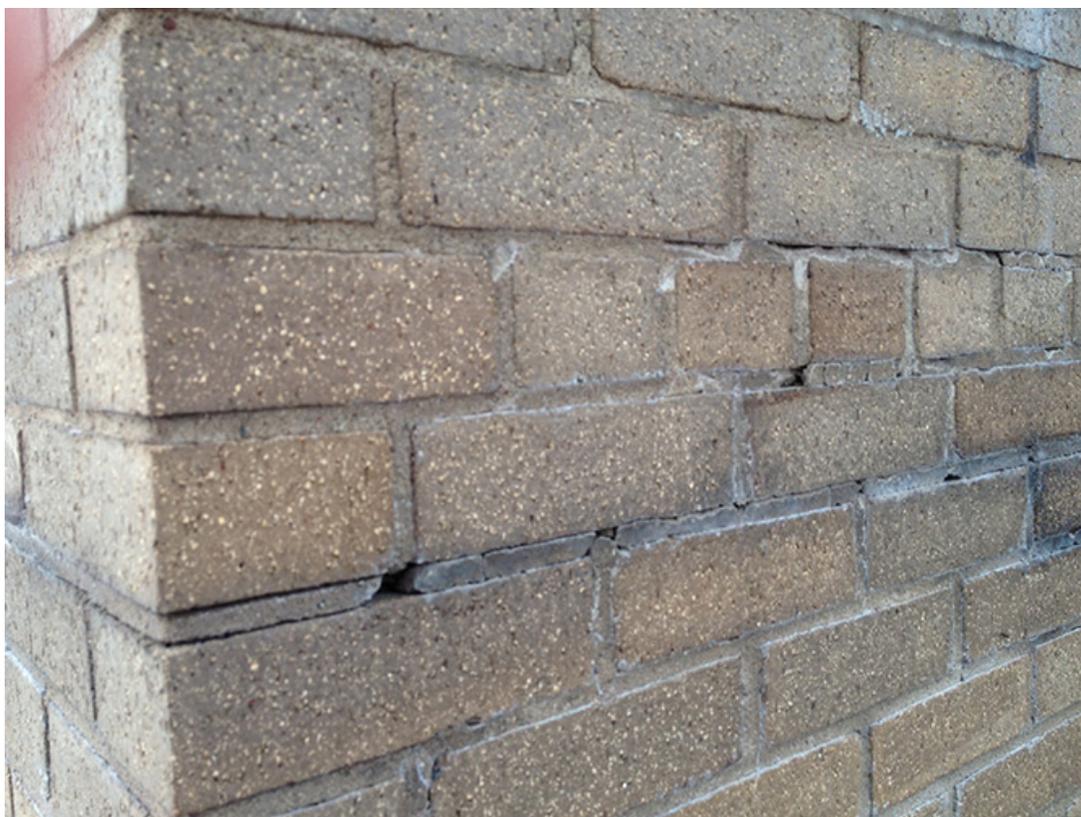
157

Municipal Center Roof: Back parapet masonry needs rejointing

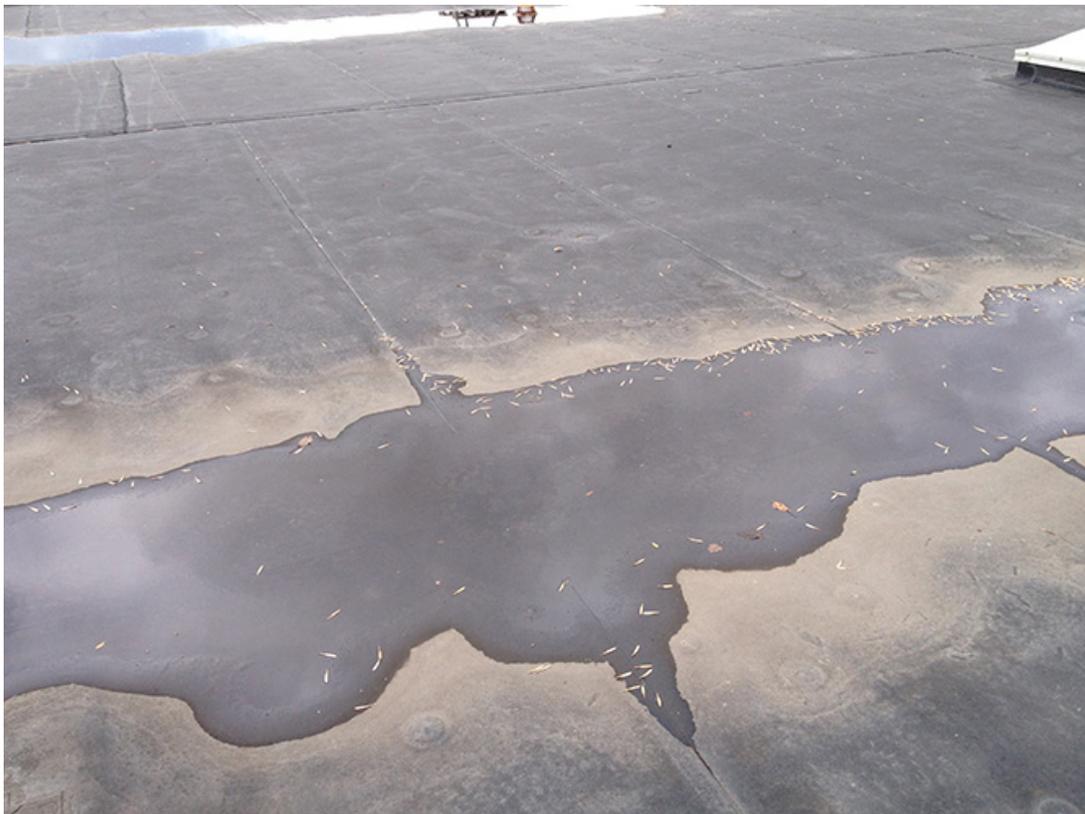
159

Fire Station Roof: Aged roof with patches

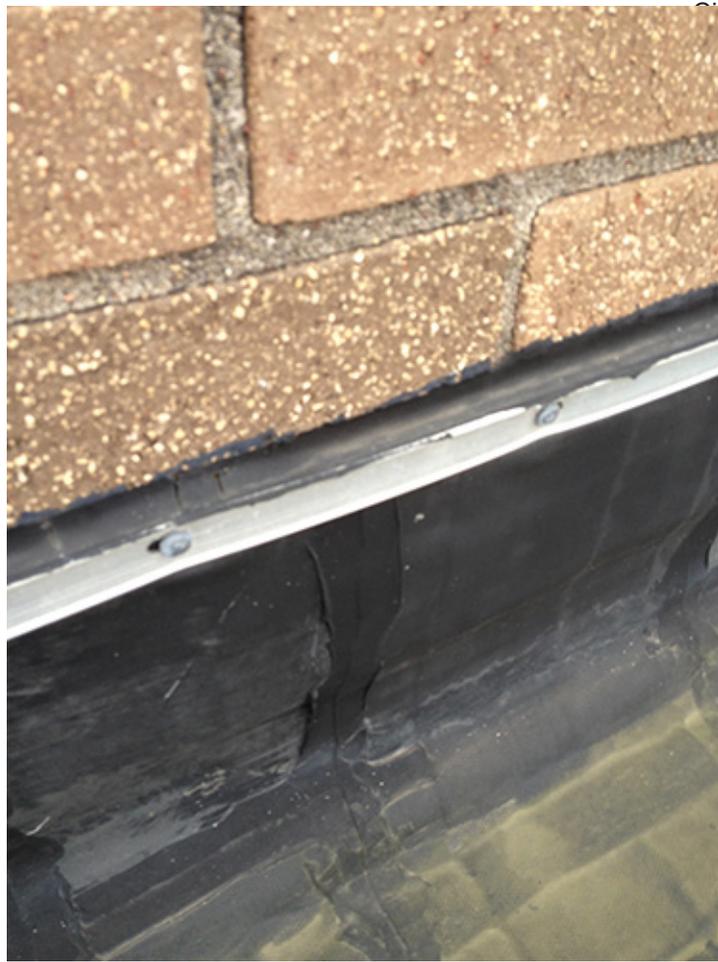
166

Fire Station Roof: Peeling membrane seams

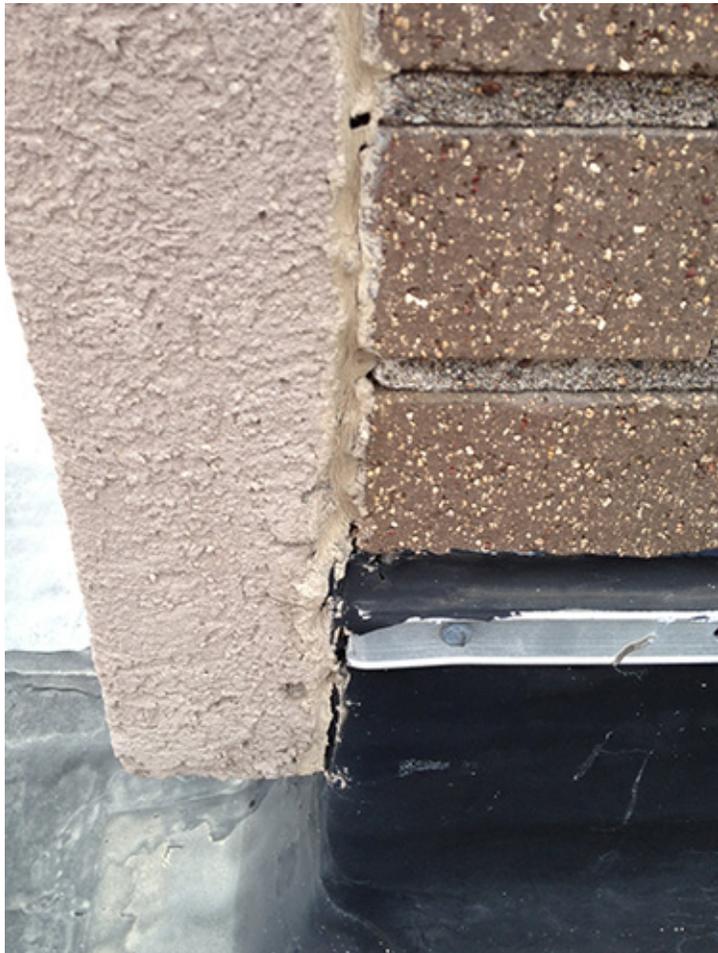
167

Fire Station Roof: Joint sealant at flashing needs replacement

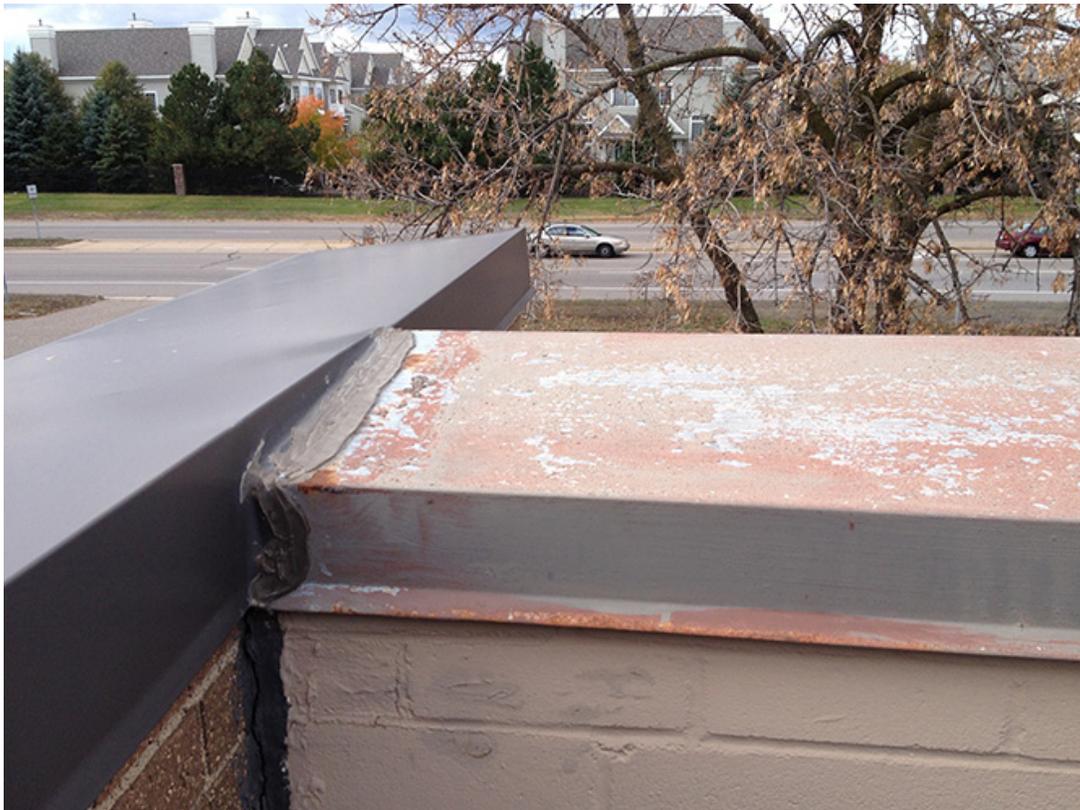
171

Fire Station: Sealant at parapet corners need replacement

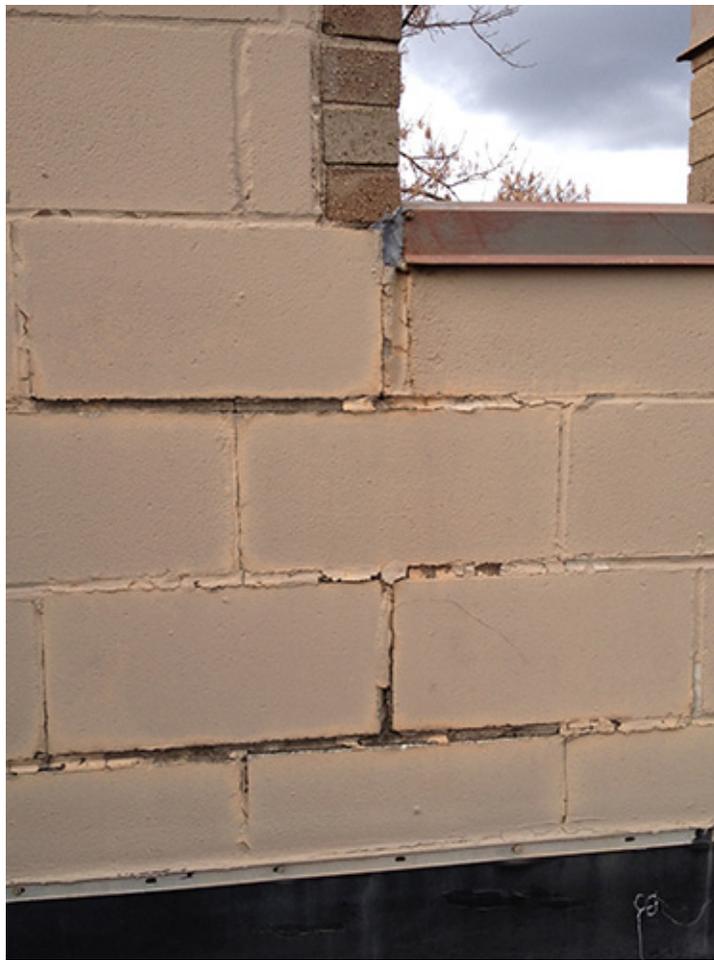
172

Fire Station Roof: Aged and weathered metal coping

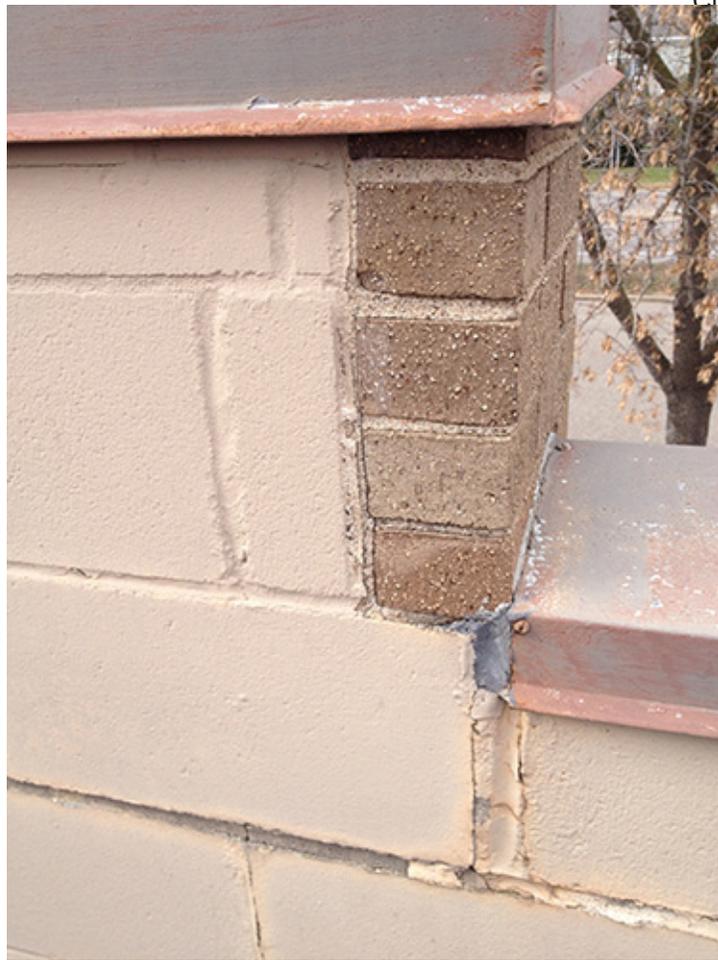
174

Fire Station Roof: Joint sealant at flashing needs replacement

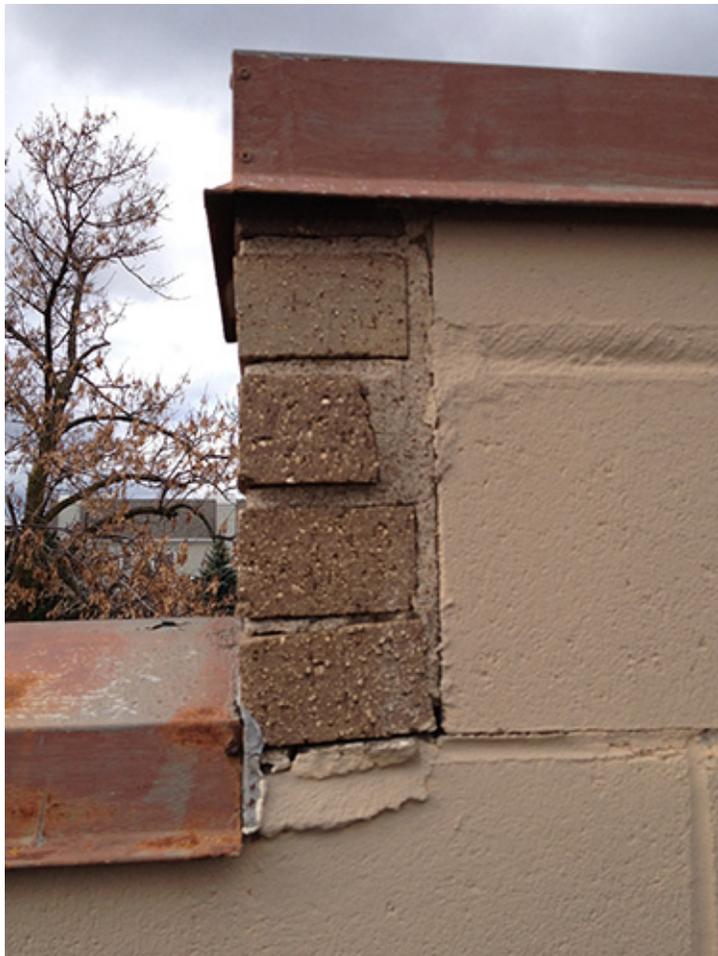
175

Fire Station Roof: Joint sealant at flashing needs replacement

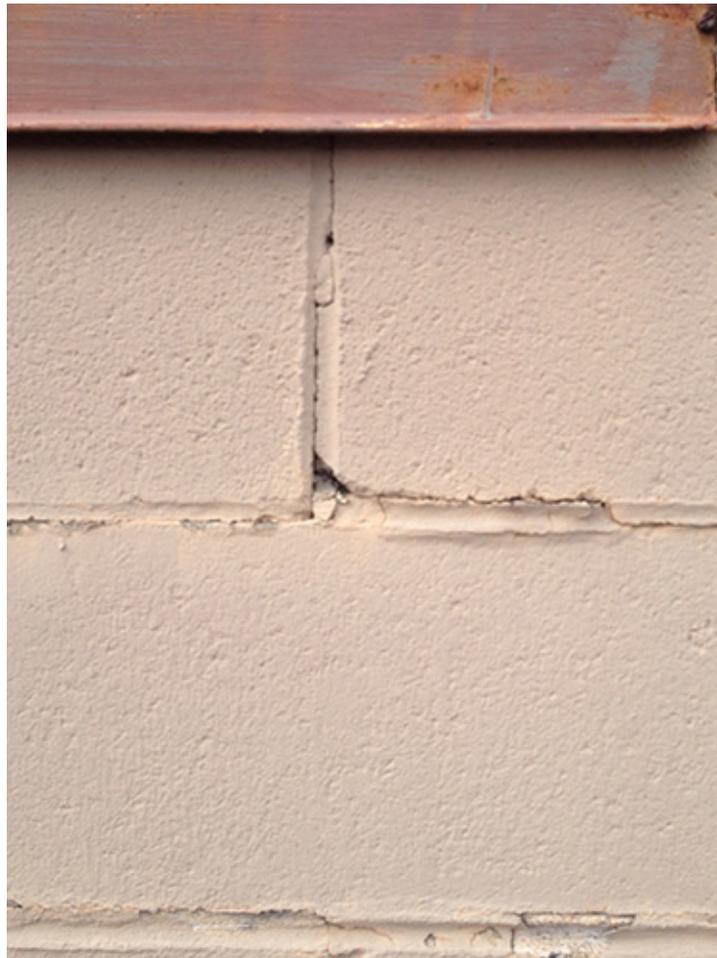
176

Fire Station: Brick at parapet needs re-tipping

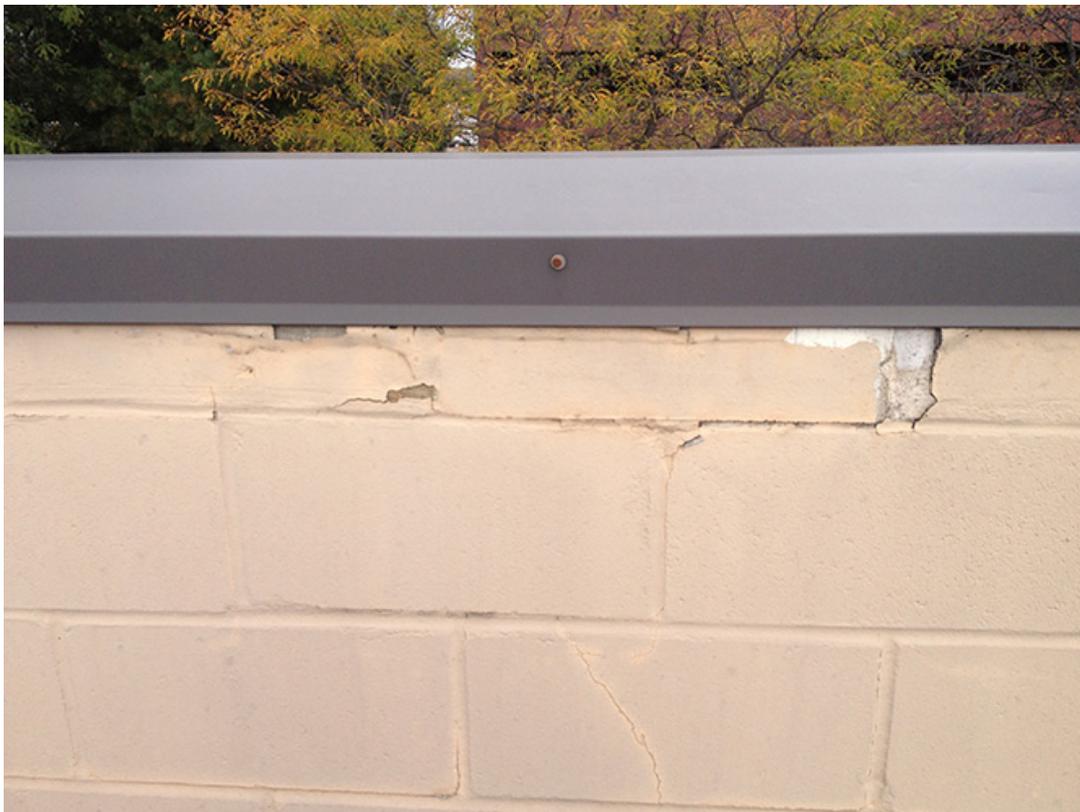
177

Fire Station Roof: Damaged and peeling painted CMU

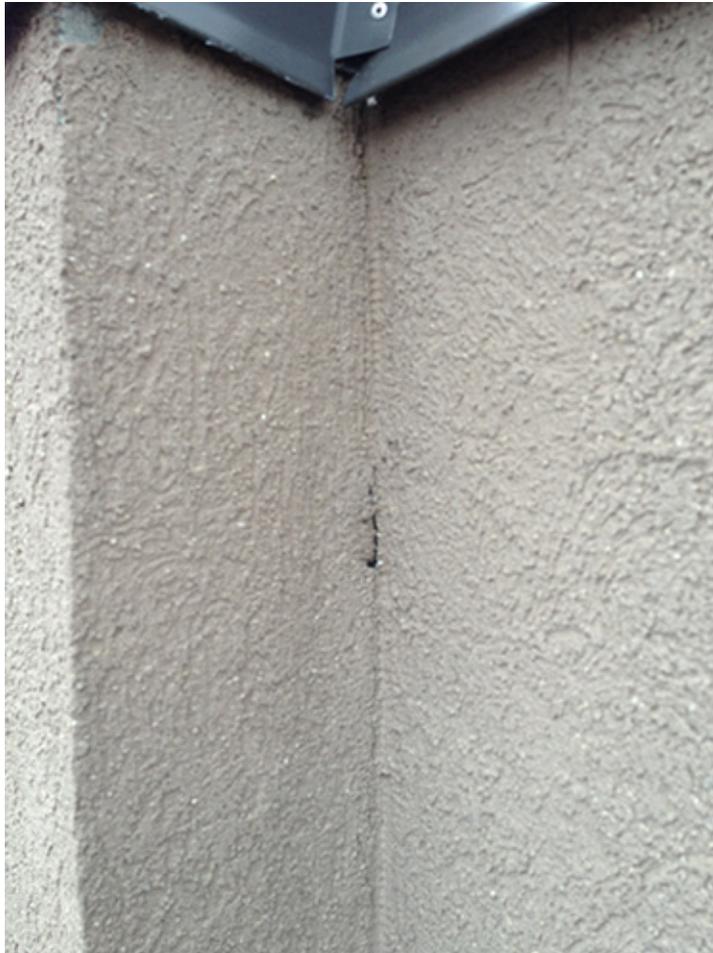
183

Fire Station Roof: No extension on overflow scupper, water drains down wall face

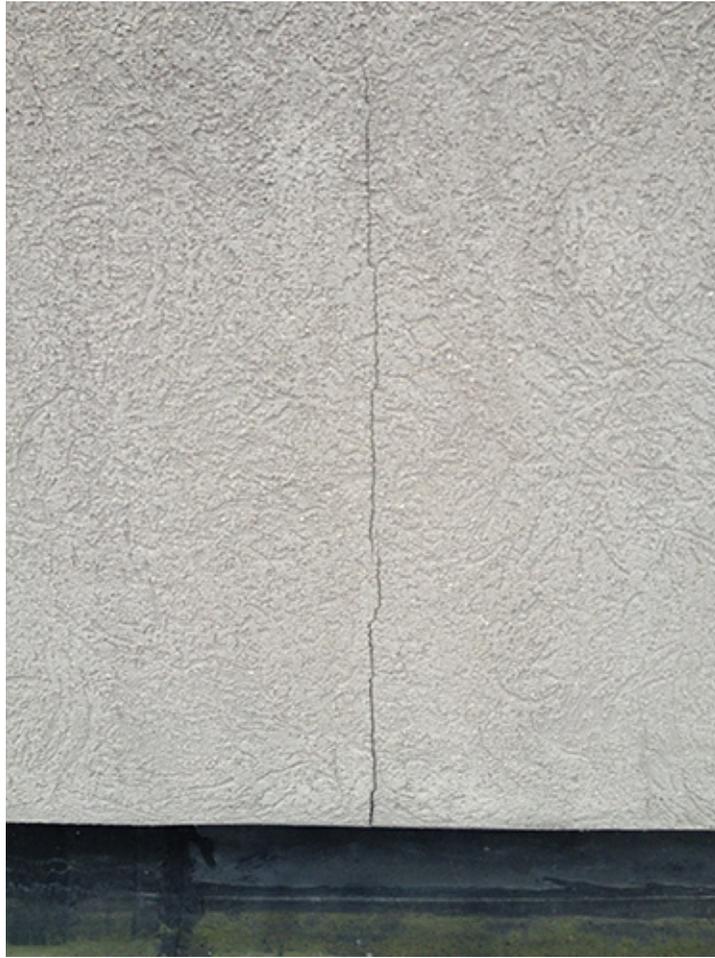
186

Fire Station Roof: Damaged stucco finish on roof

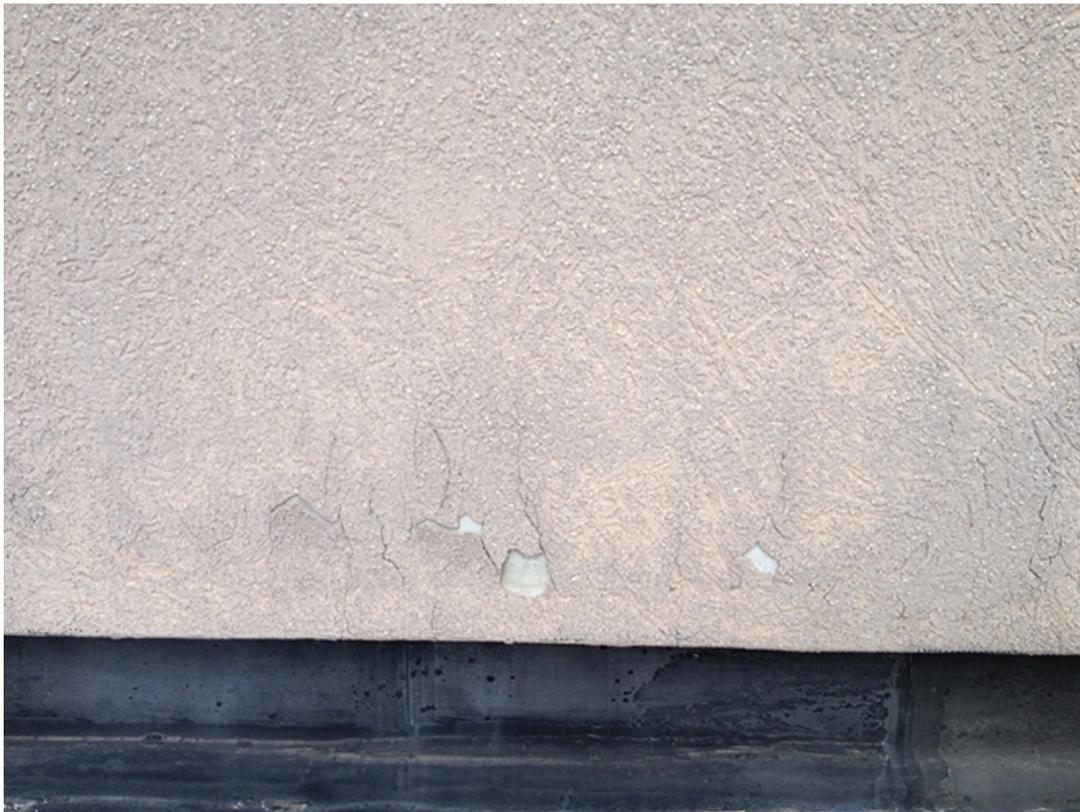
187

Fire Station: Cracking in EIFS exterior panels.

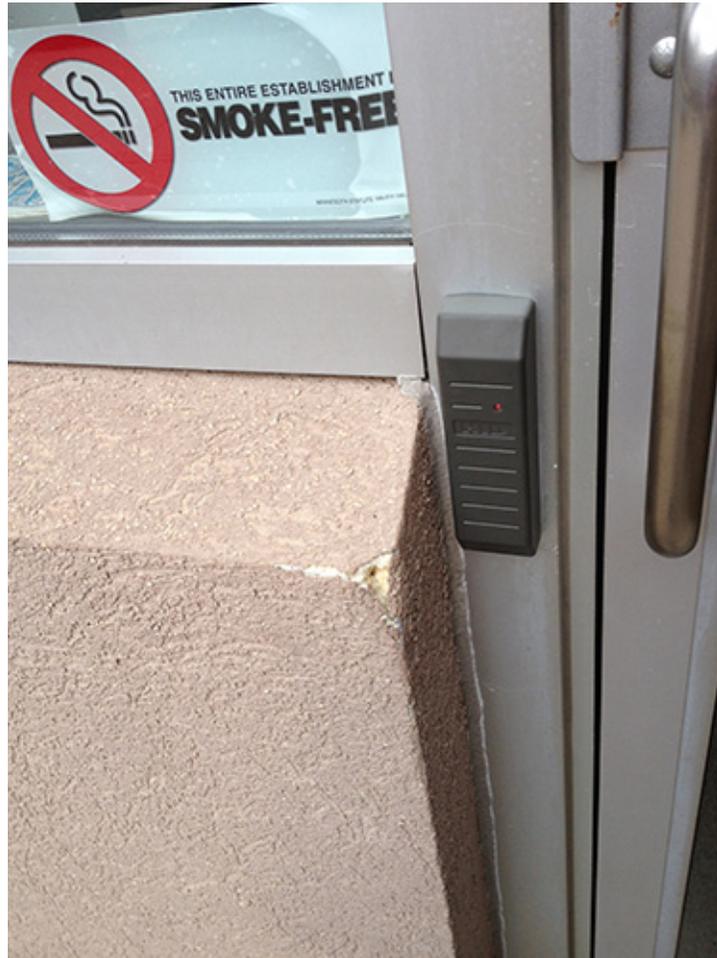
188

Fire Station: Cracking in EIFS exterior panels.

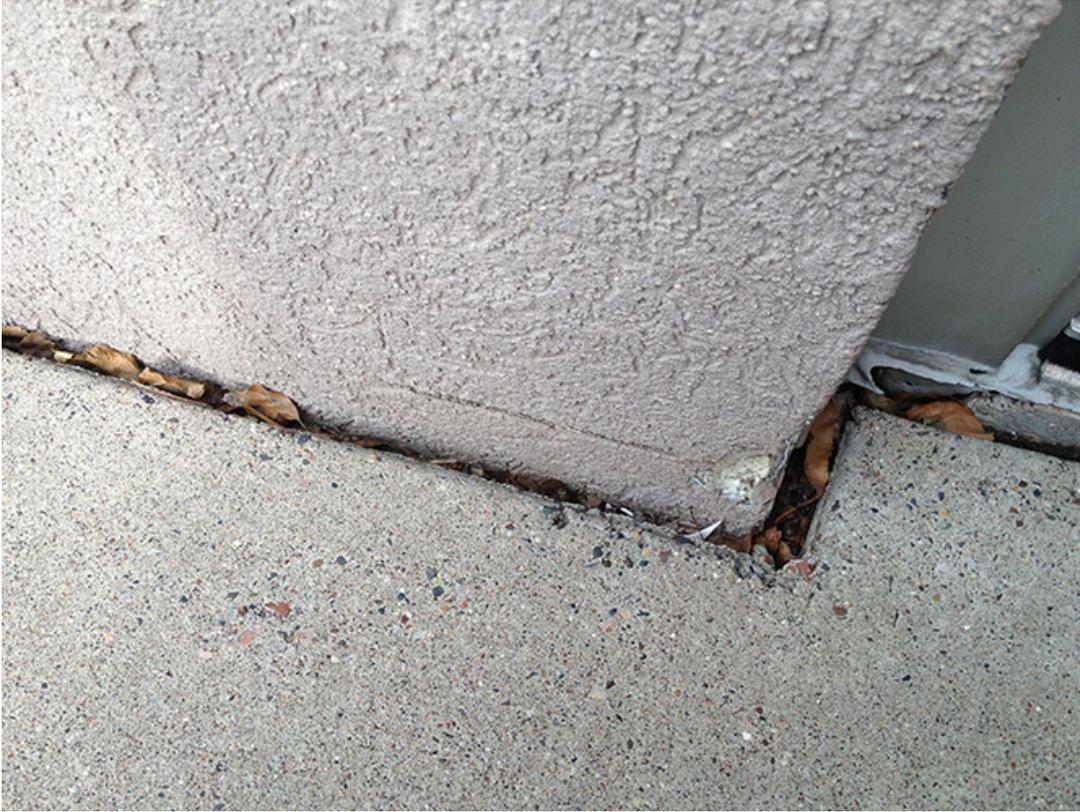
190

Fire Station: Damaged EIFS exterior panels.

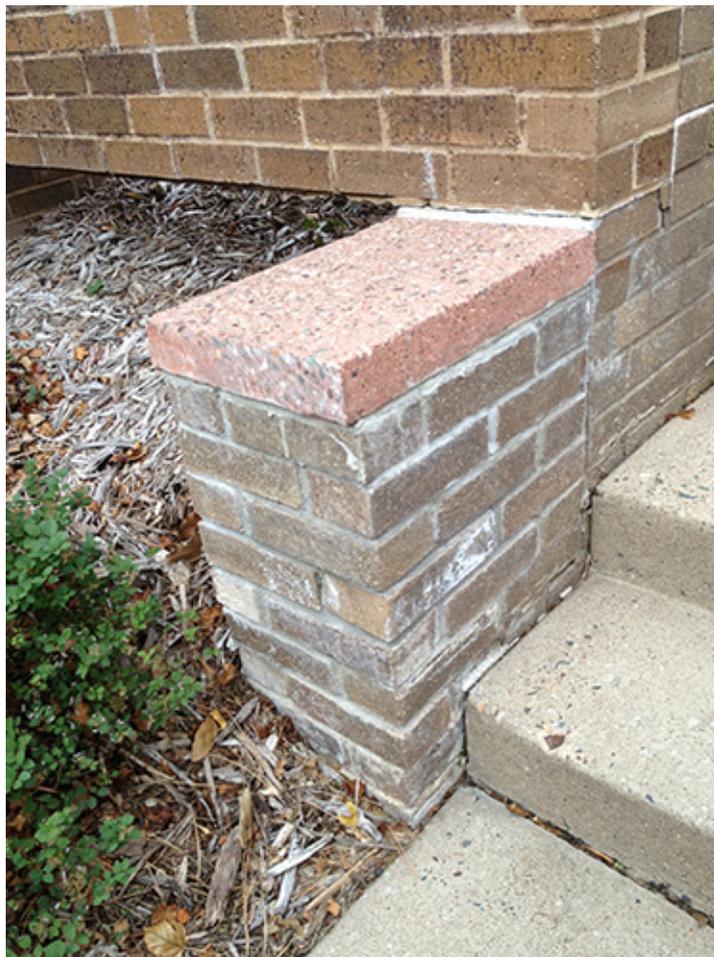
195

Municipal Center: Exterior brick efflorescence and need re-tipping

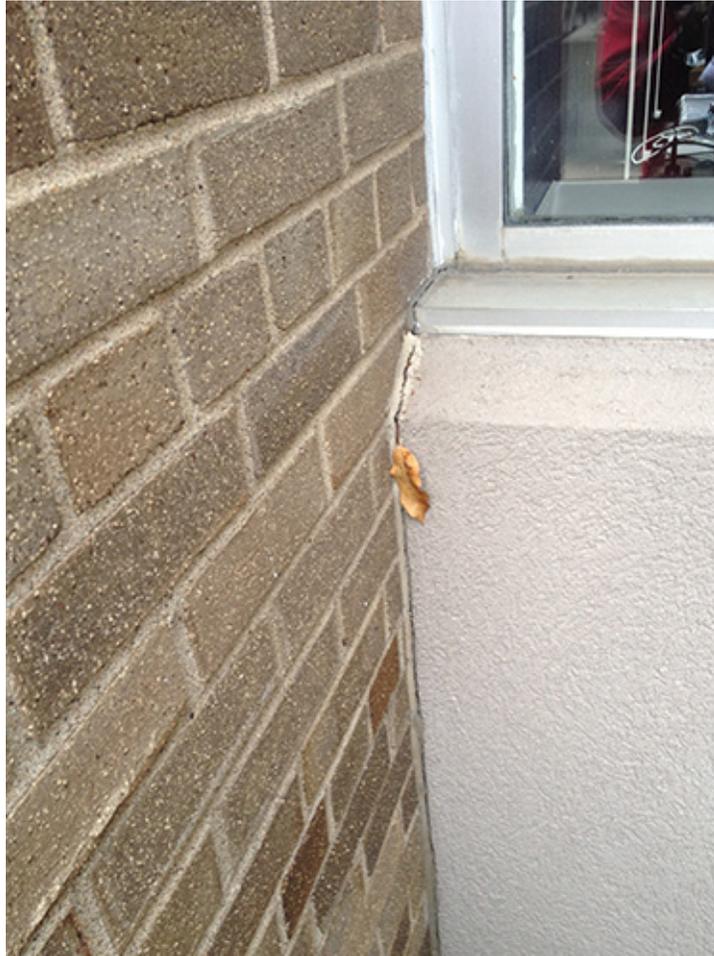
200

Municipal Center: Sealant at exterior brick joints need replacement

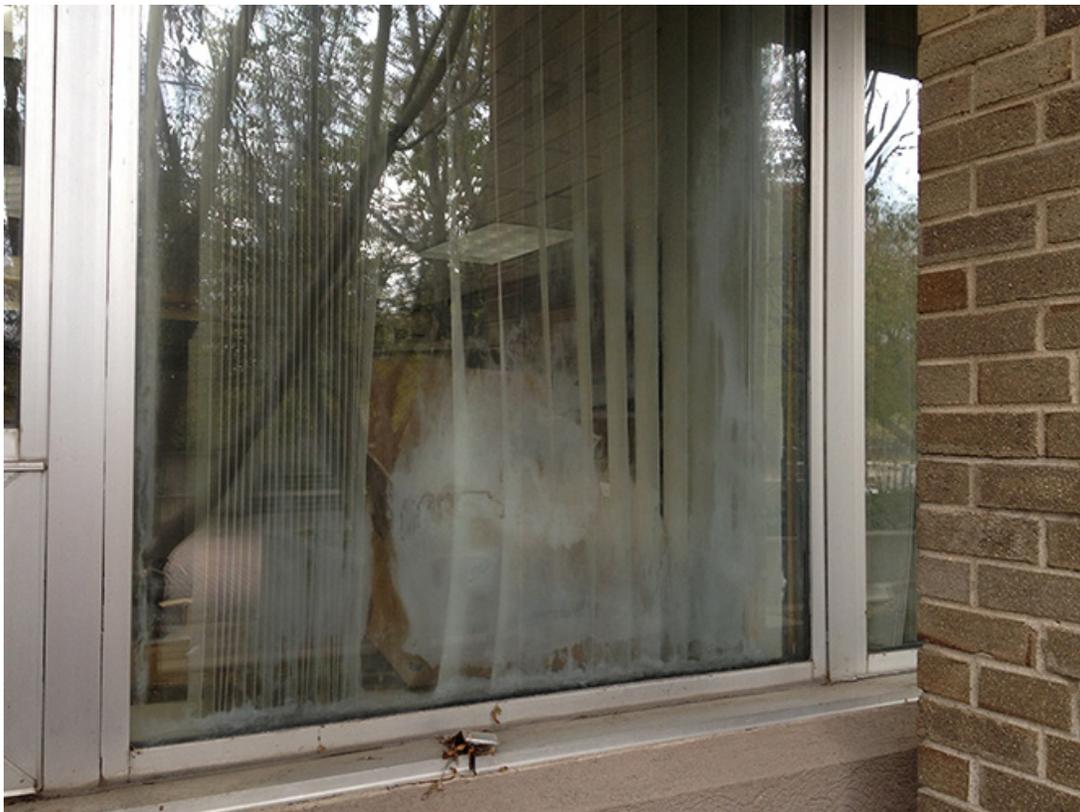
203

Municipal Center: Exterior window frame failing, air infiltration issue
