**Building Audit/Assessment**

**City of Fridley  
Municipal Center  
6431 University Avenue NE  
Fridley, MN 55432**

**December 6, 2013**

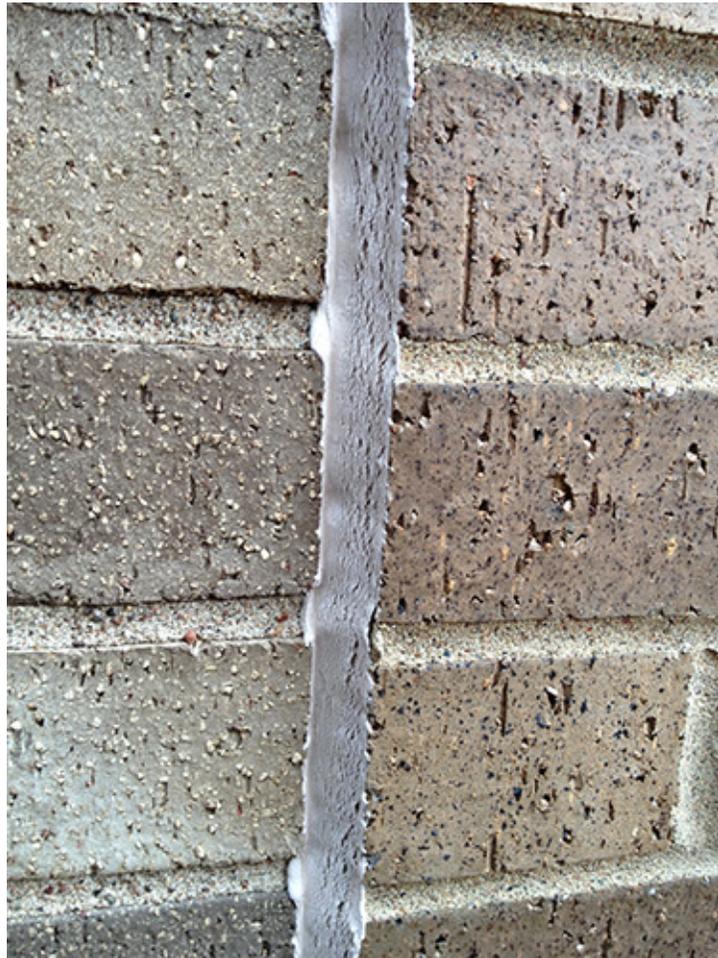
206

Municipal Center: Exterior sealant at facade joints need replacement

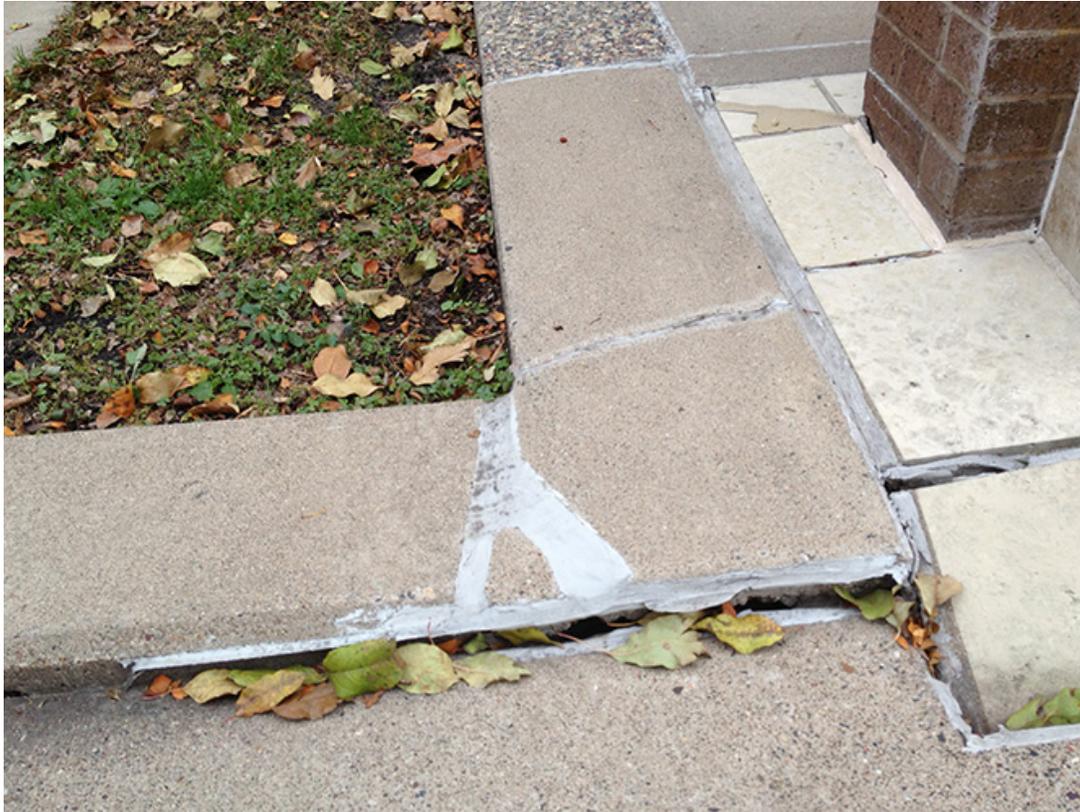
210

Municipal Center: Uneven, settled exterior pavement at column bases

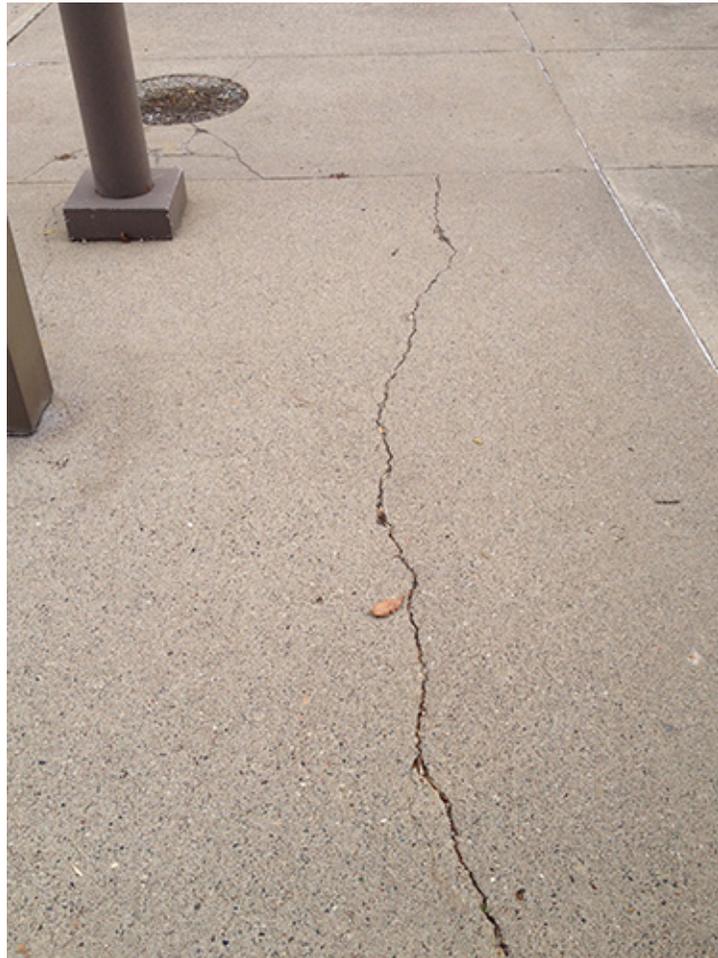
230

Municipal Center: Exterior pavement damaged, hazardous

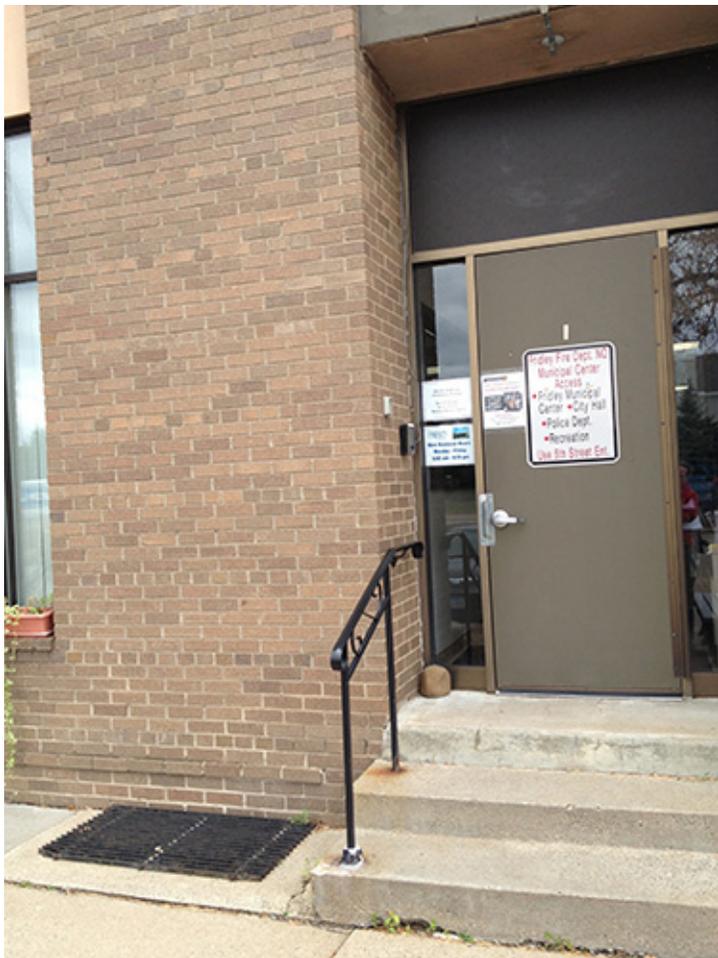
239

Municipal Center: Non-compliant exterior entrance path to Police Dept.

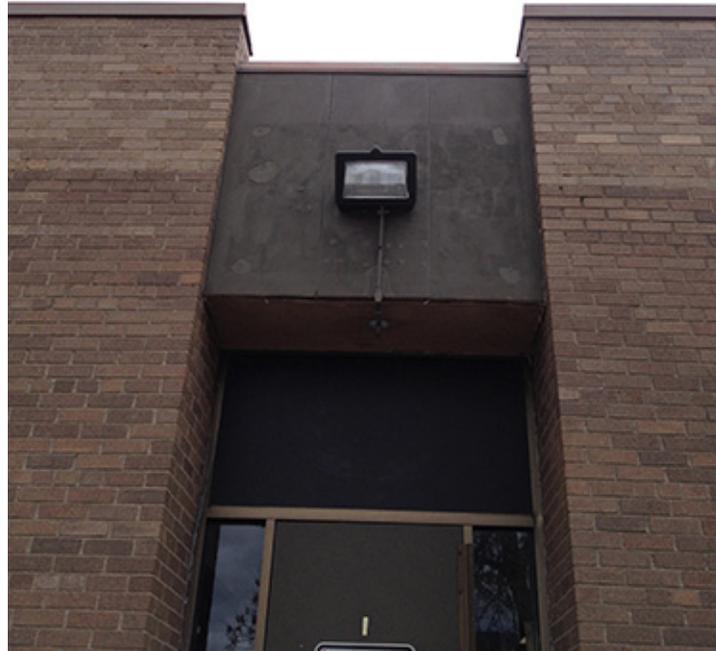
240

Municipal Center: Non-compliant exterior entrance path to Police Dept.

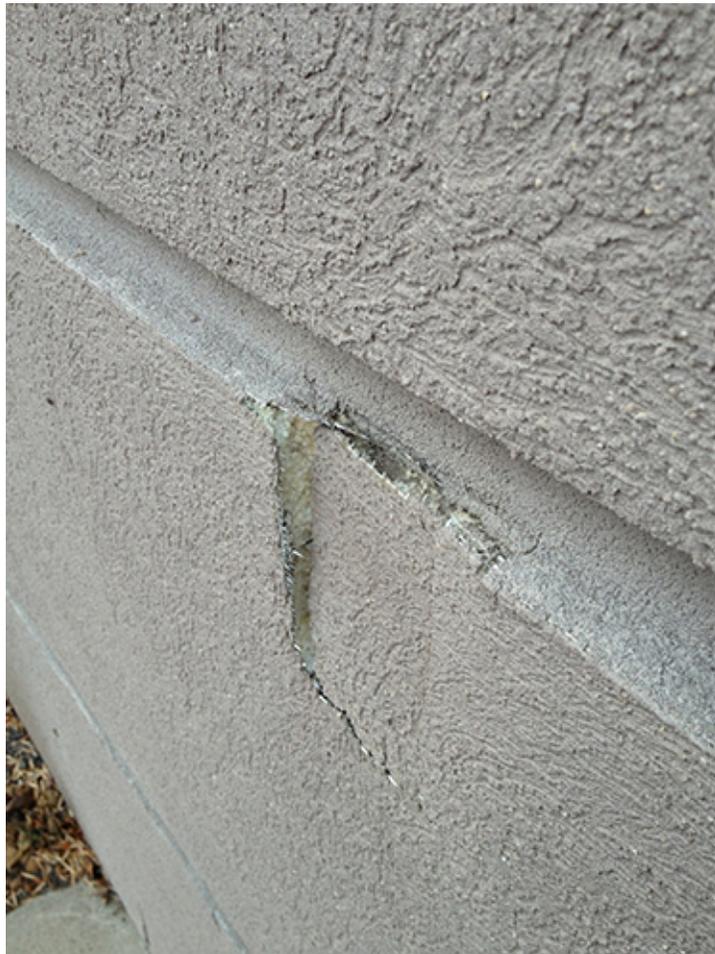
245

Fire Station: Exterior EIFS panel finish deteriorating

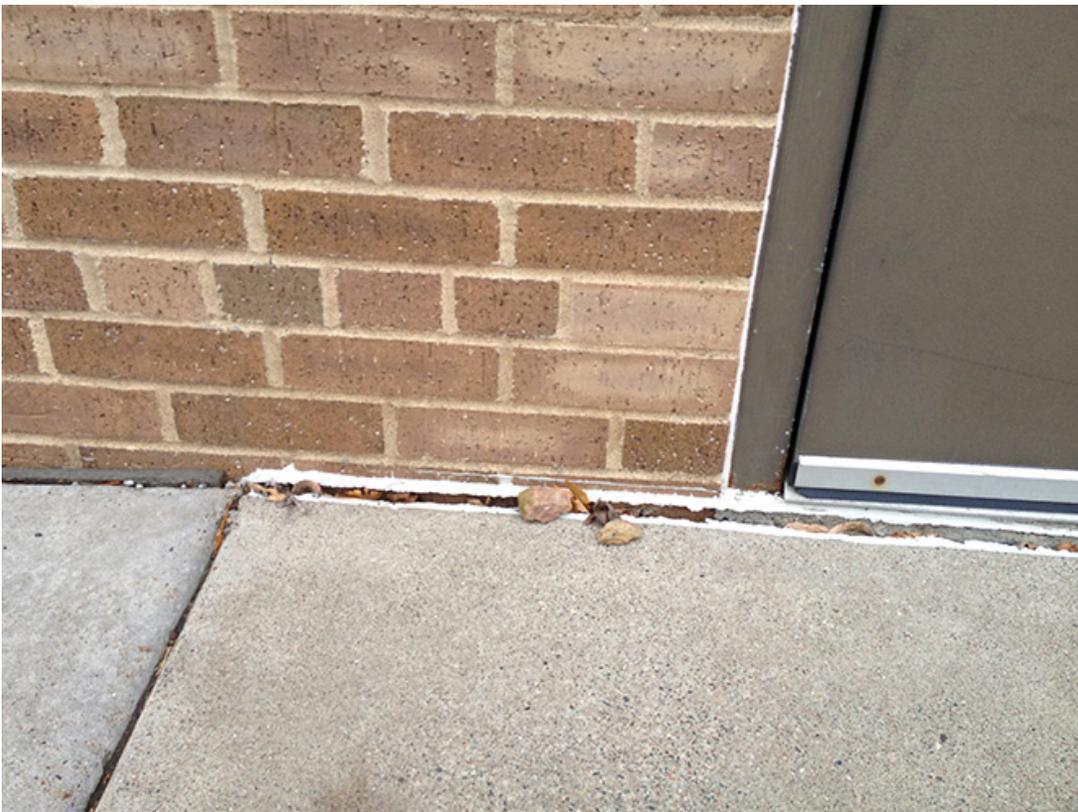
255

Municipal Center: Non-ADA compliant slope to exterior door

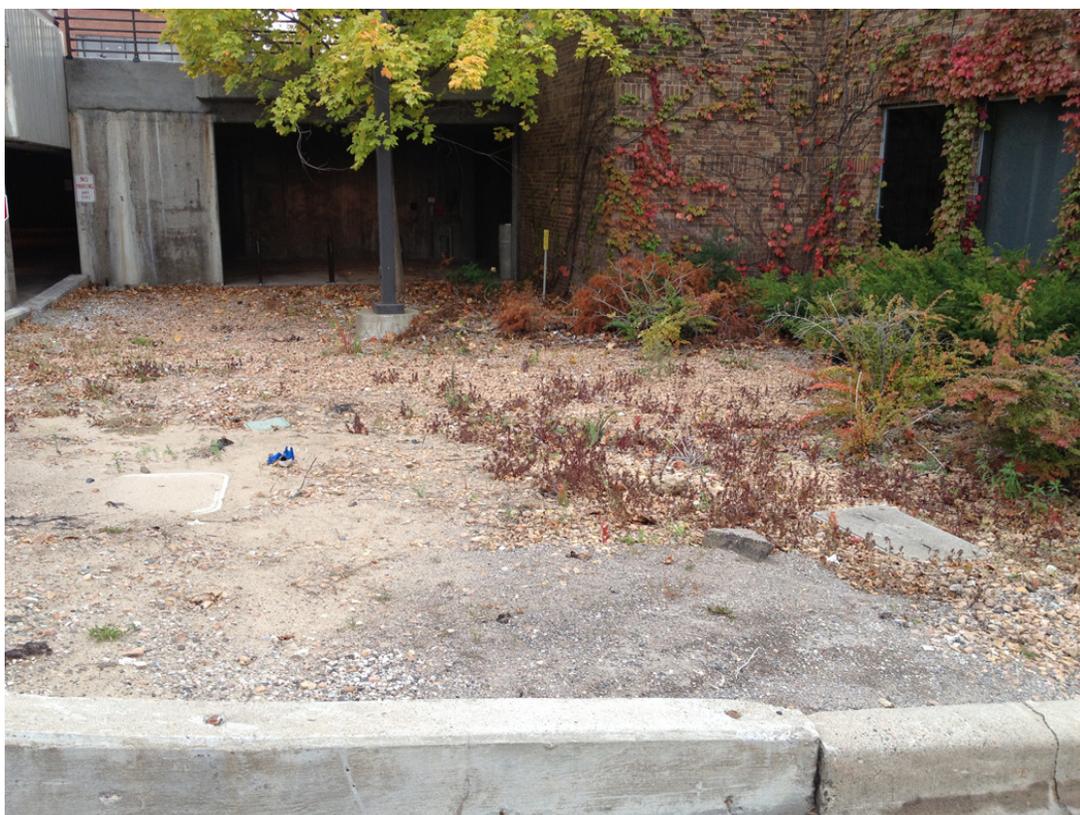
257

Municipal Center: Neglected landscape

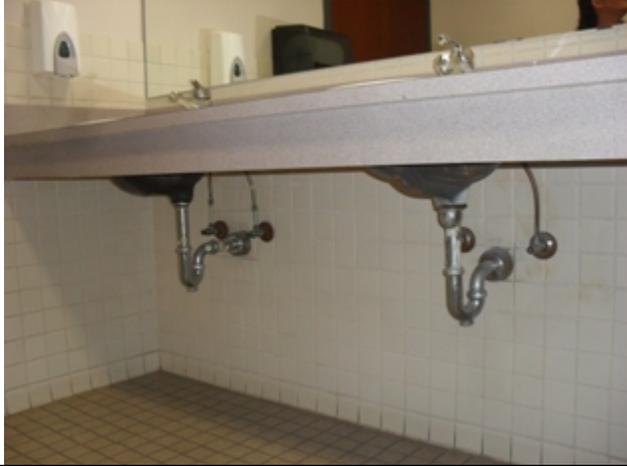
<p>Upper level public restrooms with exposed waste and water piping is not in compliances with the Americans with Disabilities Act.</p>

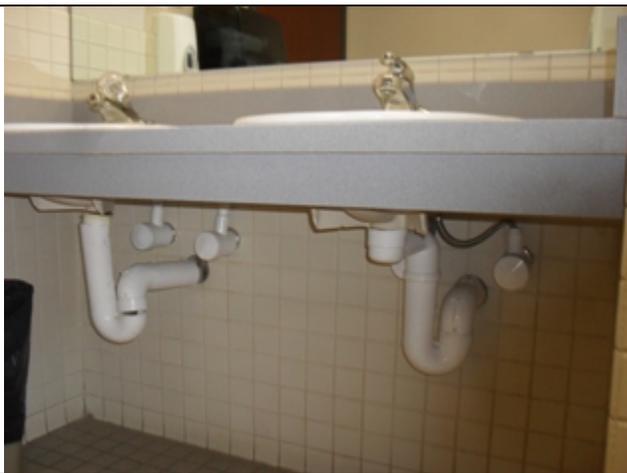
<p>Lower level public restrooms. Waste and pipe covers are installed.</p>

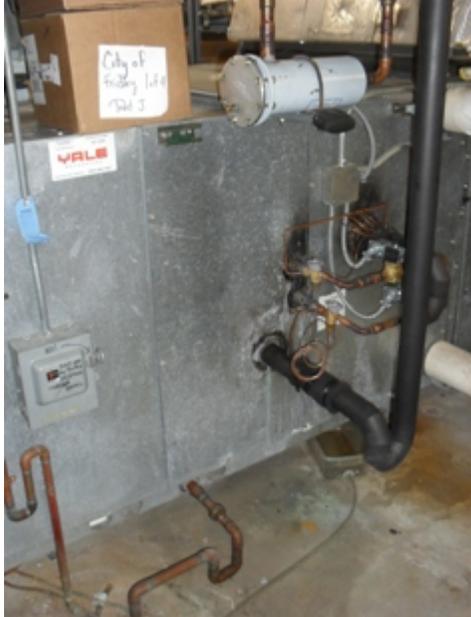
<p>Lower level air handling unit. Cooling coil was replaced in 2010.</p>

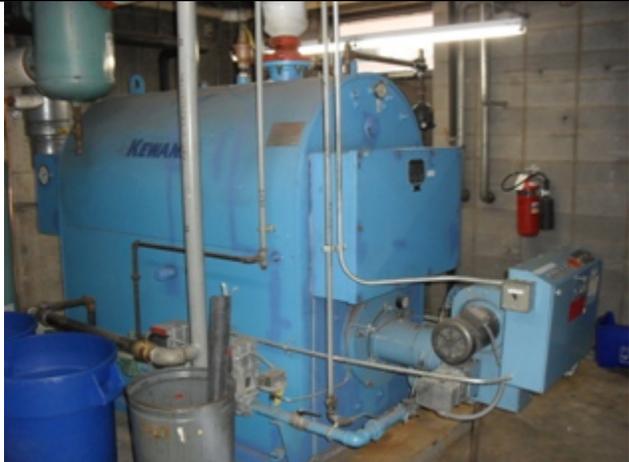
<p>Hydronic boiler installed in 1988.</p>

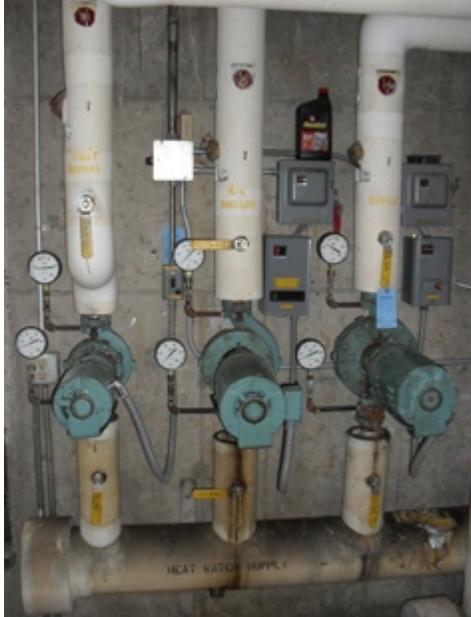
<p>The photograph shows three vertical heating water pumps mounted on a wall. Each pump has a green motor at the bottom and a white vertical pipe above it. There are several pressure gauges and electrical control boxes associated with the pumps. A horizontal pipe at the bottom is labeled "HEAT WATER SUPPLY".</p>	<p>Heating water pumps supply unit heaters, the lower level air handling unit and the office areas. The air handling unit pump in the center was off.</p>

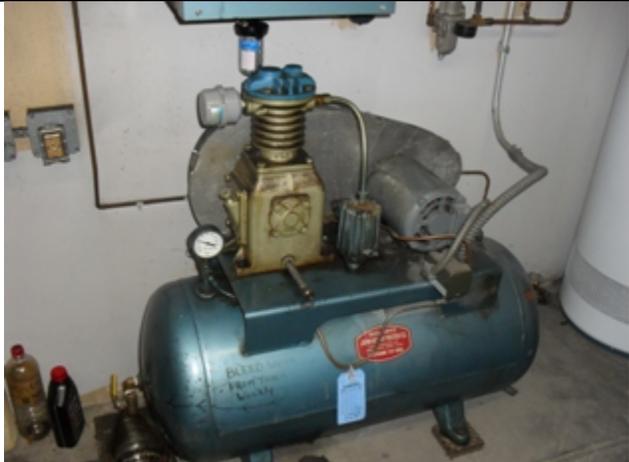
<p>The photograph shows a blue pneumatic control system air compressor. It has a large blue cylindrical tank, a yellow compressor head, and a grey motor. There are various pipes, valves, and gauges connected to the system.</p>	<p>Pneumatic control system air compressor. In good operating condition and able to maintain system pressure.</p>

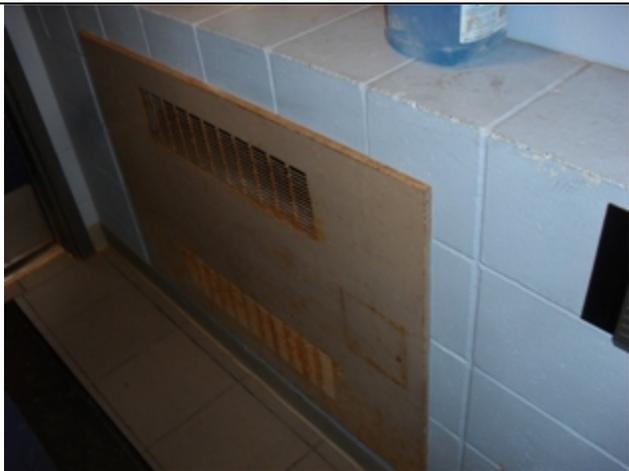
<p>Cabinet unit heater at back police station entry. Cover is rusty.</p>

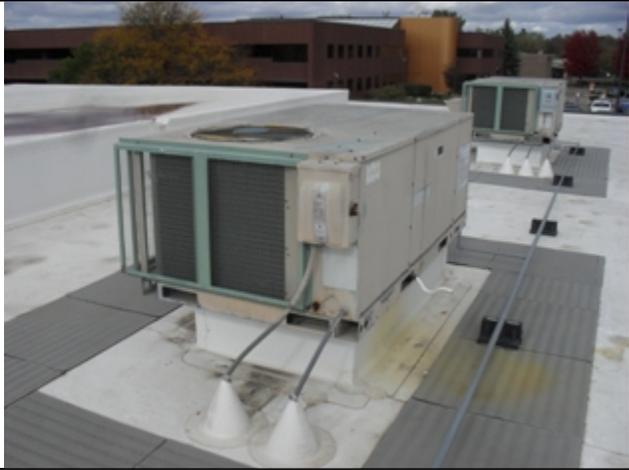
<p>Rooftop units installed in 1988.</p>

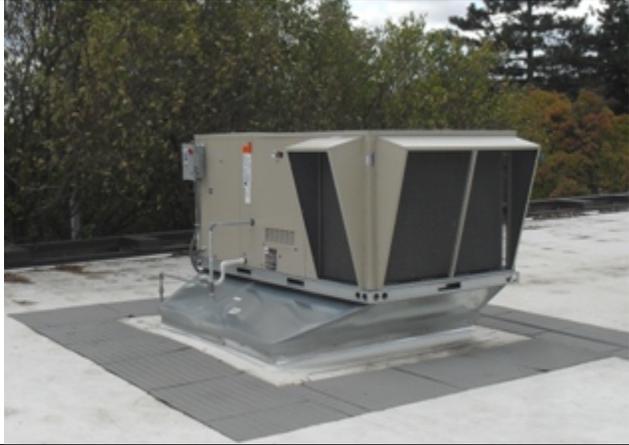
<p>Rooftop unit installed in 2011.</p>

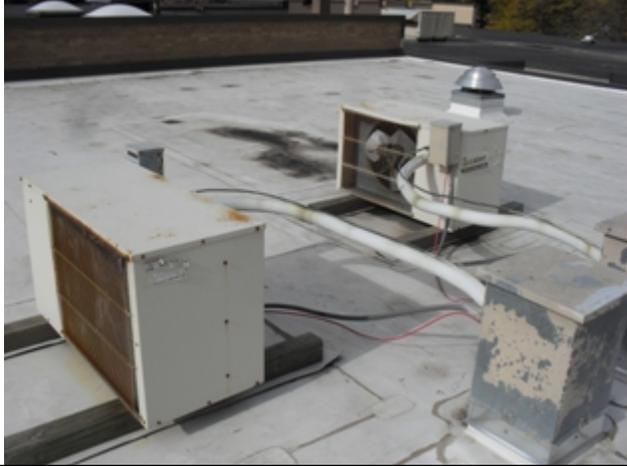
A photograph showing several outdoor condensing units for computer room air conditioning. The units are mounted on a flat, light-colored roof. One unit in the foreground is a large, white, rectangular box with a brown door. Another unit is a smaller, grey, boxy unit with a white condenser coil. A third unit is a white, cylindrical unit with a condenser coil. Various pipes and electrical conduits are visible connecting the units.	<p>Computer room condensing units.</p>

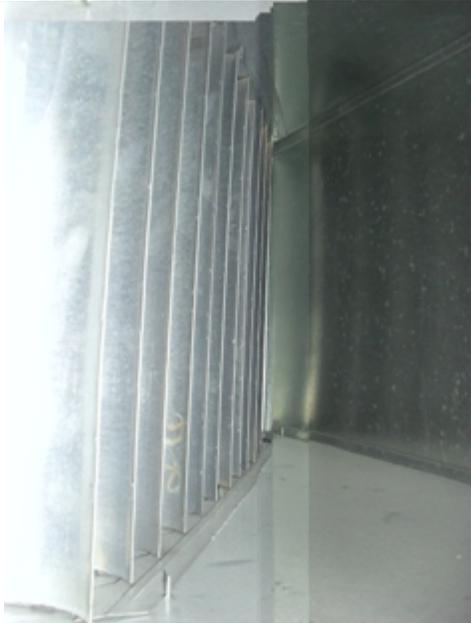
A photograph showing the interior of a return duct. The duct is lined with silver, reflective insulation. On the left side, there are several vertical, adjustable turning vanes. The vanes are made of a light-colored material and are currently in a closed position. The duct is clean and well-maintained.	<p>Turning vanes in the return duct to a computer room air-conditioning unit. Very clean.</p>

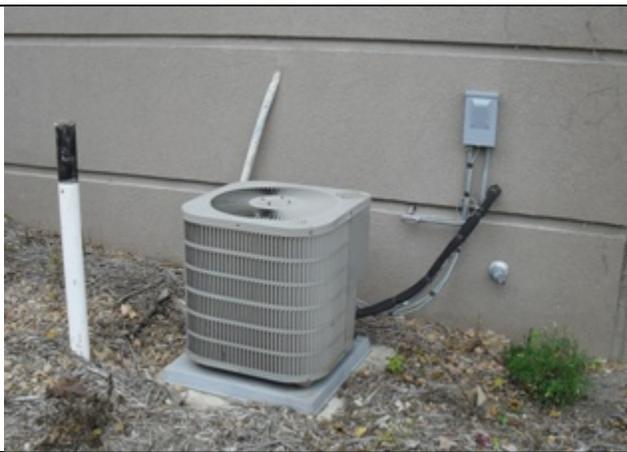
<p>Condenser for the lower level furnace is in very good condition with ample area adjacent to the unit that is free of plantings for good airflow.</p>

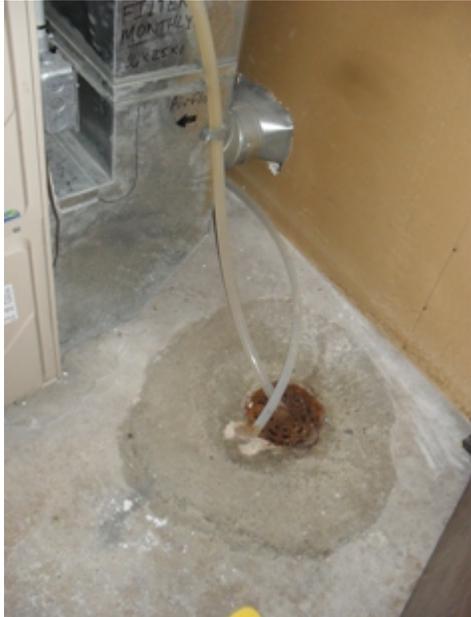
<p>Floor drain adjacent to lower level furnace unit has extensive corrosion. An acid neutralization kit should be installed to treat the condensate from the furnace before it is discharged to the drain.</p>

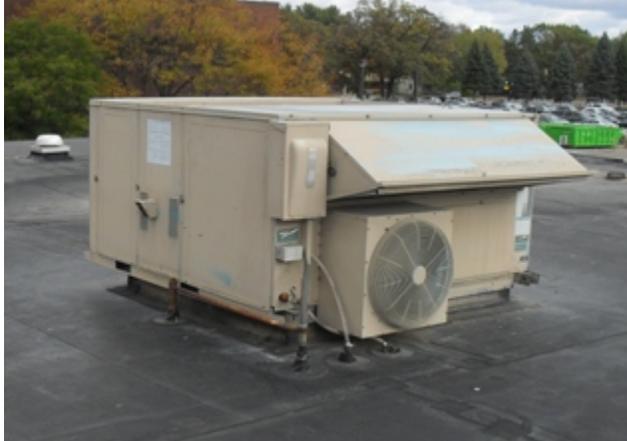
<p>Rooftop unit on housing side of fire station. Unit has failed and is scheduled for replacement in October 2013.</p>

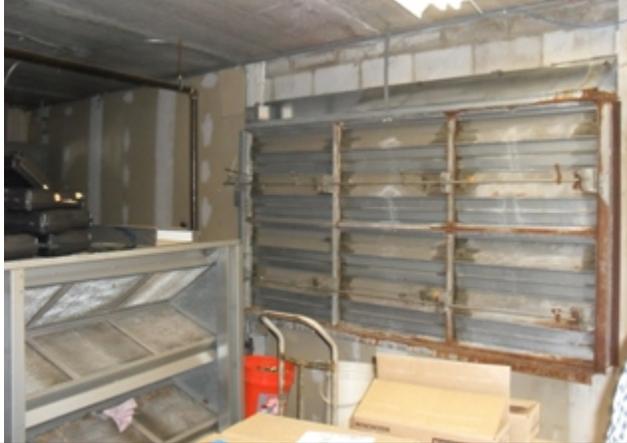
<p>Gun range makeup air unit filter intake on the left. Outside air damper on right. Rust and corrosion along right half of the unit.</p>

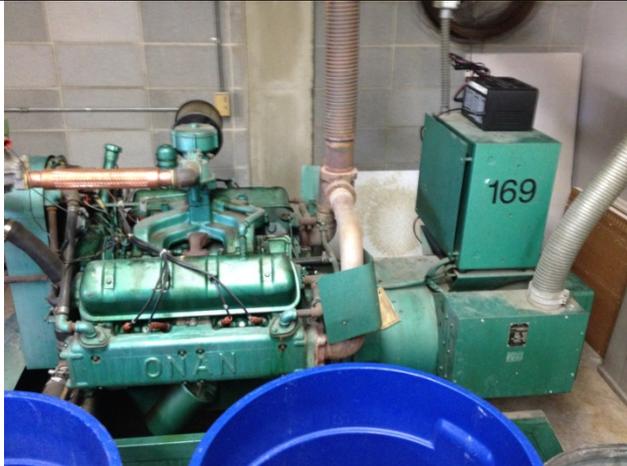
<p>The 85Kw generator located within the Municipal Center That was converted to natural gas. The age is estimated at over 40 years.</p>

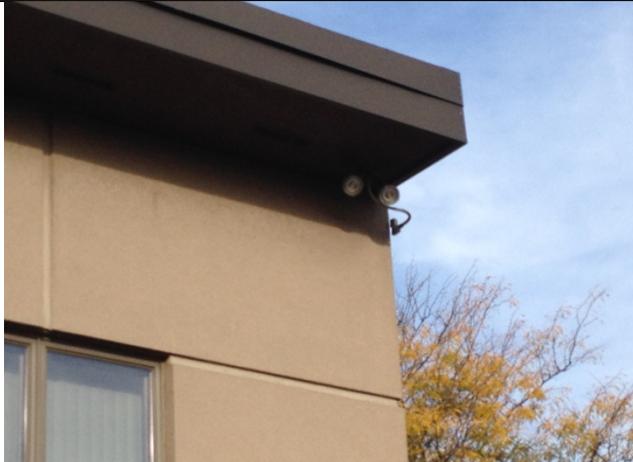
<p>Exterior wall mounted incandescent floodlight utilizing screw in fluorescent lamps.</p>

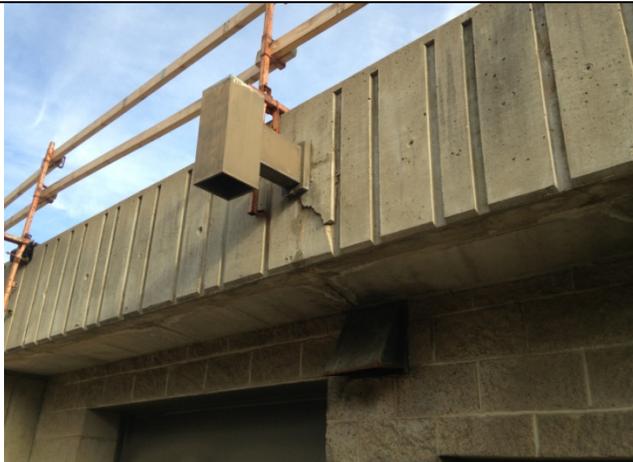
<p>The exterior wall mounted HID 'can' down light. All odds these down lights are in poor condition.</p>

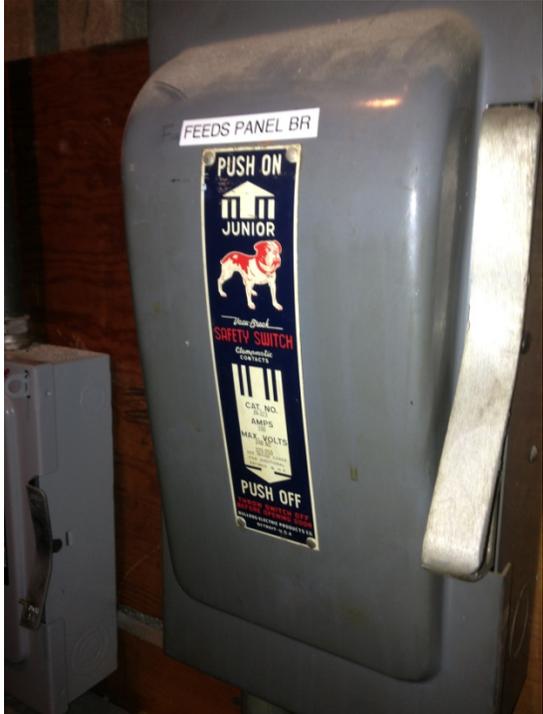
<p>A closer look at the Fire Station main service disconnect switch located in the lower level electrical closet. Estimated age of the switch is 44 years.</p>

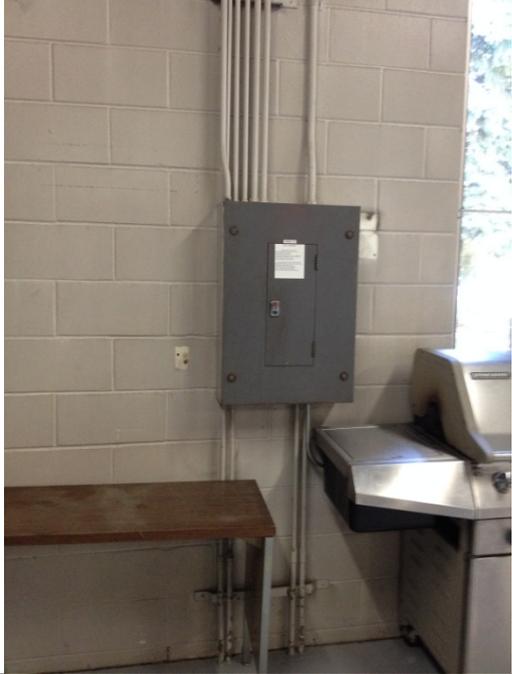
<p>Typical panel board in the Apparatus Bay of the Fire Station.</p>

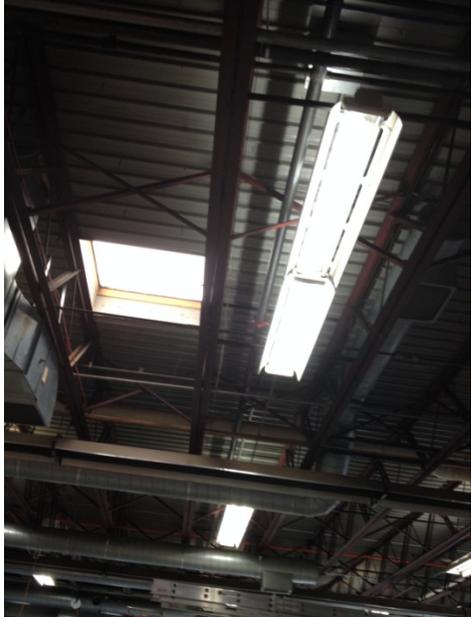
<p>Typical fluorescent industrial fixture located in the Apparatus bay of the Fire Station.</p>

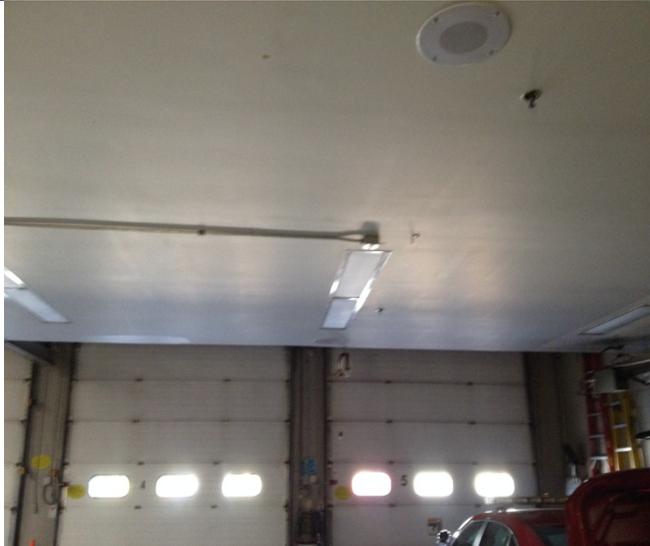
<p>Typical recessed fluorescent fixture in the Apparatus bay of the Fire Station.</p>

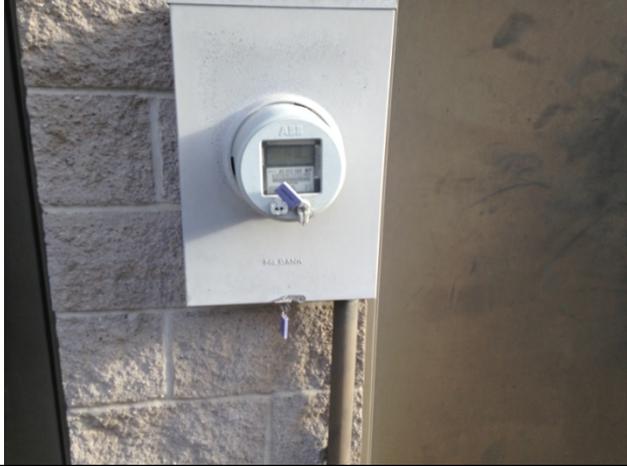
<p>Utility meter serving the Out Building.</p>

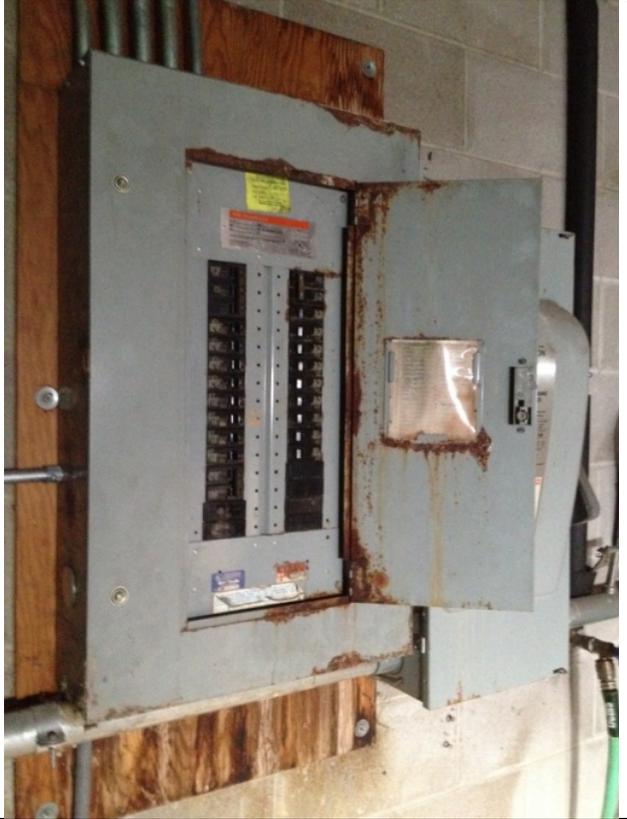
<p>Electrical panel board located in the Out Building vehicle storage area. The panel board is rusting inside and out.</p>

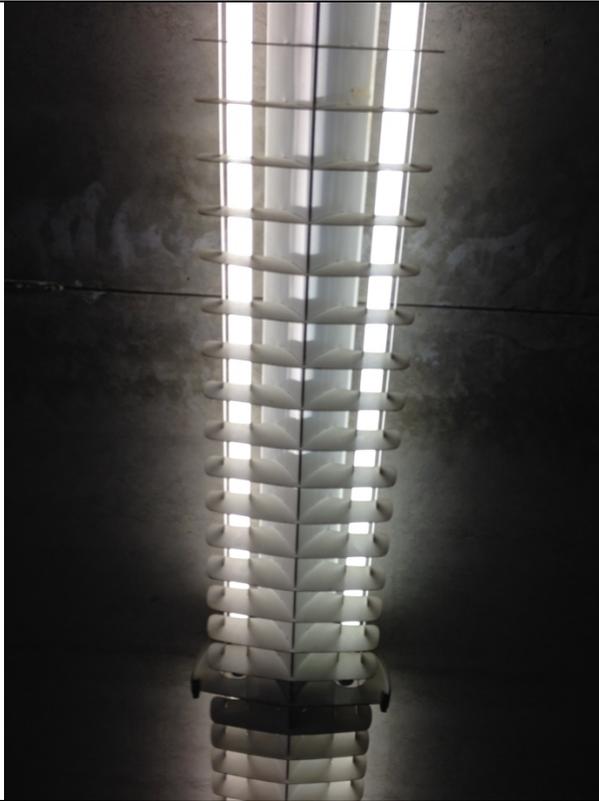
Typical 'old style' 4' fluorescent strip fixture located within the Out Building storage area.
